Wood Island Feasibility Study

Part One: Study of Site History and Initial Site Assessment

Part Two: Site Assessment and Recommendations

Completed for the Town of Kittery, Maine in cooperation with the University of New Hampshire and Appledore Engineering, Inc.

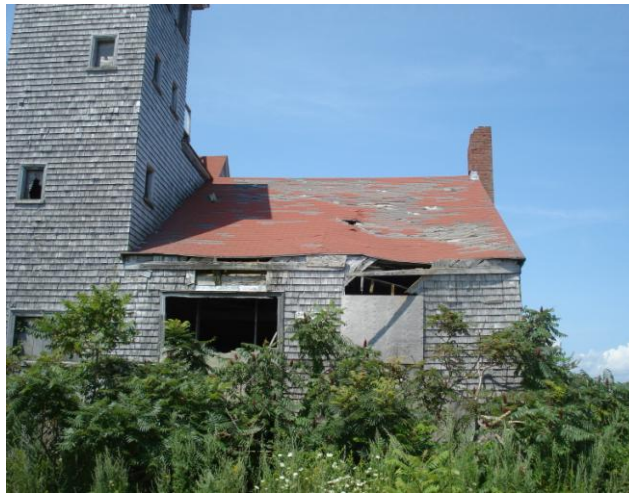
Generally the roof appears to be in good condition; however, a section over the boathouse has partially collapsed. The roof on the southern elevation has approximately fifty-percent of roofing shingles missing. This damage contributes to further deterioration of interior timber frame elements by rainwater.

Figure 6 Collapsed station roof

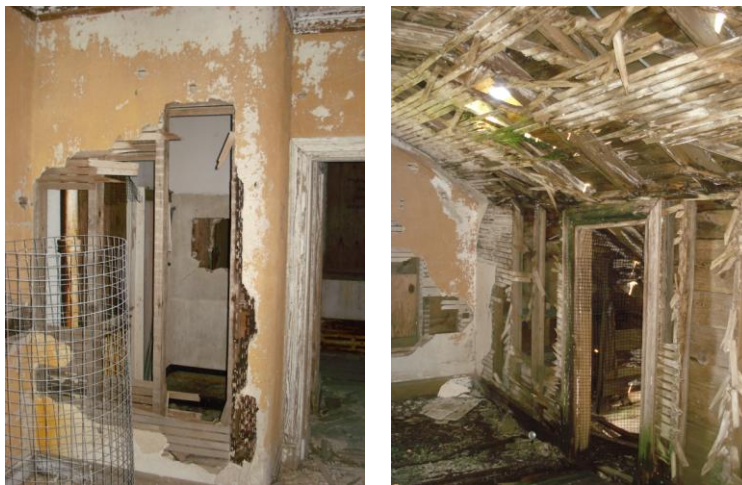
Extensive damage to non-structural elements exists throughout the interior. Wall plaster and gypsum are damaged or missing in most rooms. Entire wall sections, including framing, are also missing in many rooms.

Figure 9 Non-structural interior damage

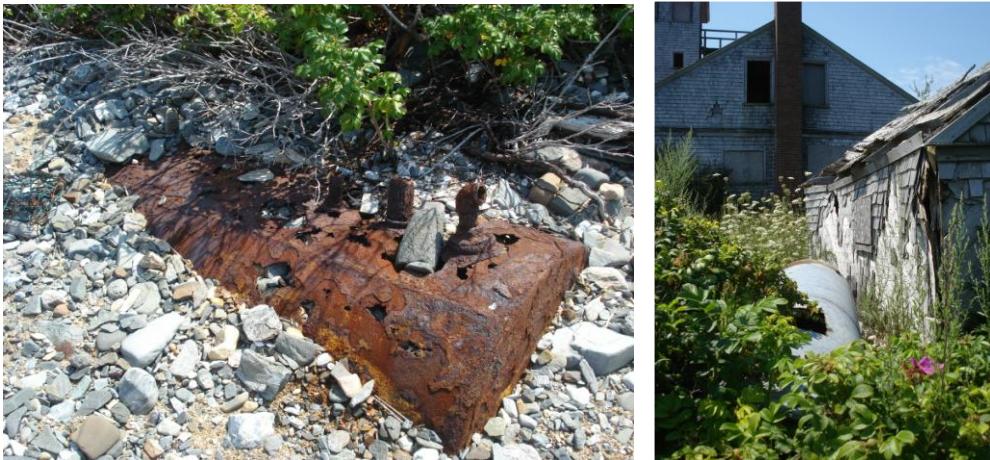
A total of three tanks were found outside near the station and tool house building. A large reservoir (assumed to be for drinking water) was found inside the basement of the station building.

Figure 24 Abandoned tanks

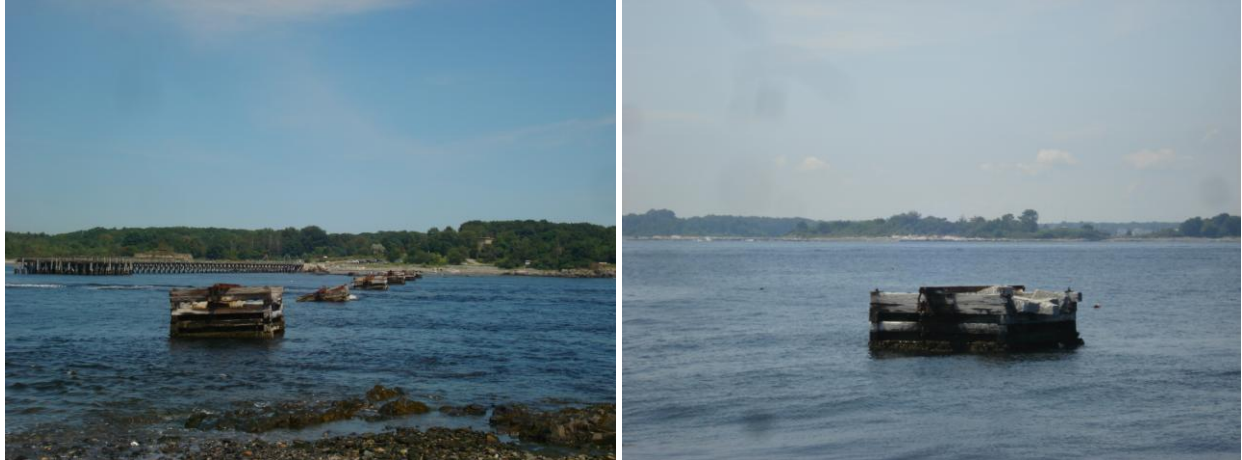
Figure 27 Cribs

Five of the seven cribs appear to be stable. Two of the cribs appear to have collapsed. The structural integrity of each crib may be comprised by wood degradation by marine-borers. A full dive inspection would be required to determine the extent of possible degradation.

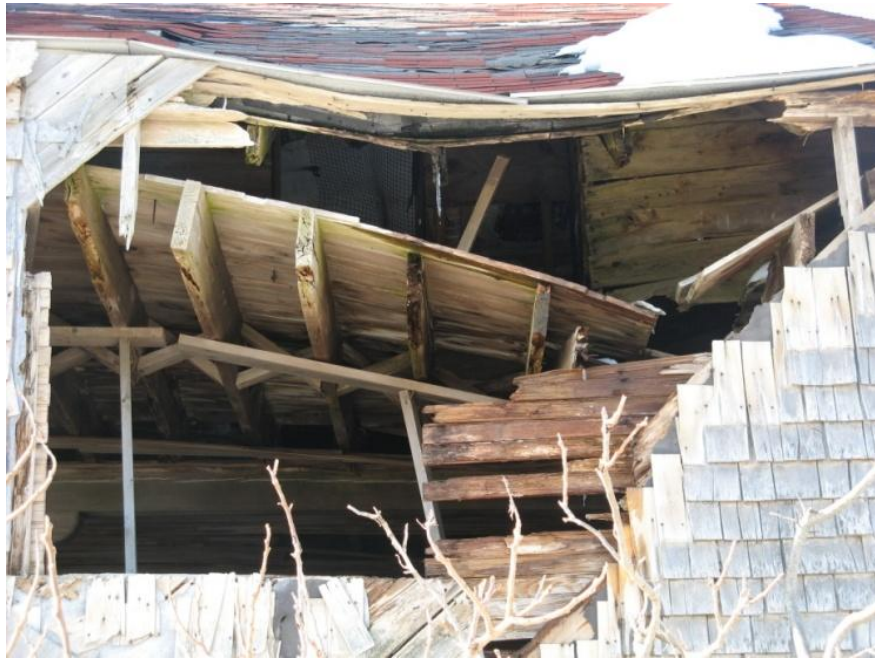
Figure 2: Damage near openings

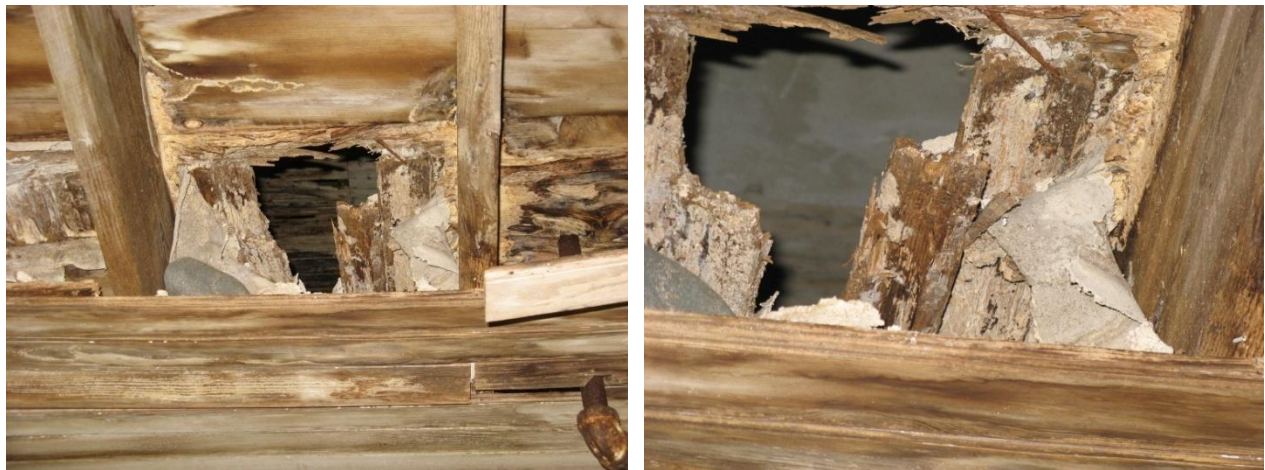
Another suspect asbestos-containing material is the roofing shingles. The roof material was replaced sometime in the 1990s, but without proof of particular material that was selected and installed; the shingles will also need to be tested. If the town of Kittery can provide documentation to disprove the existence of asbestos in the material, this test may not be necessary. The investigation also revealed a paper liner which was used throughout the entire structure, including locations from under the siding to between the floor boards and joists (Figure 4). This paper was assumed to be used as insulation, and is suspected to contain asbestos.

Figure 4: Paper liner within the floors that has been deemed suspect material

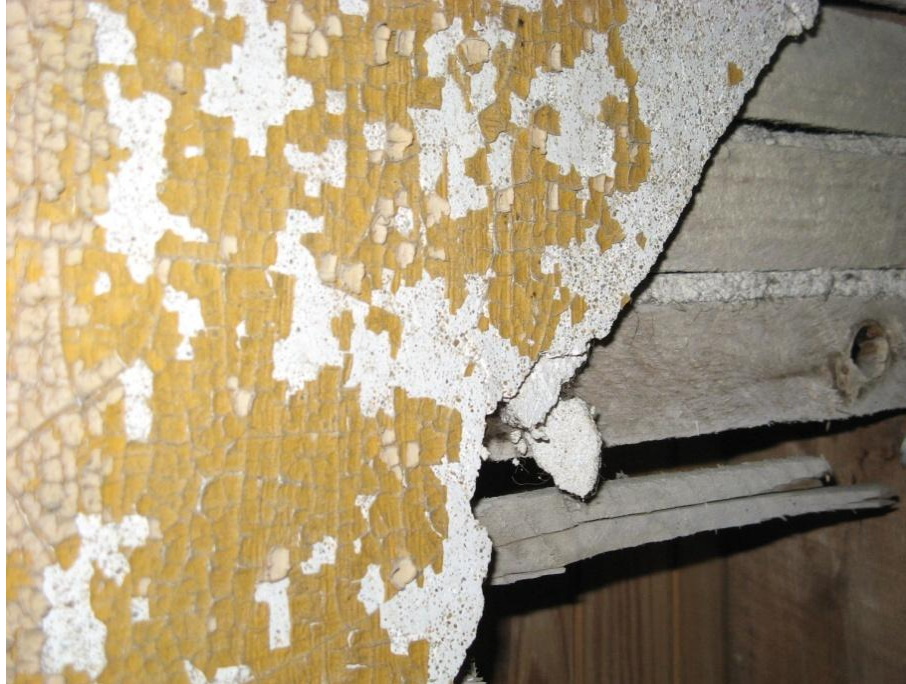
In addition to asbestos, lead paint is suspected to have been applied to the walls within the structure. This paint, as it has been exposed to a good deal of moisture and time, is now chipping off the walls. Although not a hazard unless consumed, the material could require special training for removal. It also could require special disposal. Again, laboratory testing is required before specific remediation or abatement options are considered.

Figure 5: Lead paint chipping off interior walls

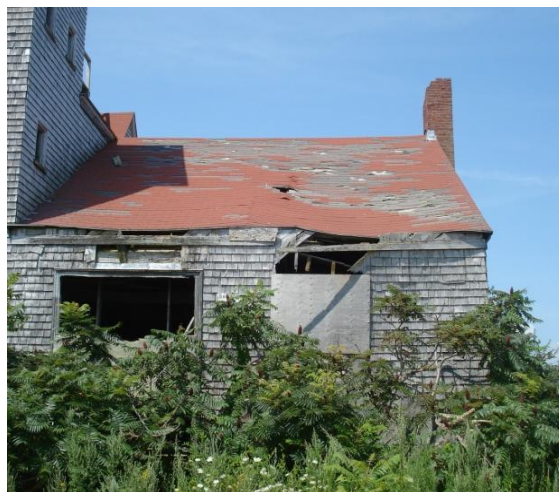
Figure 9: Damage to roof in July 2008

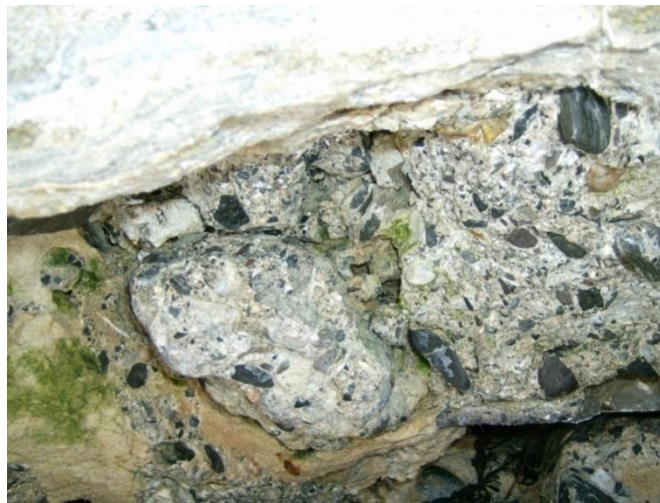
Figure 20: Closer Image of Undercutting of South Seawall

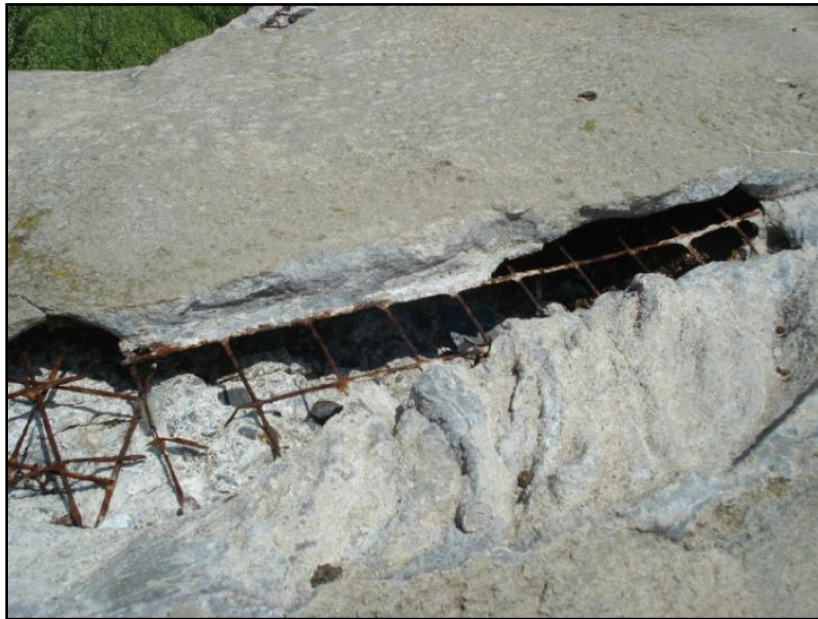
The chain and hammer test was used on the cap to determine the bonding of the shotcrete cap with the original wall. The chain test is where a large chain is dragged over the horizontal surfaces to detect a change in pitch where voids would be present under the surface. From the chain test it was found that the top horizontal face of the wall was not bonded for the entire length of the wall. The hammer test is done on vertical faces of the wall, similar to the chain test. It can determine voids present under the surface through changes in pitch as one bangs on the outside of the wall. The area of concern for bonding was found to be between the two mid-level weepholes on the wall extending to 10 feet on either side of them. In this area, a hollow sound was heard which suggests the cap was not bonded.

Figure 21: Damaged Top Section of South Seawall

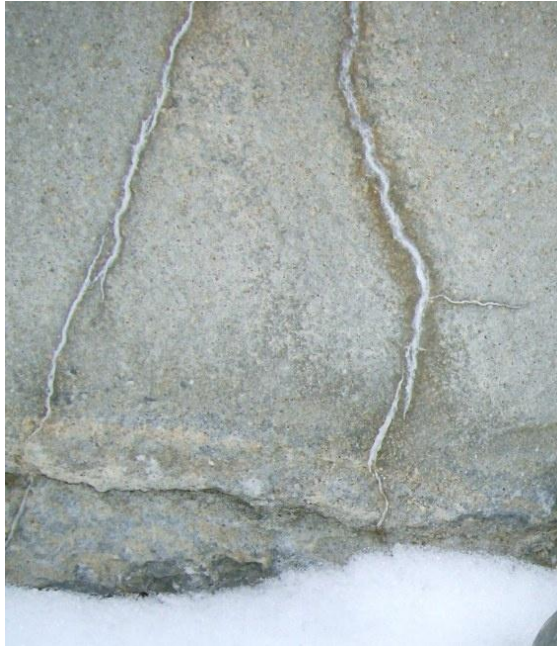
Seen in the figure below is the leaching of sulfates or salts, which were deposited from the seawater, from the face of the South Seawall. These sulfates may have contributed to the degradation of the paste of the wall, but furthermore have led to severe deterioration of the reinforcing steel mesh of the shotcreted cap. Further consideration must be paid to sulfate attack in the rehabilitation efforts due to reinforcement of a new structure as well as the use of tie anchors which would experience corrosion.

Figure 33: Leaching of Sulfates from South Seawall

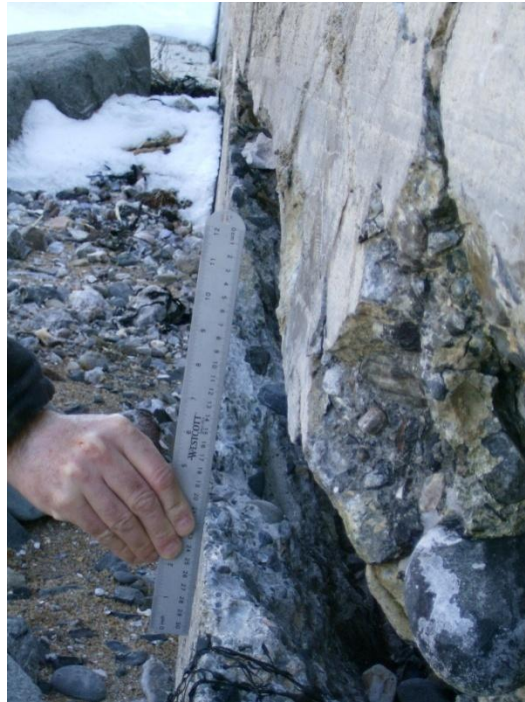
allows for the horizontal and vertical displacement of the structure as it fails and sooner or later will fall over.

Figure 36: Horizontal Displacement and Overturning of North Seawall (1)

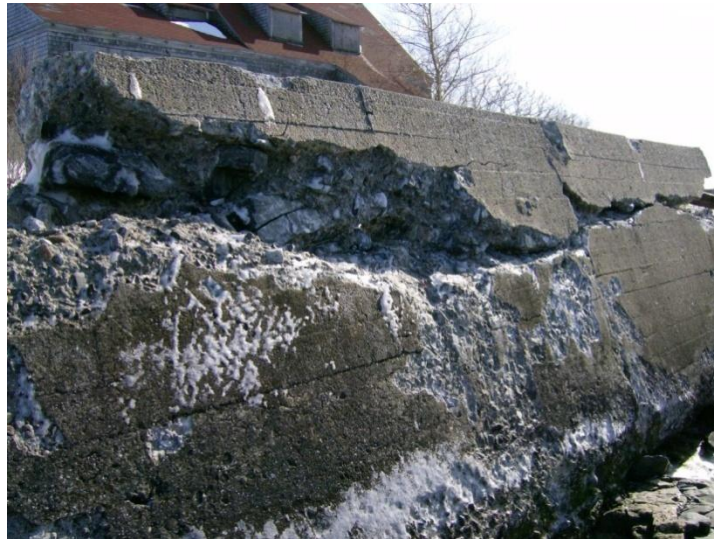
Figure 39: Freeze Thaw Action on North Seawall

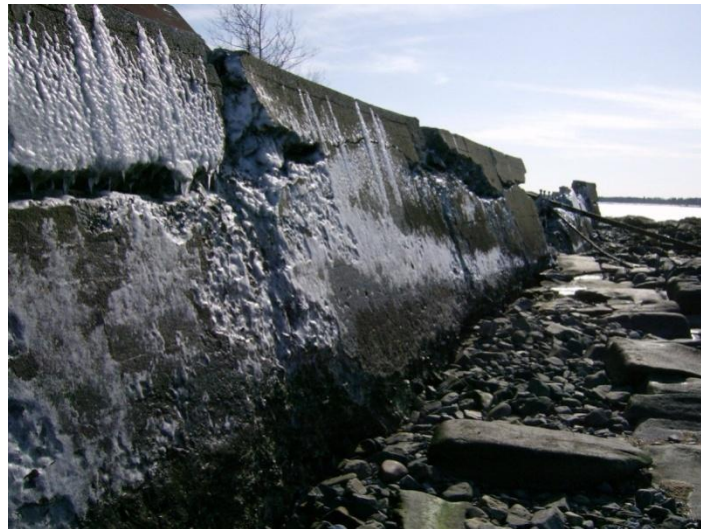
Figure 40: Visible Freeze Thaw on North Seawall

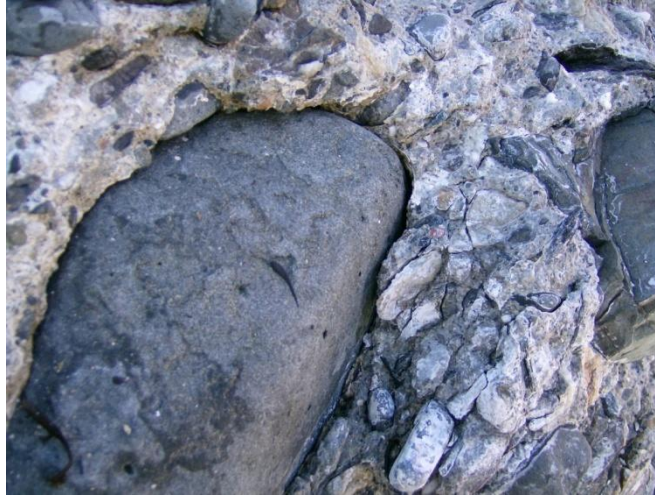
sever decrease in the structures overall strength. The voids present around the aggregates also are typical of Alkali-Silica Reaction present in the structure as internal stresses develop from ASR.

Figure 41: Un-bonding of Aggregate due to Freeze Thaw in North Seawall

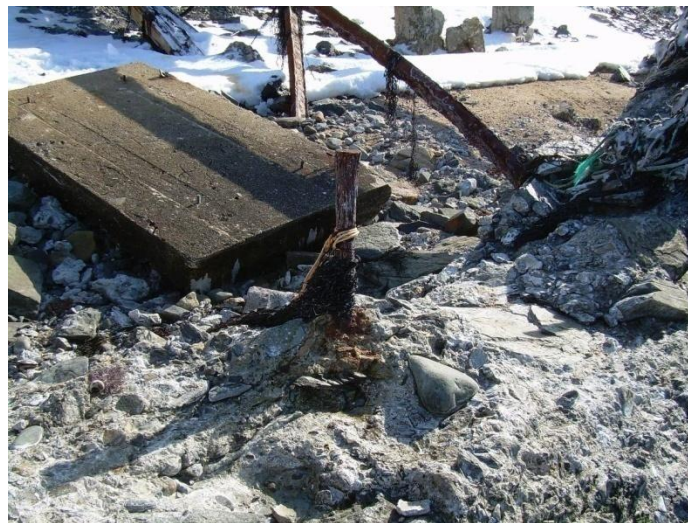
Figure 44: Corrosion of Tie Anchors along North Seawall (1)
