I. Description of Site

A. Wood Island

1. Wood Island Station

Conditions Assessment

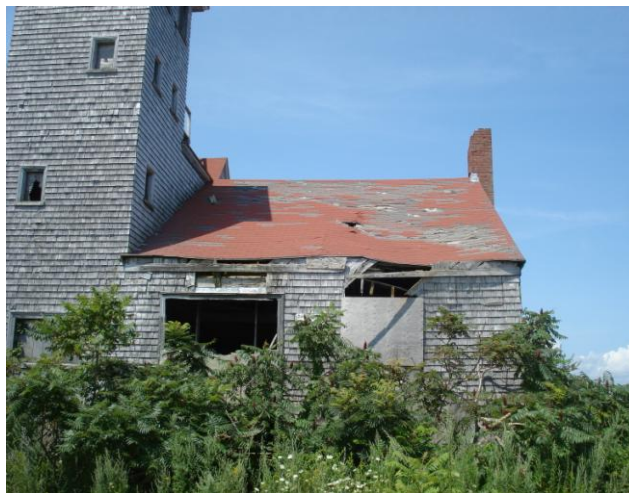
Generally the roof appears to be in good condition; however, a section over the boathouse has partially collapsed. The roof on the southern elevation has approximately fifty-percent of roofing shingles missing. This damage contributes to further deterioration of interior timber frame elements by rainwater.

Figure 6 Collapsed station roof

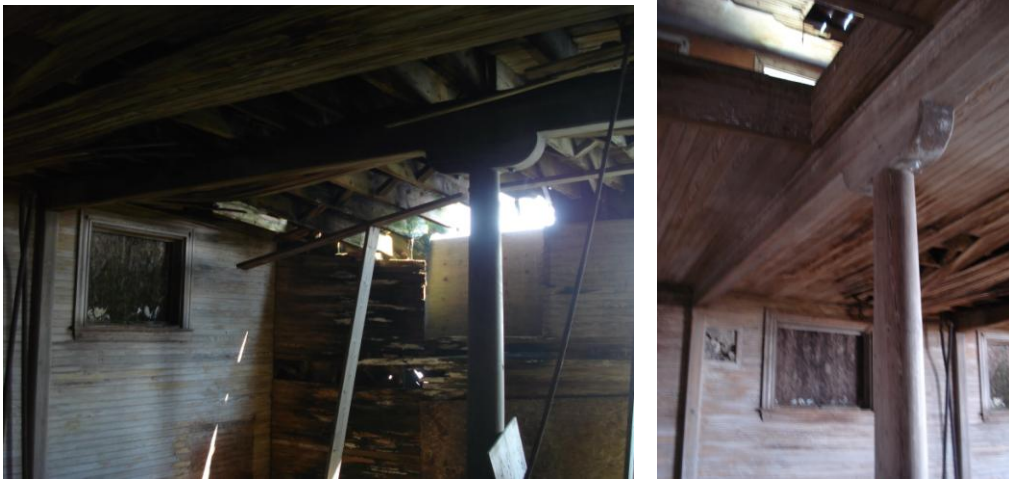
The conditions inside the structure vary depending on the condition of the roof above. Rooms below shingled roof sections are dry and without damage from moisture. The spaces in the boat house section below the roof failure have extensive damage from rotting structural elements. Parts of the floor in the boathouse on the first and second levels have damage and voids. There are dangerous soft spots in these floors. Floor damage is also present near open windows throughout the building.

Figure 8 Interior damage of boathouse

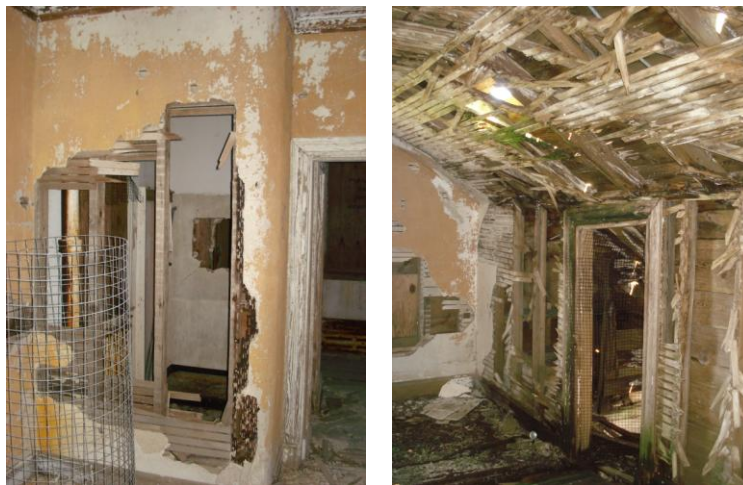
Extensive damage to non-structural elements exists throughout the interior. Wall plaster and gypsum are damaged or missing in most rooms. Entire wall sections, including framing, are also missing in many rooms.

Figure 9 Non-structural interior damage

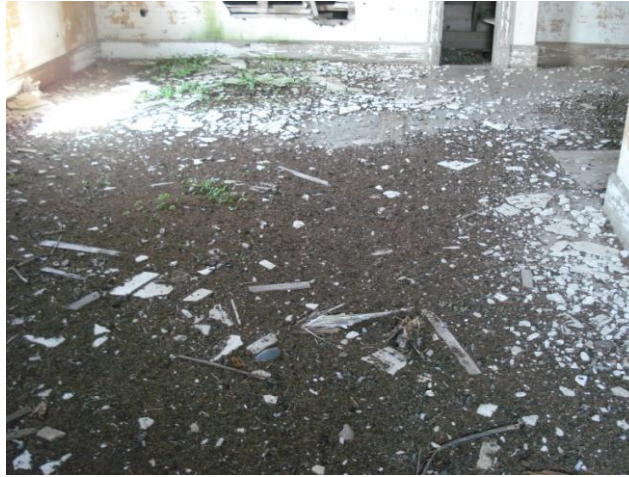
Large piles of seagull droppings exist in all spaces in the building. These piles are many inches deep in some areas on the upper levels. The putrid odor of the droppings is strong and present everywhere within the building. There is evidence that seagulls continue to inhabit the building.

Figure 10 Seagull droppings

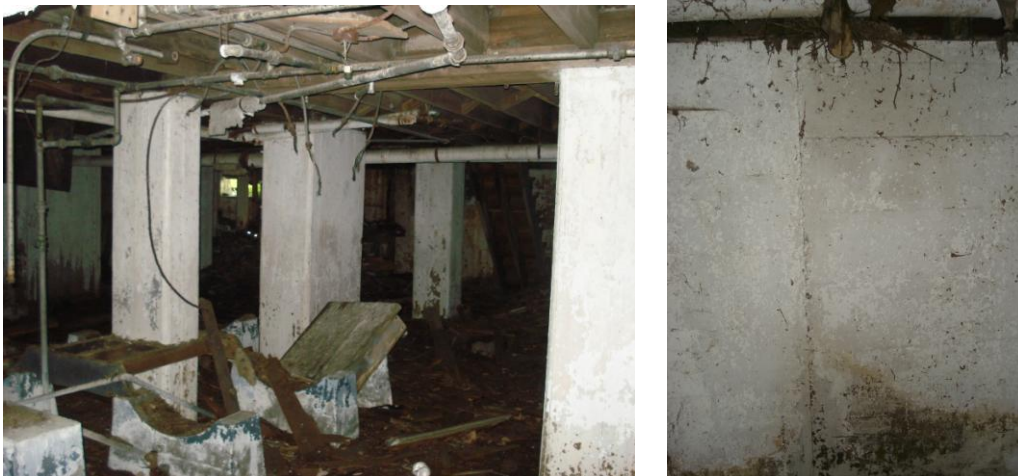
The foundations of the building are in good condition. There are no obvious signs of Alkali-Silica Reaction (ASR) on the structural columns or perimeter foundation in the basement. The smallest columns measure eighteen inches by eighteen inches.

Figure 11 Station foundations

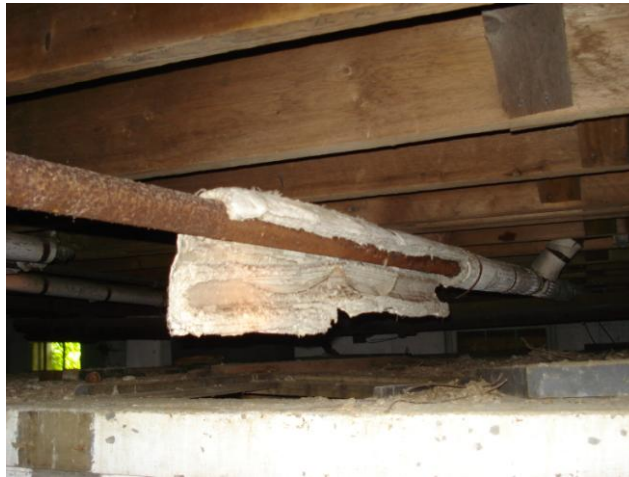
Piping in the basement appears to be covered with asbestos insulation. Only large diameter pipes like those pictured in Figure 16 are insulated.

Figure 12 Fibrous pipe insulation

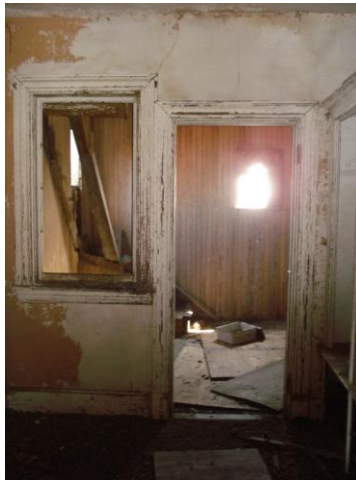
The paint used on the interior walls and moldings appears to be lead based due to its flaky appearance and the time period the building was constructed and maintained.

Figure 13 Stairs and peeling paint

The stairs throughout the interior are damaged or missing. On many levels, make-shift boards with footings were installed previously. The stairs to the basement from the first floor and from the outside are in good condition.

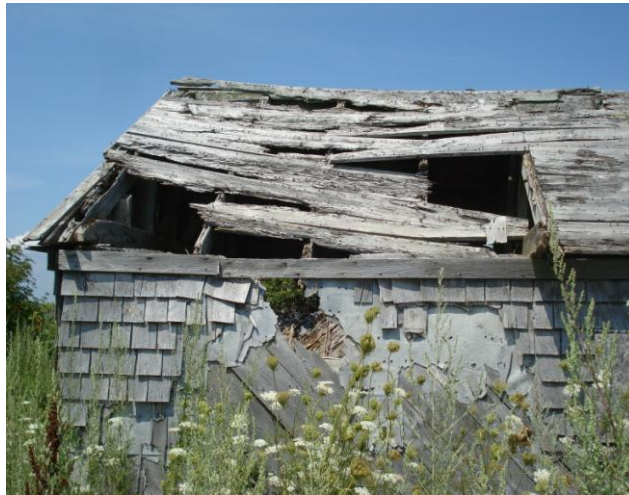
Figure 14 Tool House Building

A section of rafters failed resulting in a partial collapse of the roof. Much of the roof structure is heavily deteriorated and at risk of collapse. A section of the rear wall has been destroyed.

Most of the siding shingles remain and are in good condition; they appear to match the shingles on the station.

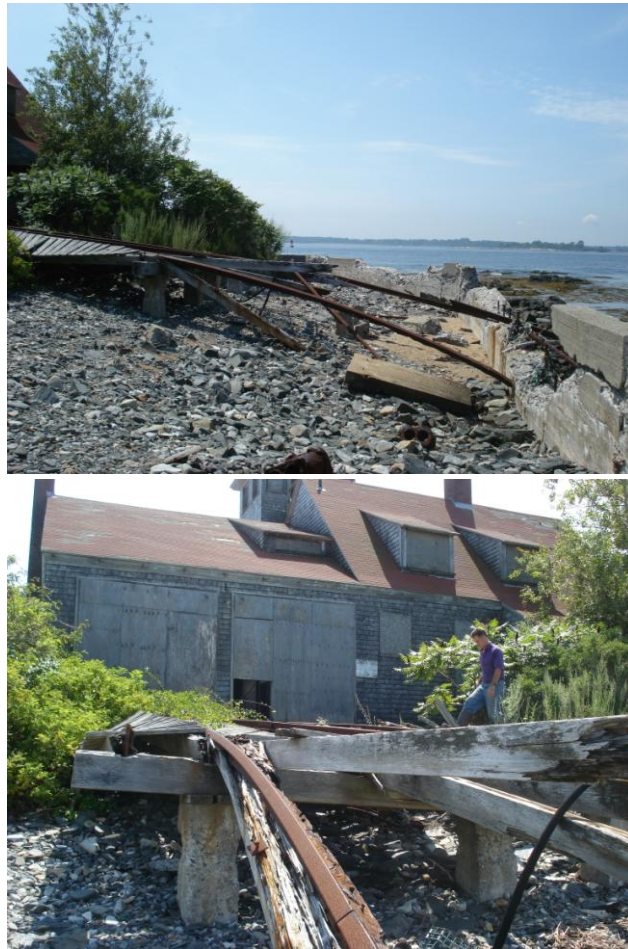
Figure 16 Marine Railway

The railway is badly damaged and unsafe. The railway originally extended several yards beyond the sea wall. The concrete foundation is intact but has degraded and appears damaged. The primary wood beams supporting the rails are partially intact; some secondary beams have collapsed. The rails and wooden decking have also collapsed. Most of the original rails have bent out of shape due to the missing substructure. Sections of the rail are missing.

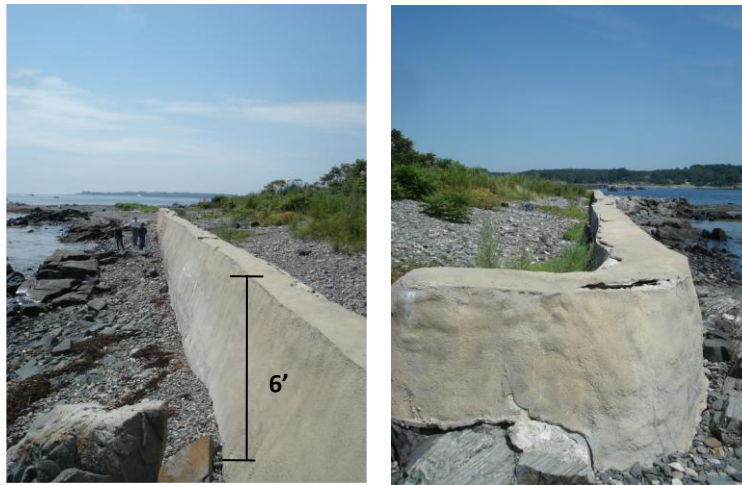
Figure 18 Outer south seawall

By visual inspection, the entire two hundred and fifteen foot wall appeared to have been covered with new concrete. Many sections along the top of the wall have broken away from the steel mesh as seen in Figure 26.

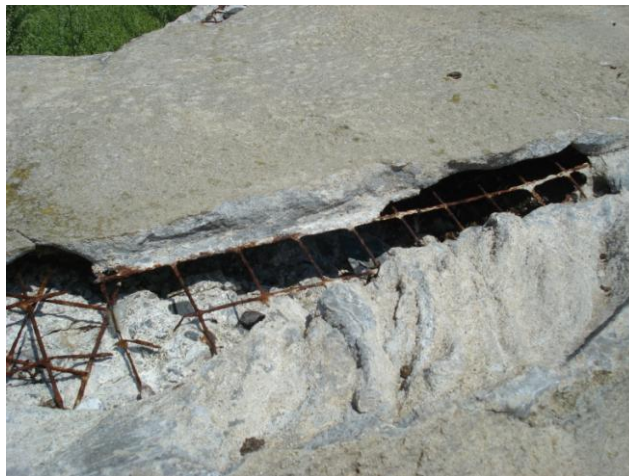
Figure 19 Damaged top section of south seawall

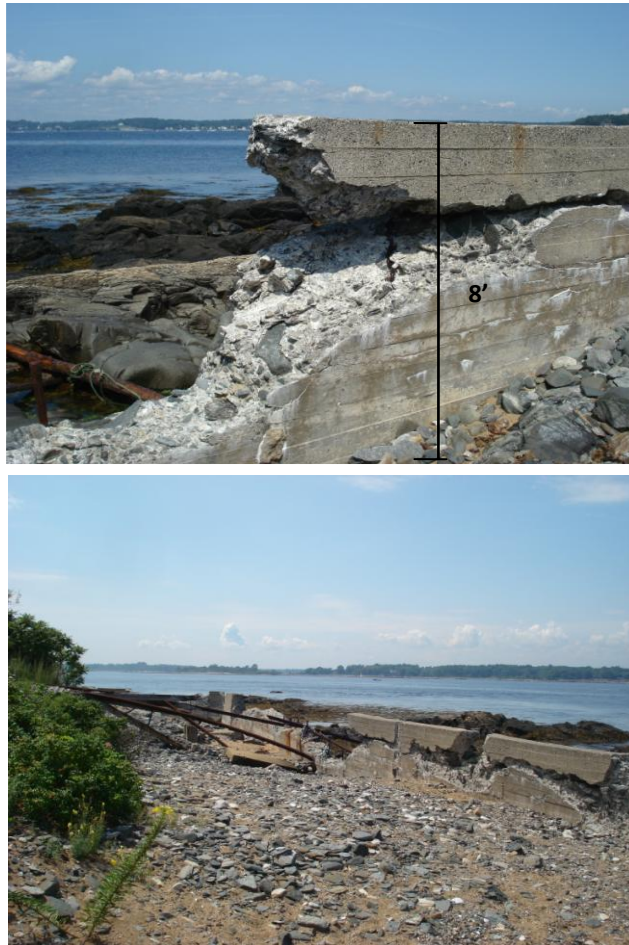
Signs of Alkali-Silica Reaction (ASR) are present along the seawall. ASR will need to be confirmed by laboratory testing. Large wall sections have been destroyed and are missing. Presumably the combination of wave action, ASR expansion and freeze/thaw cycles has reduced the wall to its present state.

Figure 20 Inner north seawall damage

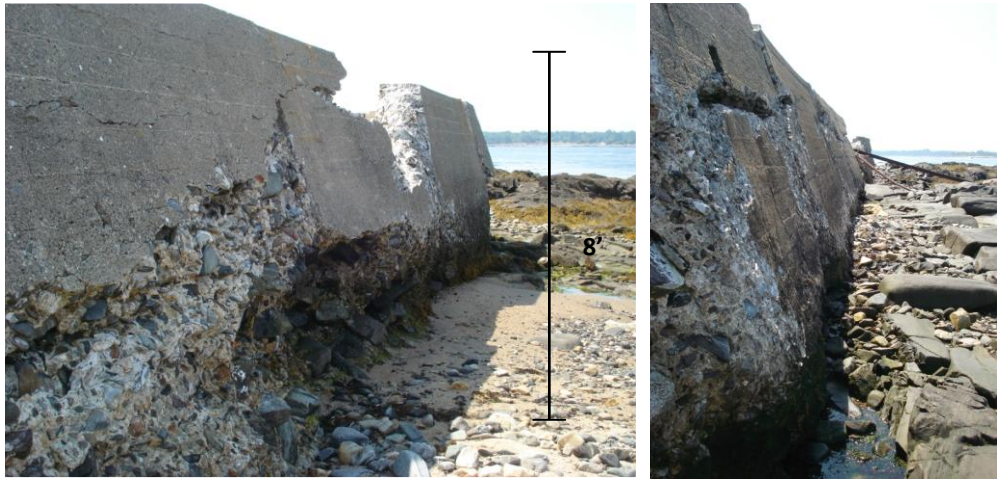
Figure 21 Outer north seawall damage

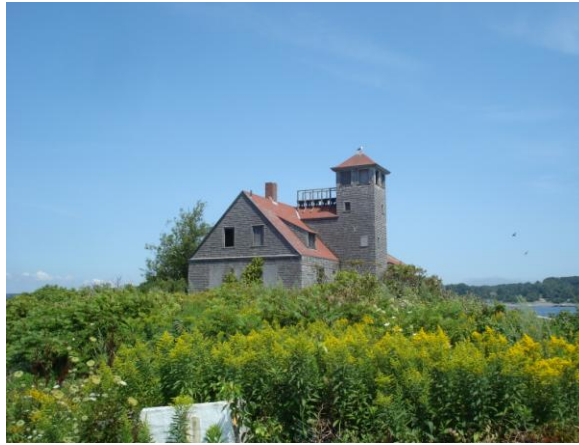
As seen in Figure 33, any existing pathways on the Island are completely overgrown.

Figure 23 Overgrowth

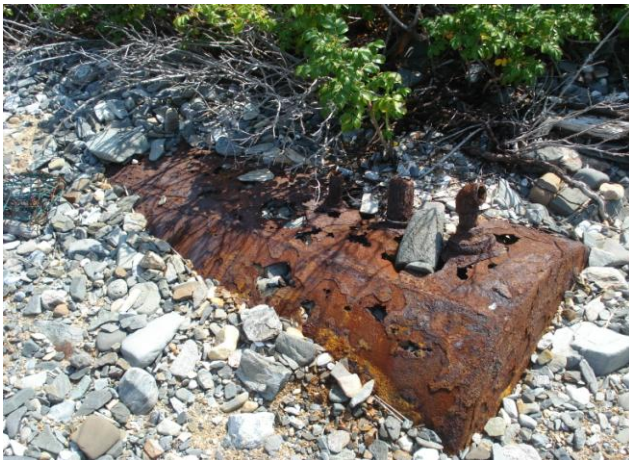
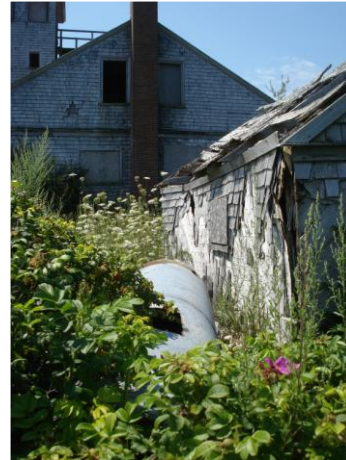
A total of three tanks were found outside near the station and tool house building. A large reservoir (assumed to be for drinking water) was found inside the basement of the station building.

Figure 24 Abandoned tanks

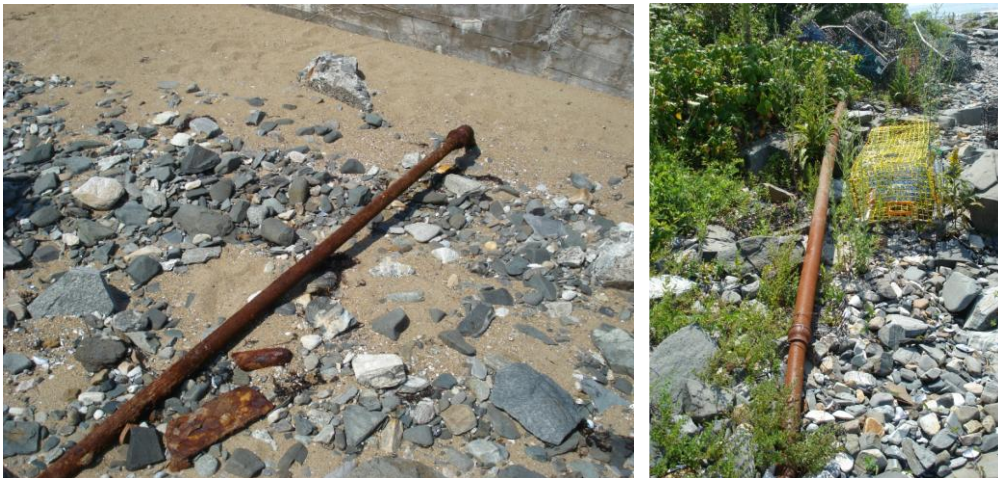
Many large diameter pipes lay scattered on the island. They appear to be damaged and corroded through. There are also several dozen abandoned lobster traps scattered across the island as seen in Figure 38.

Figure 26 Piping

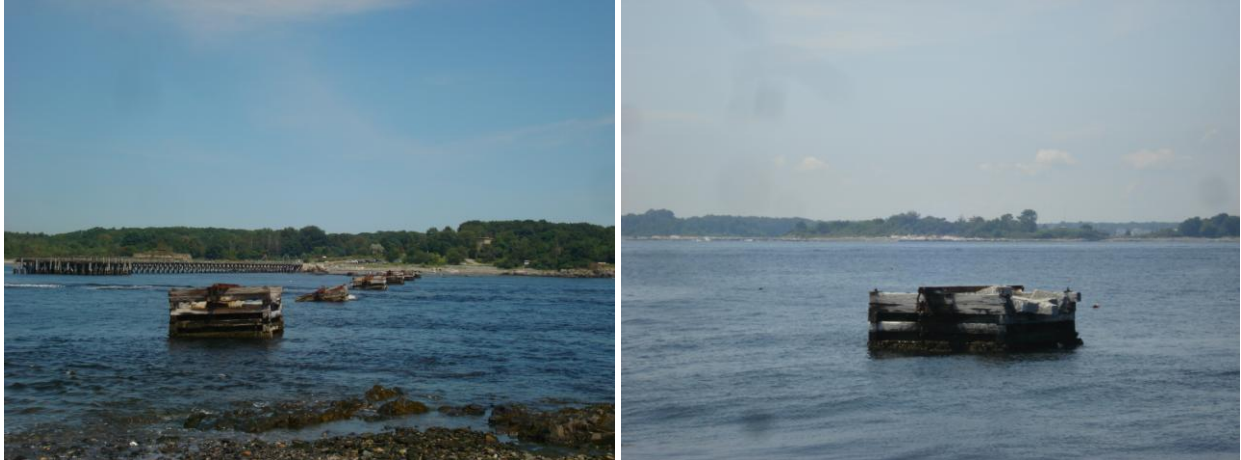
Figure 27 Cribs

Five of the seven cribs appear to be stable. Two of the cribs appear to have collapsed. The structural integrity of each crib may be comprised by wood degradation by marine-borers. A full dive inspection would be required to determine the extent of possible degradation.
