April 2009

## **II. Seawall Assessment**

Katherine Andruchuk, Seth Lizotte

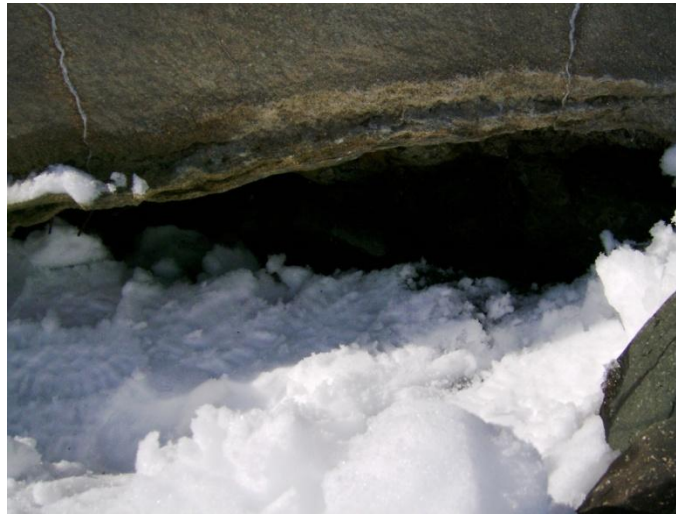
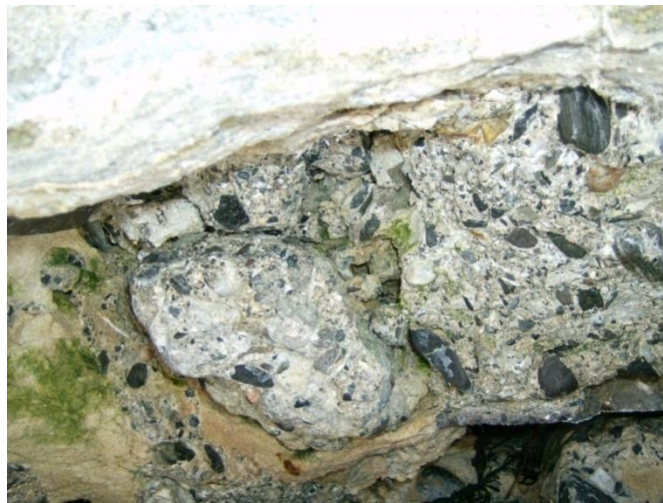
One of the initial observations made of the south seawall was the signs of undercutting by wave action.

**Figure 19: Undercutting of South Seawall**

**Figure 20: Closer Image of Undercutting of South Seawall**

Undercutting has occurred on the structure since no foundation was originally constructed for the seawall. As seen from visual inspection, it was rather cast in place on the island and anchored into the bedrock. As weathering occurs over time, waves come in contact with the bottom of the seawall and wear away at the base. Weathered segments of the wall are then carried away, undercutting the seawall as a whole and thus weakening the overall stability of the structure.

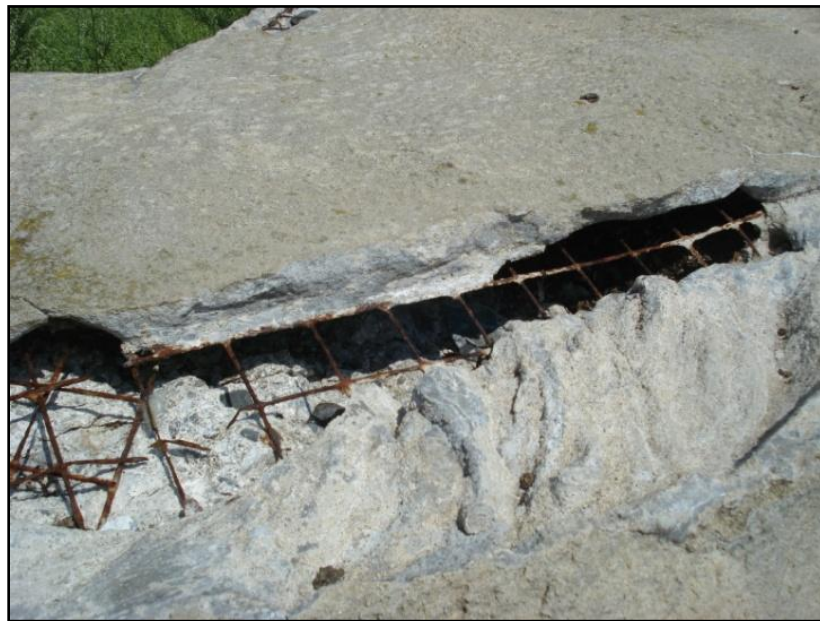
The chain and hammer test was used on the cap to determine the bonding of the shotcrete cap with the original wall. The chain test is where a large chain is dragged over the horizontal surfaces to detect a change in pitch where voids would be present under the surface. From the chain test it was found that the top horizontal face of the wall was not bonded for the entire length of the wall. The hammer test is done on vertical faces of the wall, similar to the chain test. It can determine voids present under the surface through changes in pitch as one bangs on the outside of the wall. The area of concern for bonding was found to be between the two mid-level weepholes on the wall extending to 10 feet on either side of them. In this area, a hollow sound was heard which suggests the cap was not bonded.

**Figure 21: Damaged Top Section of South Seawall**

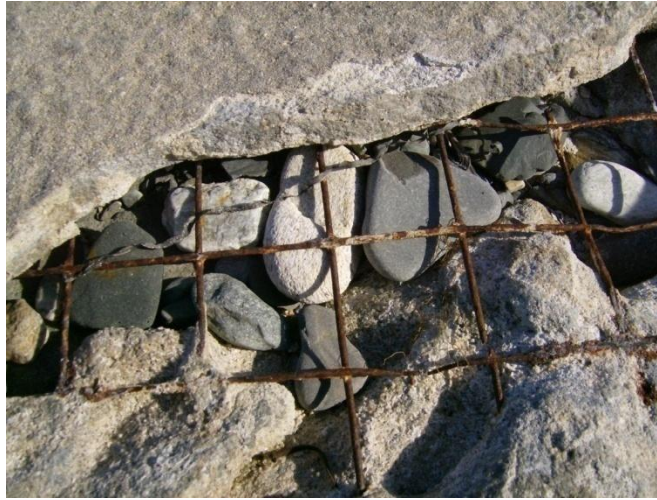
By visual inspection, the entire two hundred and fifteen feet of wall have been previously covered with a shotcreted face. This cap consisted of sparse fiber reinforcement in the paste, a 1/8" mesh reinforcement cage which overtopped the existing wall, and ranged in thickness from less than half an inch in some areas to as much as 2 inches in others. From observation, it seems that the previous contractor filled holes present on the surface of the existing structure with gravel found on the island prior to capping, to fill in voids, see figure below.

**Figure 22: Un-bonded Shotcrete Cap of South Seawall with Gravel Fill**

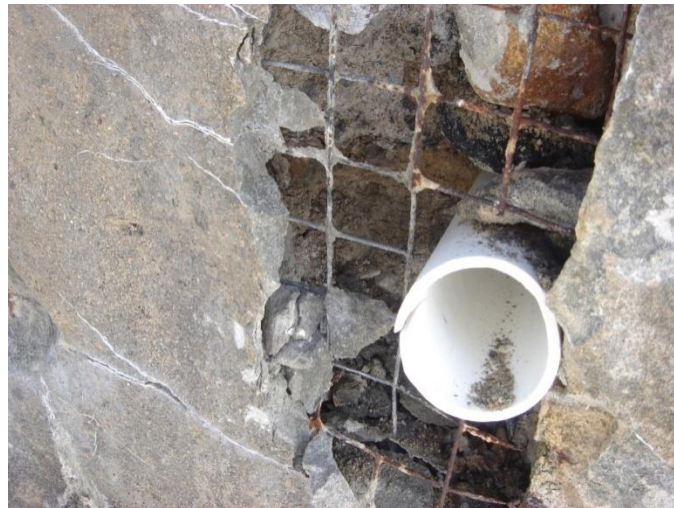
**Figure 23: Shotcrete Cap Not Bonded along face near Weepholes**

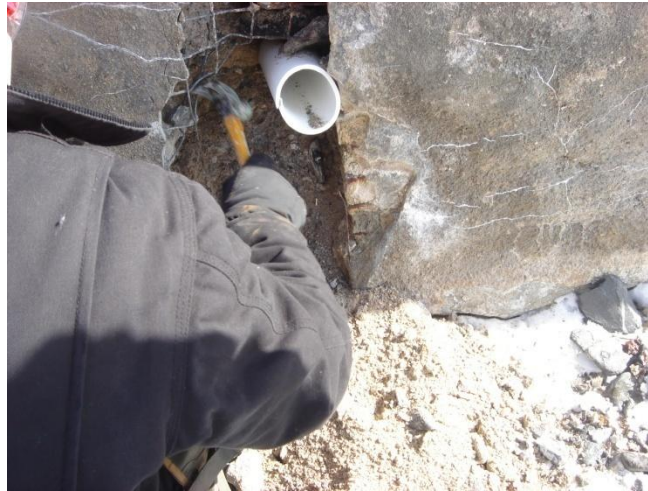
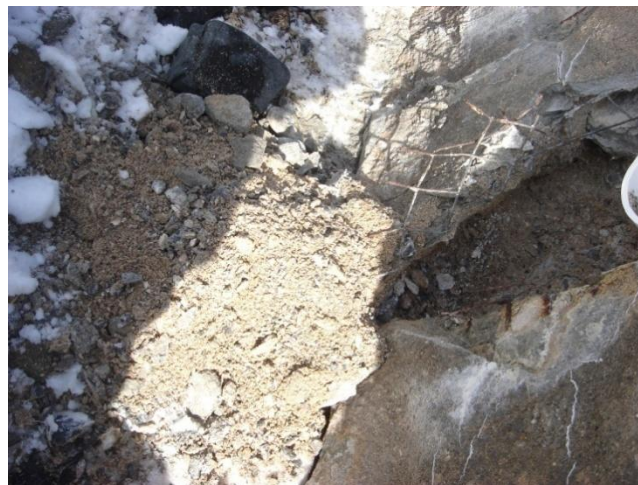
To determine the internal state of the existing south seawall, a chisel and hammer were used to expose concrete further into the structure. Since the most noticeable signs of weathering had occurred surrounding the weepholes, it was determined this was the best location to see the full extent of the damages. Using the chisel and hammer, a hole was made into the face of the wall with minimal effort. During chiseling, visual signs were seen of the degradation of the paste which bonds to the aggregates and provides strength. The paste crumbled into a sandy mixture and thus provided no strength to the wall; see the figures below. To examine various portions of the south wall, other holes were made which revealed the same results. It seems that not only the exterior of the wall was susceptible to weathering

and conditions, but as freeze thaw and Alkali-Silica Reactions occurred, weathering moved internally and has severely weakened the structure.

**Figure 24: Chiseling into Original Wall near Weephole Weathering**

**Figure 25: Weathering of Paste as seen through Chiseling**

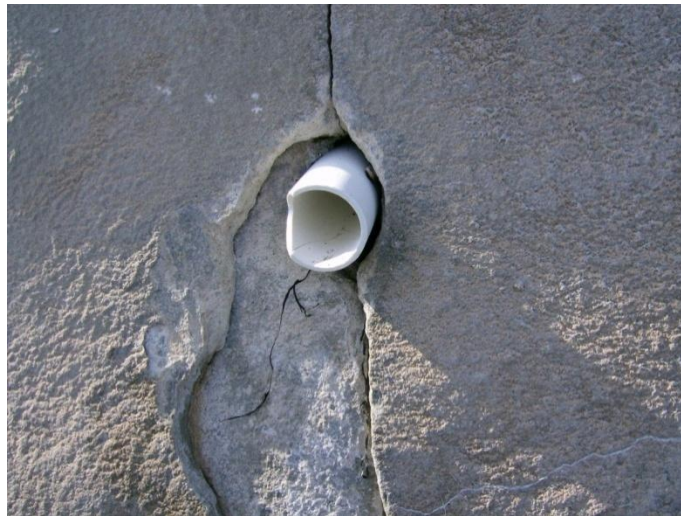
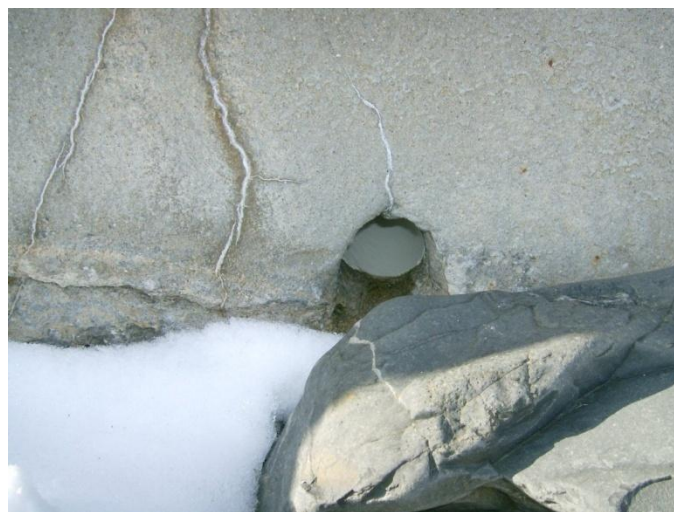
south seawall there was only four weepholes along the entire length. Two were located about 3 feet from the toe of the structure and two were located at the toe of the structure. Due to the inadequacy of the drainage, it conceivably led to the erosion of the backfill as well as further freeze thaw cycling as retained water would be in constant contact with the structure.

**Figure 26: Weephole located halfway up on South Wall**

**Figure 27: Weephole at toe of South Wall**

Under Duncan Mellor's guidance from experience on previous projects, it is recommended that weepholes be present in 8 foot intervals horizontally and with 3 foot vertical spacing along the entire length of the wall.

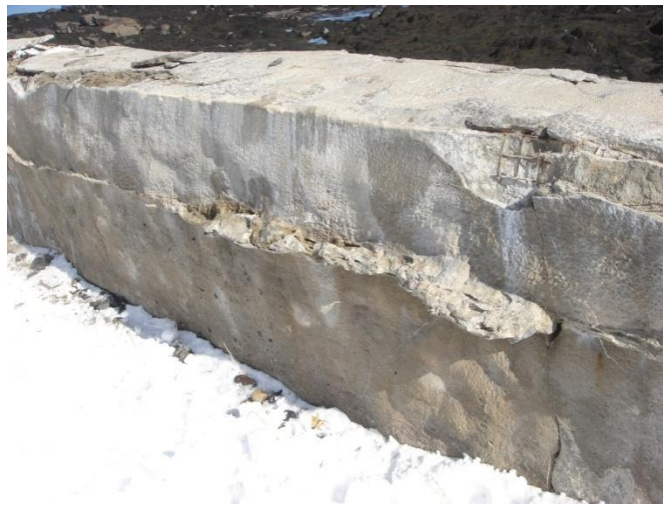
Backfill is added behind seawalls to allow for structure support against wave action as well as providing adequate drainage of waters. It allows water retained behind the wall to migrate towards areas of drainage. Due to the inadequacy of the drainage on the south wall, it was observed that the backfill had significantly eroded along the entire length. Since the wall was shotcreted well after the initial structure had been constructed, a visible line could be seen where the shotcrete had once come to the interface of the backfill which resided behind the wall. Seen in the figure below is a distinct line which indicates the initial position of the backfill, and as seen, this line is now over a foot above the now residing backfill. This clearly shows that the backfill which is integral to the stability of the structure has and is continuing to erode.

**Figure 28: Signs of Backfill Weathering**

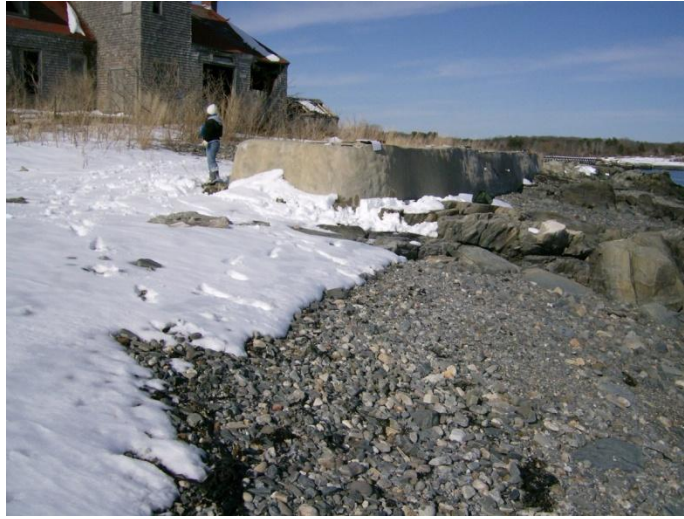
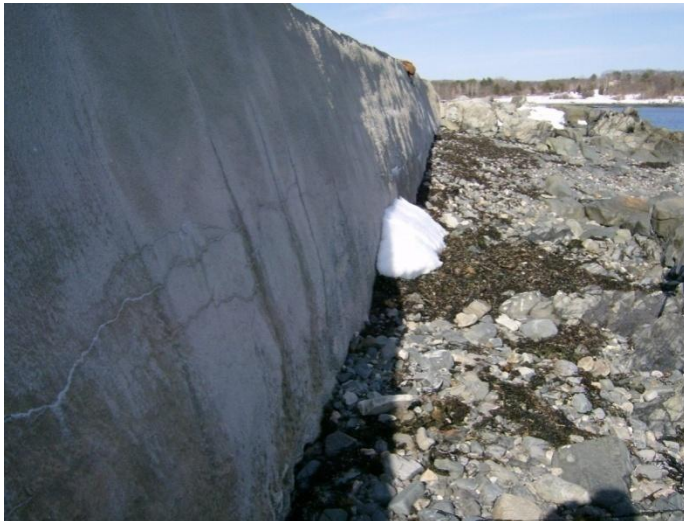
From collected tide data it suggested that high tide would not come within 5 feet of the toe of the existing structure. Upon the March 5, 2009 site visit, shortly after a recent snowfall, marks of the high tide could be seen in the melting of the snowfall. Seen in the figures below is that high tide does come into contact with the bottom of the wall and that this would warrant concern of continuing undercutting of the structure and weathering.

**Figure 29: High Tide Marks on South Seawall (1)**

**Figure 30: High Tide Marks on South Seawall (2)**

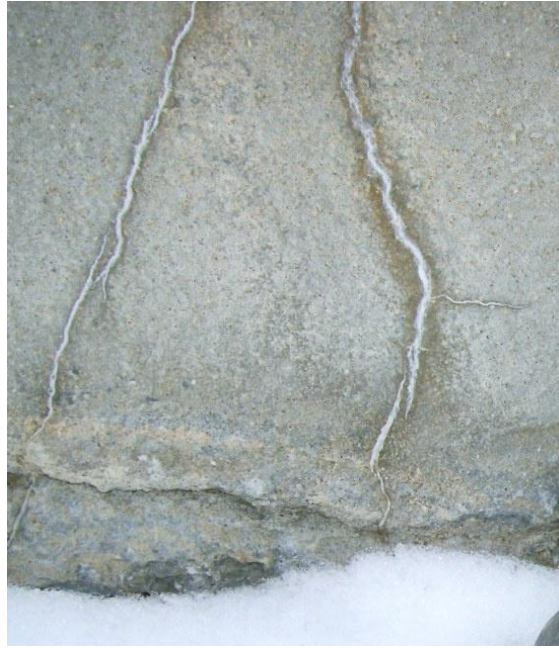
Seen in the figure below is the leaching of sulfates or salts, which were deposited from the seawater, from the face of the South Seawall. These sulfates may have contributed to the degradation of the paste of the wall, but furthermore have led to severe deterioration of the reinforcing steel mesh of the shotcreted cap. Further consideration must be paid to sulfate attack in the rehabilitation efforts due to reinforcement of a new structure as well as the use of tie anchors which would experience corrosion.

**Figure 33: Leaching of Sulfates from South Seawall**

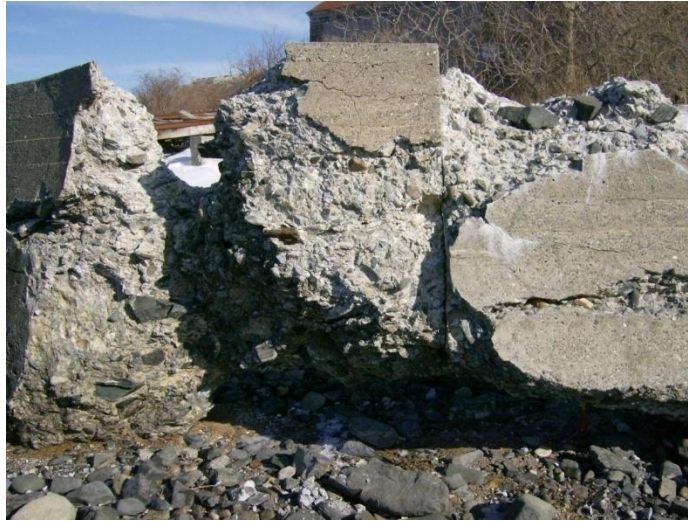
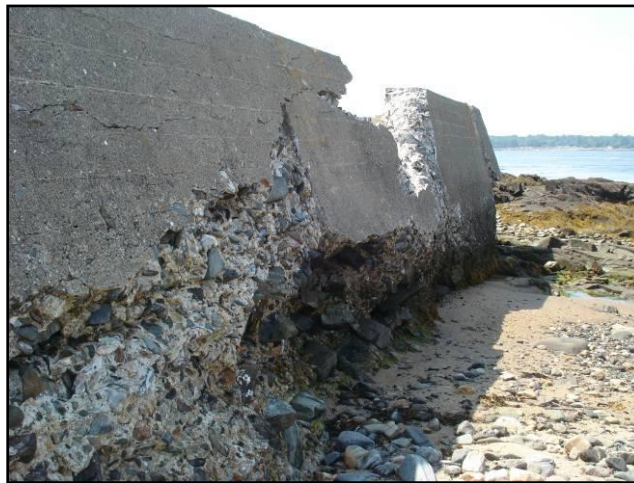
The north seawall shows significant signs of undercutting due to wave action. Since the seawall was originally placed directly on top of the exposed bedrock, and no footing exists, waves which come into contact with the toe of the seawall slowly erode and wash away the toe of the wall; undercutting the structure. Seen in the figures below are the combinations of undercutting at the toe and freeze thaw deterioration. As undercutting occurs, it poses large risks to the stability of the structure.

**Figure 34: Undercutting of North Seawall (1)**

**Figure 35: Undercutting of North Seawall (2)**

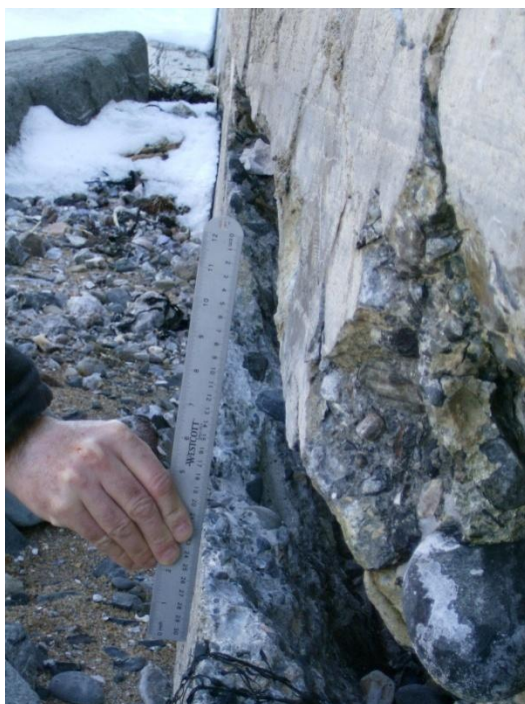
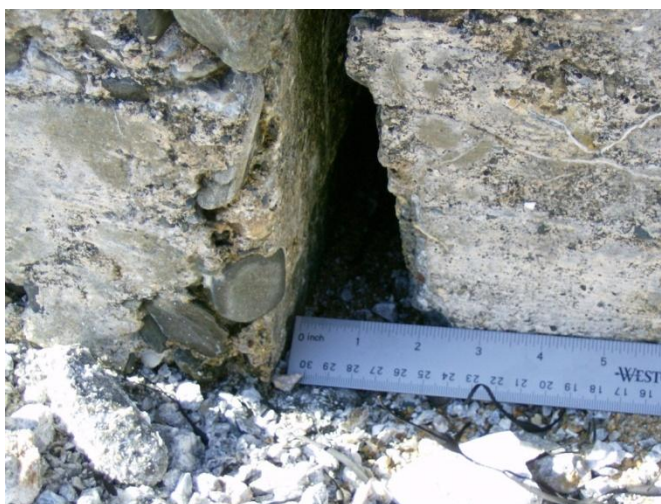
The combination of undercutting and other weathering events on the seawall cause a change in the stability of the structure. As the foundation wears away and wave force pounds at the structure, the wall begins to collapse due to its displaced center of gravity and continual battering. Seen in the figures below is a section of the seawall which is experiencing this local instability due to undercutting and wave action. As parallel freeze thaw cracks move across the face of the wall, the cracking allows for internal degradation of the concrete. As seen below, the top portion of the structure is independent of the bottom and has begun to overturn. Since the structure has cracked and acts in independent fashions, it

allows for the horizontal and vertical displacement of the structure as it fails and sooner or later will fall over.

**Figure 36: Horizontal Displacement and Overturning of North Seawall (1)**

**Figure 37: Horizontal Displacement and Overturning of North Seawall (2)**

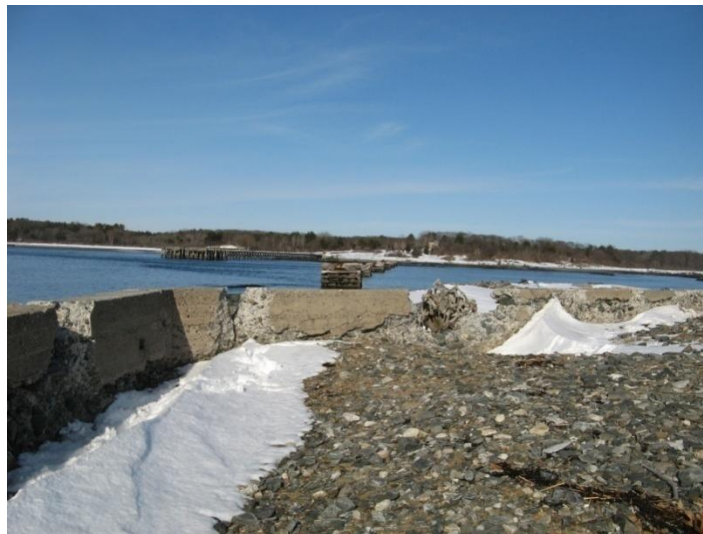
It seems that the north wall was constructed in segments. At locations approximately every 10 ft horizontally it was observed that construction joints lie where one section ended and another began. These construction joints may have served as expansion and contraction joints or rather as paths for drainage, but have since become a localized area for freeze thaw action. As water penetrates the cracks and then freezes, it expands and then puts stresses in between the segments. This pressure slowly forms cracks and as seen in the figure below is the primary region where the most severe weathering has occurred.

**Figure 38: Weathering at Locations of Construction Joints along North Seawall**

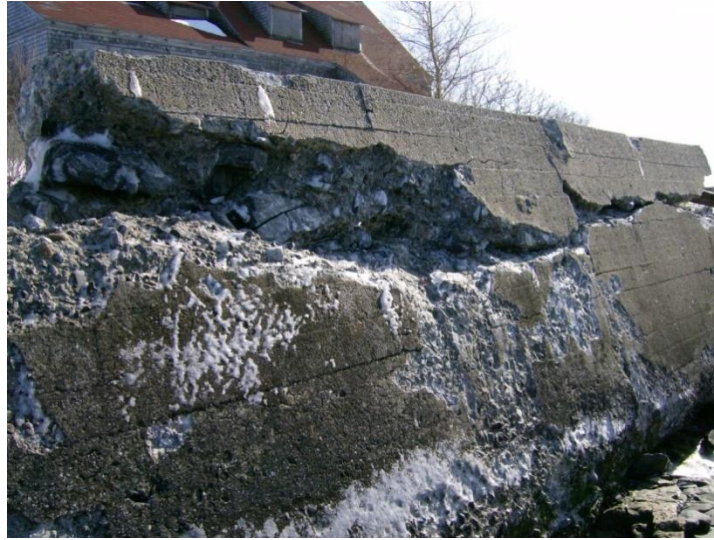
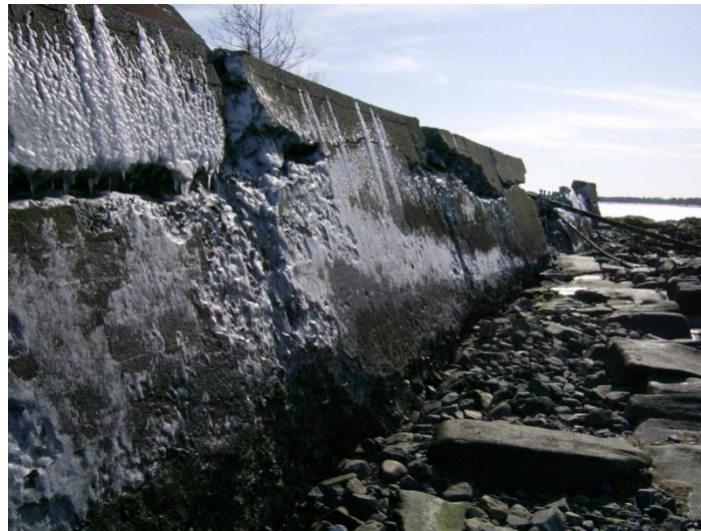
Freeze thaw action seems to originate at the construction joints. From there, the water works its way into the internal structure of the wall and forms cracks parallel to the surface. These cracks are vividly seen in the figures below and contribute to the overall weakening of the stability of the structure. As the water expands internally, the induced internal stresses break apart the concrete. Freeze thaw is more obviously seen as the figures below show faces of the wall which are coated in ice from the nearby waters.

**Figure 39: Freeze Thaw Action on North Seawall**

**Figure 40: Visible Freeze Thaw on North Seawall**

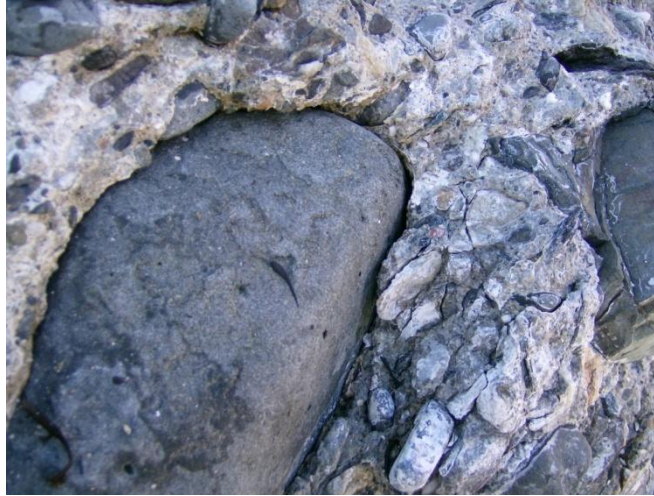
As water penetrates into the wall, its stresses can expand around aggregates and in turn form voids around the aggregates. Since native aggregates on the island were most likely used in the walls construction, they were largely varying in size and posed larger areas for water to encompass. Seen below, the water infiltrated the surface of the wall at one point and went through freeze thaw cycling around the aggregate located in the picture. This in turn leads to un-bonding of the aggregate and a

sever decrease in the structures overall strength. The voids present around the aggregates also are typical of Alkali-Silica Reaction present in the structure as internal stresses develop from ASR.

**Figure 41: Un-bonding of Aggregate due to Freeze Thaw in North Seawall**

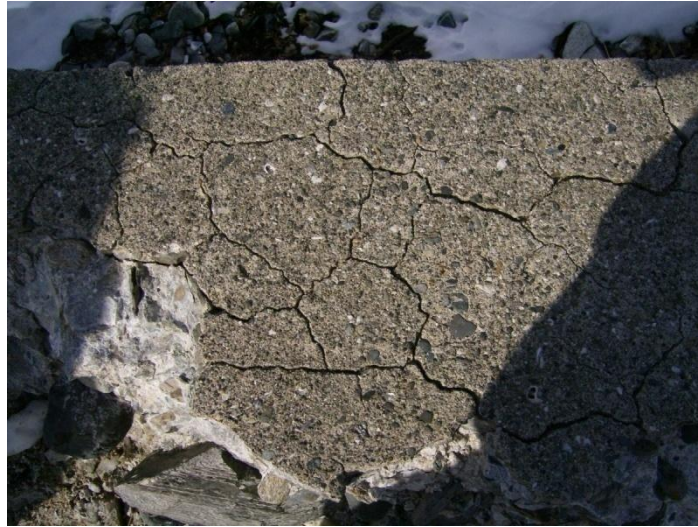
Alkali-Silica Reaction (ASR) occurs between the hydroxyl ions in the alkaline cement pore solution present in the paste of the concrete and reactive forms of silica in the aggregate. When this occurs, a gel-like substance is formed from the reacted paste and absorbs water; inducing internal stresses in the concrete (Consultants, 2005-2009). Duncan Mellor explained that the cracking seen from ASR is not parallel in structure similar to that of freeze thaw action, but forms spider web cracks similar to that seen in the figure below taken from the north seawall. These cracks were seen along the surface of the north seawall and gave reason for further testing to occur within the laboratory to confirm that ASR was occurring. Also, the geometry of the cracks which originated at the construction joints, due to freeze thaw, showed signs of ASR in that at the corners they would curve upward. This was noted as a sign of ASR by Duncan Mellor during a site visit.

**Figure 42: Spider Web Cracking Signs of ASR along North Seawall**

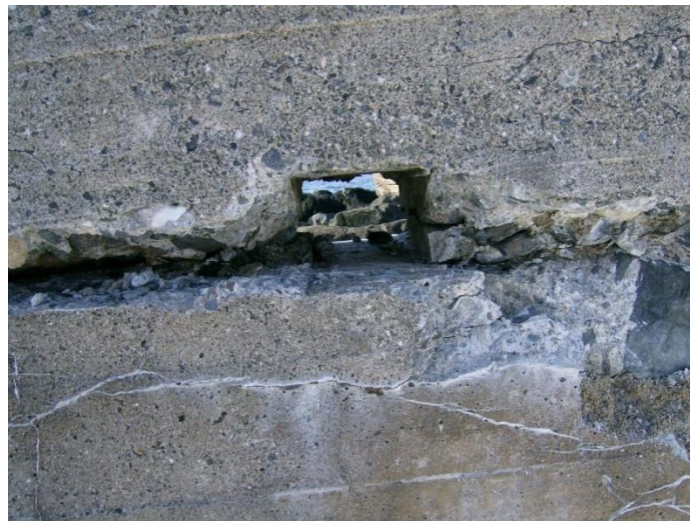
Drainage paths were seen on the north wall as cast in place holes rather than weepholes as the south side had. The drainage holes were about 3 inch by 3inch and had one located at the bottom and one about halfway up the wall for every segment. As seen in the figure below, these were also sites for freeze thaw action to penetrate and form the typical parallel cracking across the walls face.

**Figure 43: Cast in Place Drainage along North Seawall**

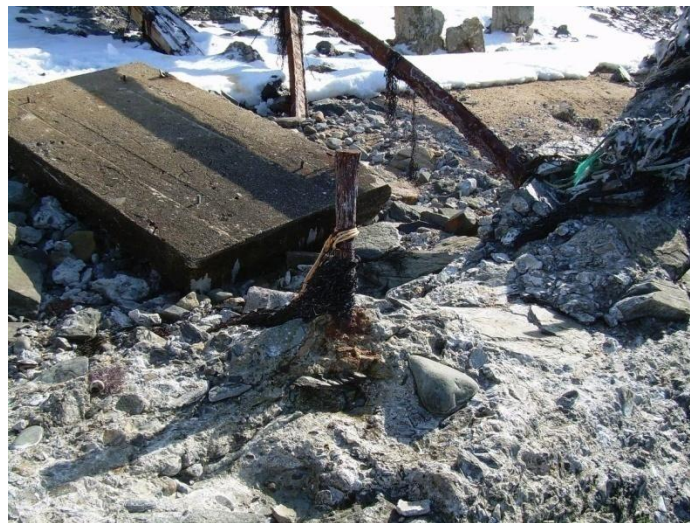
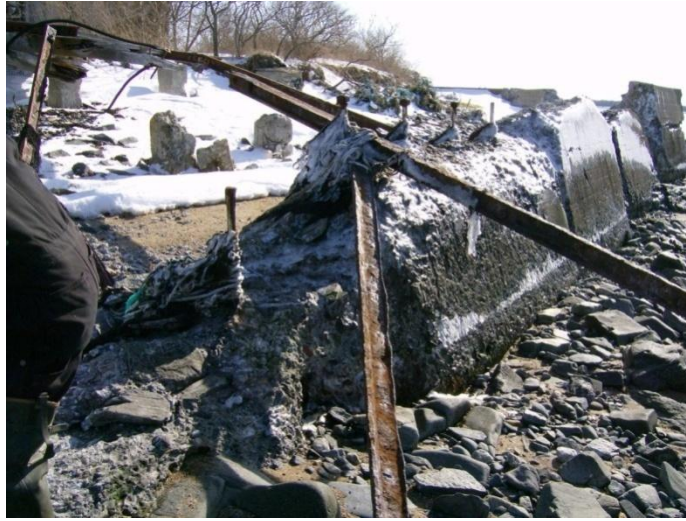
Vertical tie anchors were seen where sections of the wall had collapsed and been washed away. The tie anchors seen, extended about 2 ft vertically from the bedrock and were used to provide stability to the foundation of the original wall. In areas where large portions of the wall were missing, it was seen that tie anchors were spaced about 10 ft horizontally along the length of the wall. Seen in the pictures below are the tie anchors, and serious corrosion has occurred due to the sulfate content of the nearby seawater.

**Figure 44: Corrosion of Tie Anchors along North Seawall (1)**

**Figure 45: Corrosion of Tie Anchors along North Seawall (2)**

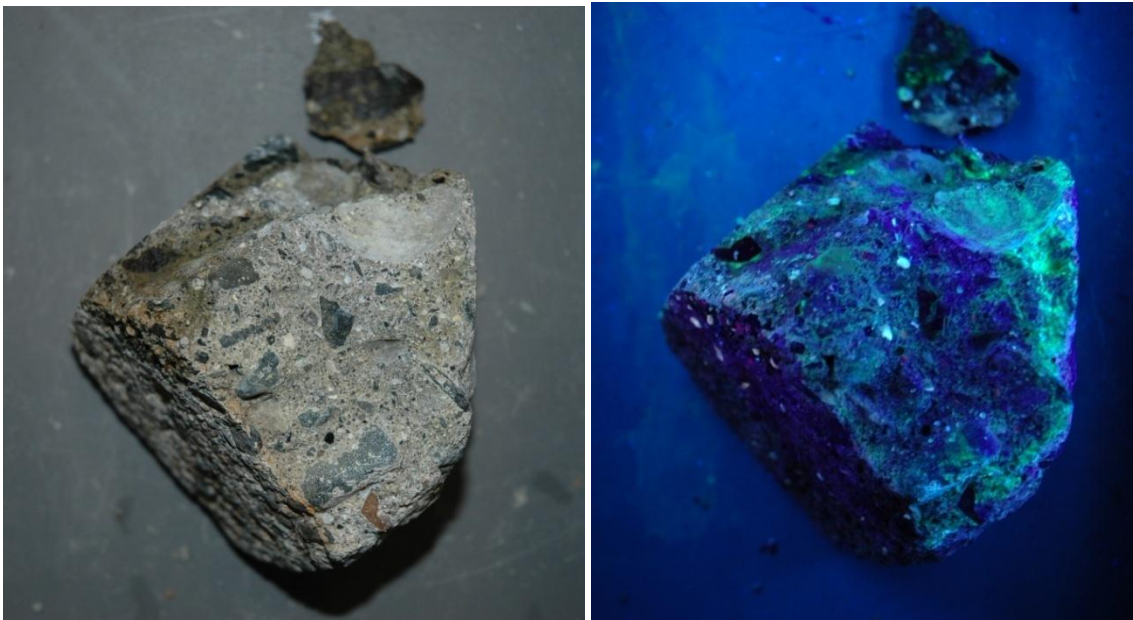
From observations, ASR was present in the sample, yet to a degree which seemingly was of minimal concern to the integrity of the structure. ASR was also observed in a cut and polished section of the sample and was seen as dark rings which surround some aggregate faces showing the damage due to portland cement expansion.

**Figure 49: Sample Showing before and after with ASR Fluorescence under Black Lights**
