# Wood Island Feasibility Study

## Part Two: Site Assessment and Recommendations

**April 2009**

Completed for the Town of Kittery, Maine in cooperation with the University of New Hampshire and  
Appledore Engineering, Inc.

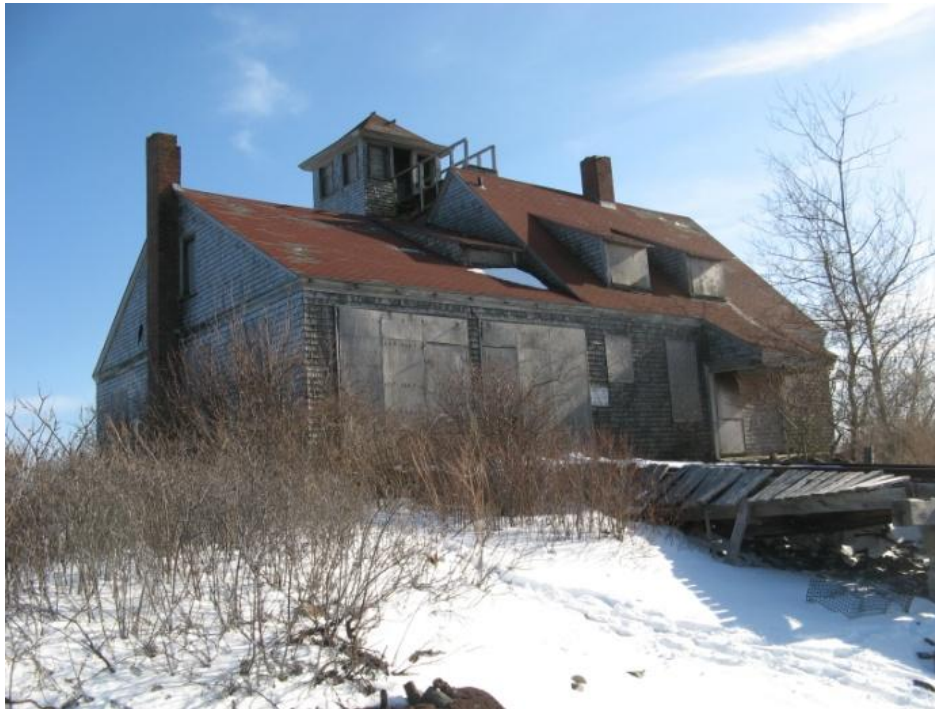
Currently, efforts have been made to close off the structure to visitors. These efforts mainly involved boarding up windows and doors. Unfortunately, these boards have not been able to withstand the harsh wind and rain, as well as visitors, vandals and bird traffic. All of these factors have been able to take down these window and door boards one at a time. Currently, the structure is very much open to the elements and is serving as home for many local birds. These seagulls, as well as other coastal birds, have been further destroying the interior elements.

**Figure 1: Boarded side of Lifesaving Station**

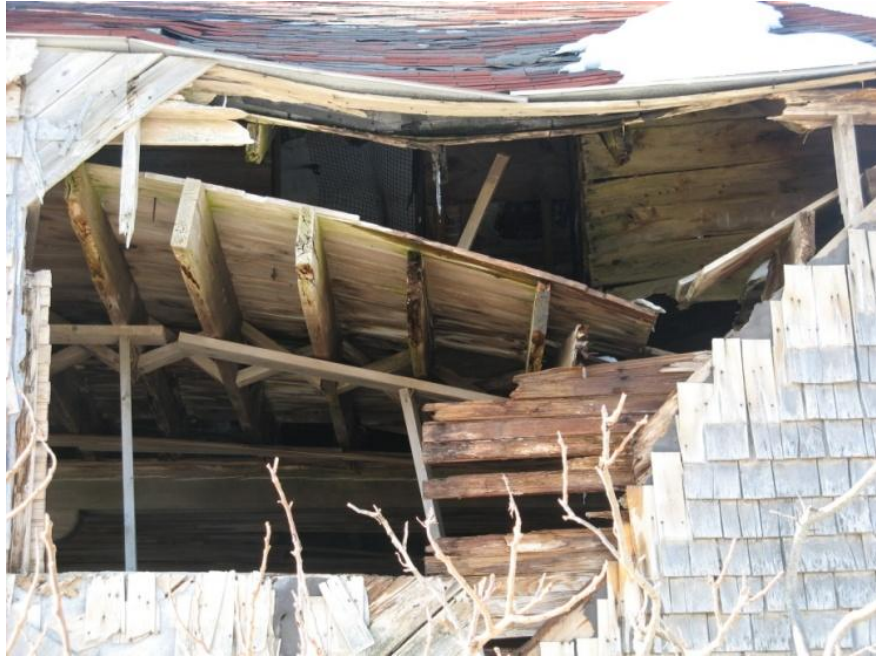
**Figure 2: Damage near openings**

Action needs to be taken to end to the visible deterioration and potential dangers. Due to the historical significance, the structure does not fall to ruins under the close watch of the seacoast area. Also, it is extremely important that those visiting Wood Island are safe. The current state of the structure allows for visitors to easily access the inside of the Lifesaving Station, which, as previously mentioned, can be very dangerous. This report is meant to outline some the feasible options to remediate these problems.

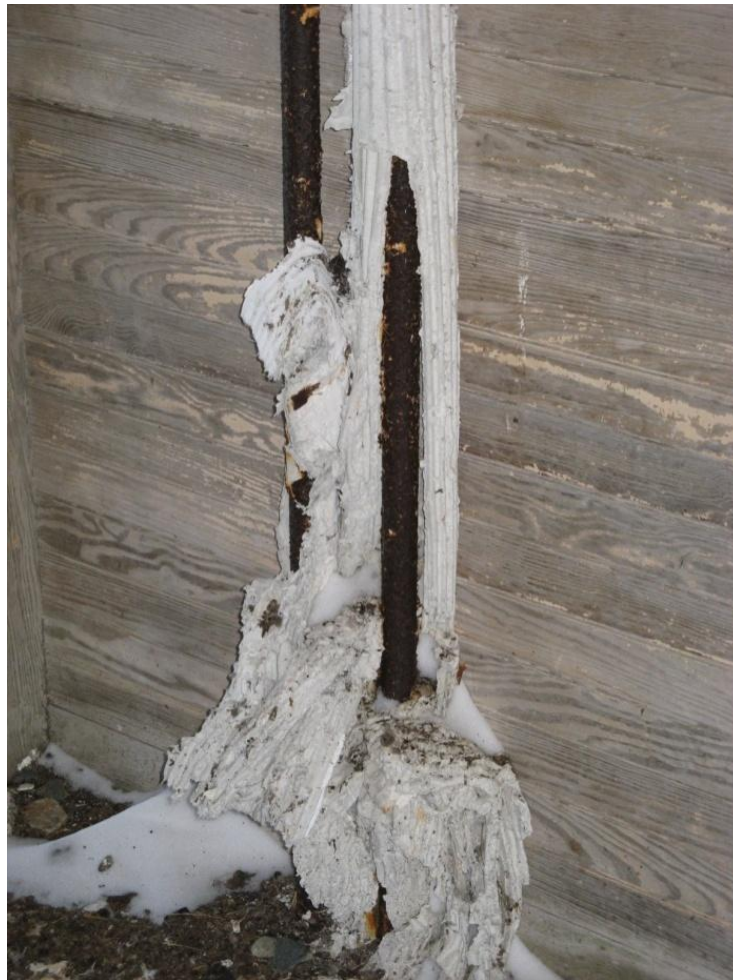
**Figure 3: Piping with suspect asbestos containing material used as insulation**

One of the most important concerns Mr. Oliver had involved the insulation found on the piping in the boat house (Figure 3). He suspects that this material contains asbestos and would abatement if any type of construction were to occur. Mr. Oliver also stated that it could be dangerous to have out in the open as it is currently. This material would most likely require special removal as well as special landfill disposal procedures and/or costs. Again, this material is deemed suspect only. A laboratory test would need to be conducted to prove it contains asbestos.

A complete suspect materials survey and laboratory testing is required to make an appropriate decision regarding abatement options. Mr. Dave Oliver, of Terracon Inc., has indicated that the survey must be in accordance with NESHAP regulations for asbestos materials within buildings for renovation/demolition. The cost estimate to have an inspection performed by a State of Maine licensed asbestos inspector and the paint to be sampled for presence of lead would be approximately \$2,800 to \$3,500.

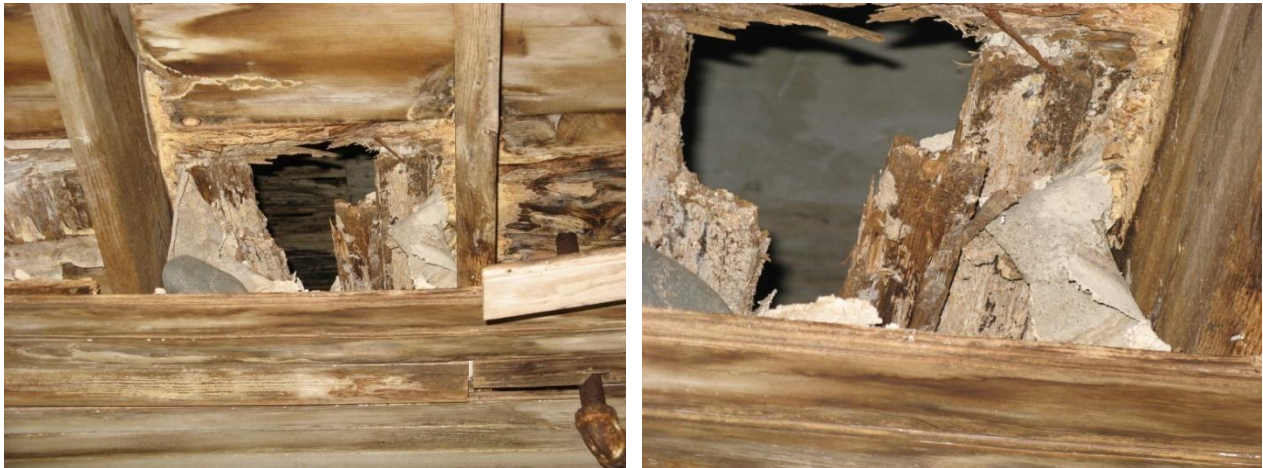
Another suspect asbestos-containing material is the roofing shingles. The roof material was replaced sometime in the 1990s, but without proof of particular material that was selected and installed; the shingles will also need to be tested. If the town of Kittery can provide documentation to disprove the existence of asbestos in the material, this test may not be necessary. The investigation also revealed a paper liner which was used throughout the entire structure, including locations from under the siding to between the floor boards and joists (Figure 4). This paper was assumed to be used as insulation, and is suspected to contain asbestos.

**Figure 4: Paper liner within the floors that has been deemed suspect material**

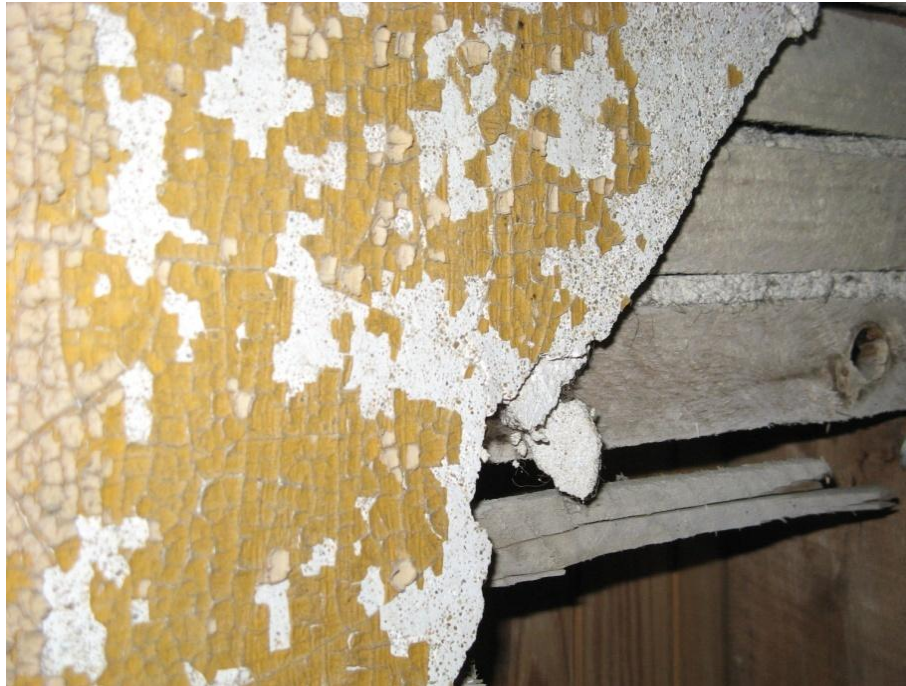
In addition to asbestos, lead paint is suspected to have been applied to the walls within the structure. This paint, as it has been exposed to a good deal of moisture and time, is now chipping off the walls. Although not a hazard unless consumed, the material could require special training for removal. It also could require special disposal. Again, laboratory testing is required before specific remediation or abatement options are considered.

**Figure 5: Lead paint chipping off interior walls**

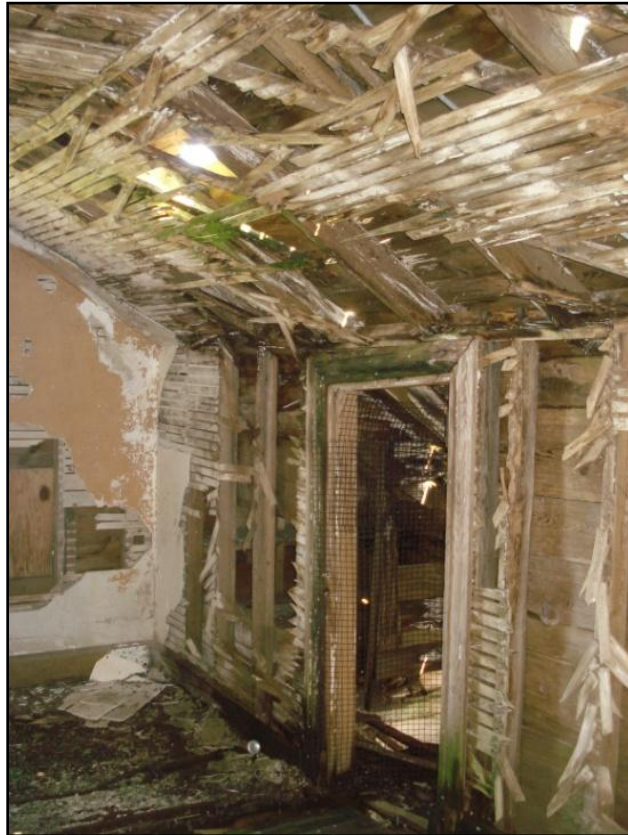
As this structure is situated on an island, harsh snow and rain are to be expected. The failed roof system over the boat hose portion of the structure, as well as the missing window and door boards meant to close off the building, have left the interior to be exposed to water infiltration. As it is a wooden structure, this has caused much damage to the interior flooring and floor supports. Constant wetting and drying has caused a good deal of the wood to rot. It has rendered some portions of the building un-navigable.

Water can destroy wood for many reasons. One such reason in older structures is lack of or failing trim or flashing elements (Historic Lighthouse Preservation Handbook). This can allow for water to slowly build up in locations. It can deteriorate the wood it is in contact with, and in the Wood Island Lifesaving Station's case, this led to failing surfaces that gave way to the water to infiltrate further and further into

**Figure 6: Interior damage to wooden elements**

It is of the upmost importance to the survival of the structure that the water damage be prevented. In addition to closing off the structure to prevent further water infiltration, measures should be considered to dry out the current condition.

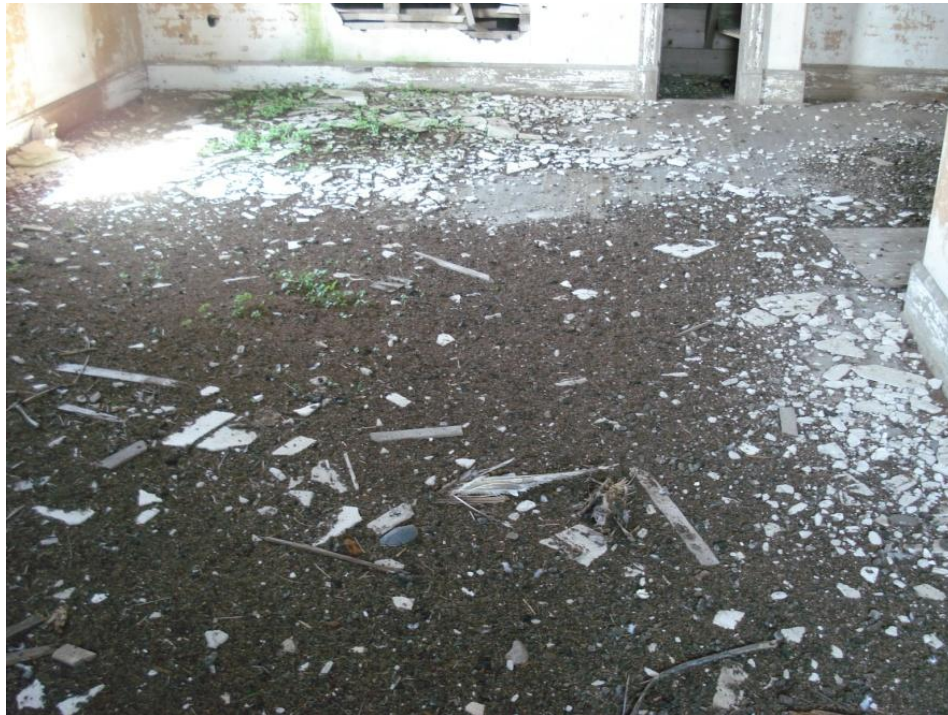
In addition to damage, the birds' presence is causing an unhealthy situation within the building. On one site visit, several dead birds were found inside the structure. These birds had not made the winter, and their carcasses were most likely providing habitat for unwanted bacteria or potential scavenger creatures. Also, bird droppings are found to spread an array of diseases and in enough volume can be considered hazardous waste (Wells, 2007). This is not a healthy environment for Wood Island visitors or maintenance/construction personnel that might need to access the structure for any improvements.

**Figure 7: Bird droppings**

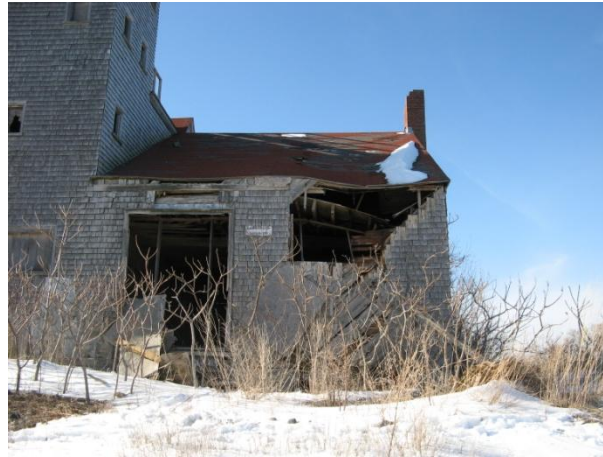
Snow has been taking a large toll on the structure. In particular, the boat house roof, which has been deteriorated by water infiltration, wind effects and bird droppings, is also suffering from increased snow loads. As the roof fails, the snow has more of a tendency to collect within the failed areas. Within the duration of this investigation, it has been evident the deterioration has increased. The increased damage within this past winter is evident in the photographs below.

**Figure 8: Increased damage in March 2009**

The louvers and blockades described above will protect the structure against intruders, birds and the elements that are entering from the sides. There is also an extreme danger from above. The roof system is currently failing, in particular, the area of the roof located over the boathouse. There is a notable difference in interior deterioration on the boathouse side when compared to the rest of the building still protected by a roof. This is a depiction of how important a functioning roof is to the Lifesaving Station. This investigation leads to the suggestion of a replacement of the roof.

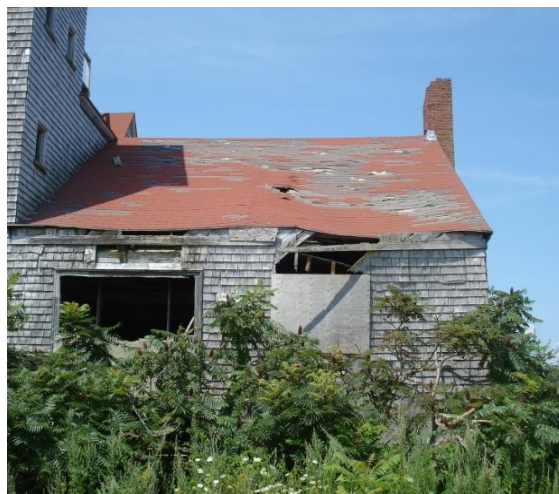
**Figure 9: Damage to roof in July 2008**
