WOOD ISLAND LIFE SAFETY STATION WOOD ISLAND – KITTERY POINT, MAINE STRUCTURAL OBSERVATIONS

Town of Kittery, Maine
200 Rogers Road Ext.
Kittery, Maine 03904
Attn.: Jonathan Carter, Town Manager

December 6, 2010
Project No.: C129-10

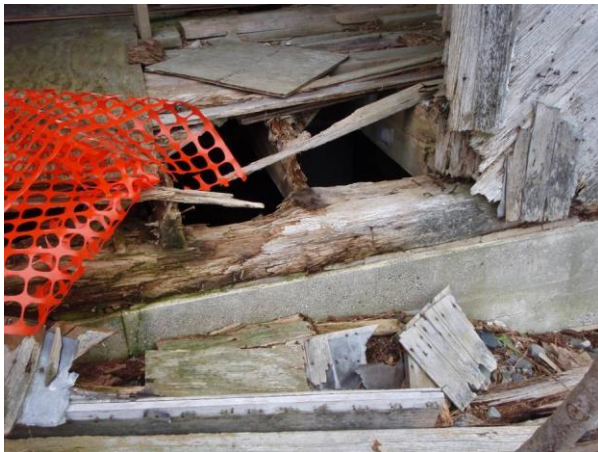
The south-east corner of the building, containing a portion of the boat storage area, appears to have sustained the most damage, probably from re-occurring storm surges which have caused a partial collapse of the floor and attic joists, rafters and roof sheathing. The roof rafters and second floor joists have separated from supporting wall plate; additionally, portions of the first floor wall and floor joists have been compromised, allowing storm surges to deposit sand, gravel and other debris within the basement area. In other areas, the roof ridge appears to be relatively level and plumb.

SOUTHEAST CORNER – 1ST FL. DAMAGE

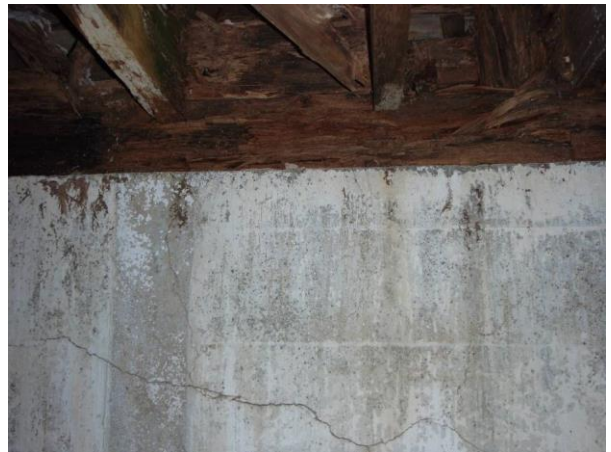
The concrete basement walls appear to be cracked in several locations, although no wall sections appear to have separated from adjacent sections. The basement contains a large concrete cistern, located in the northwest corner and a hot water boiler and tanks, located in the easterly portion; heat and water supply pipes have been lagged with asbestos.

First floor sill members have deteriorated in several locations. The northern portion of the boat storage area contains some deteriorated sill members, floor joists and laid-up board flooring. Timber column and beam members supporting the second level floor, which are visible within this area, appear to be in good condition. Flooring and support members located in the kitchen and living area in the westerly portion of the first floor appear to be in fair to good condition. A majority of the area is covered with seabird guano and remnants of the original lath-plaster applied to the ceiling and walls. Water intrusion appears to be minimal. A few of the original window and door openings are open to the weather.

FOUNDATION WALL CRACKS/DAMAGED SILL

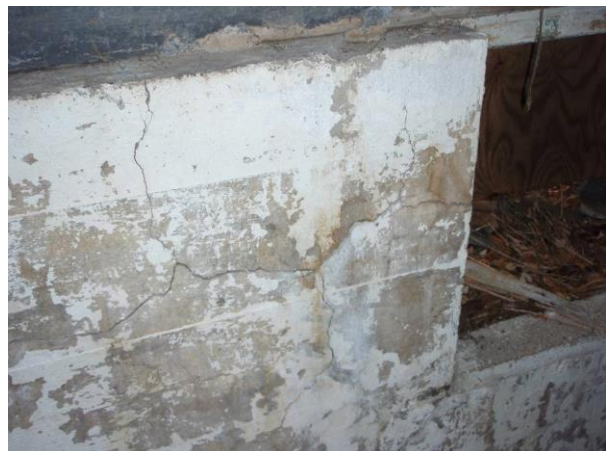
FOUNDATION CRACKS – EXTERIOR

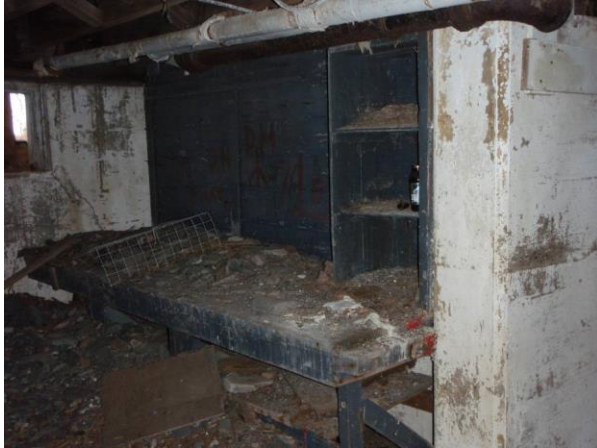
BASEMENT – STORM SURGE DEBRIS

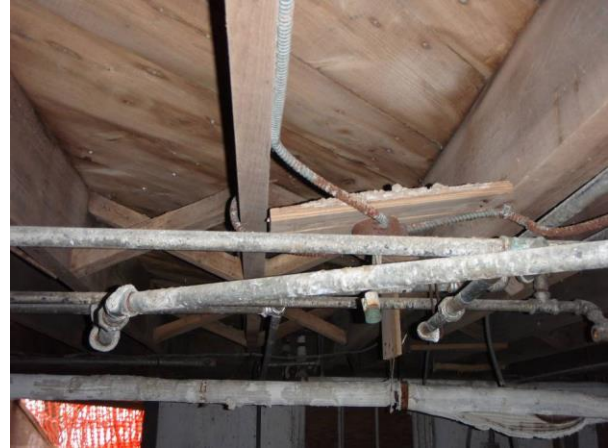
BASEMENT – ASBESTOS LAGGING

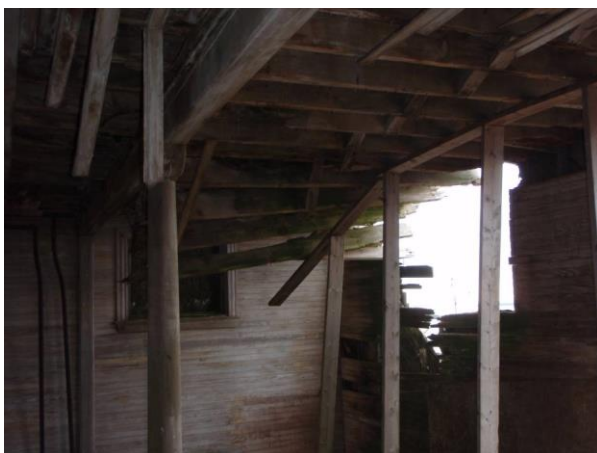
COLLAPSED SOUTHEAST SECTION

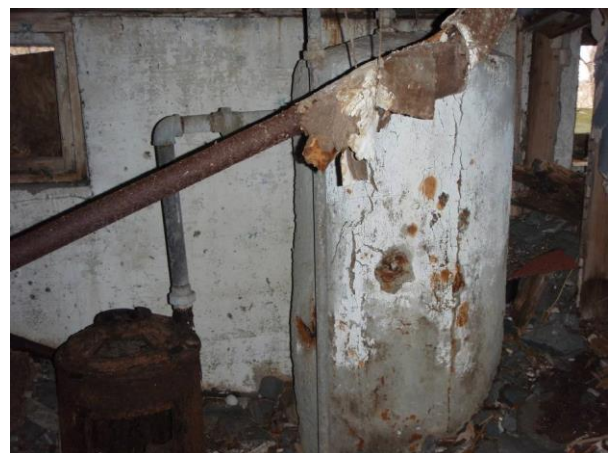
ASBESTOS LAGGED HOT WATER TANK

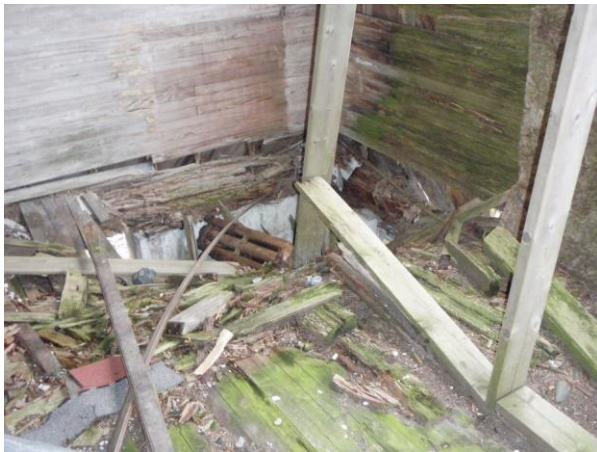
DAMAGED FIRST FLOOR

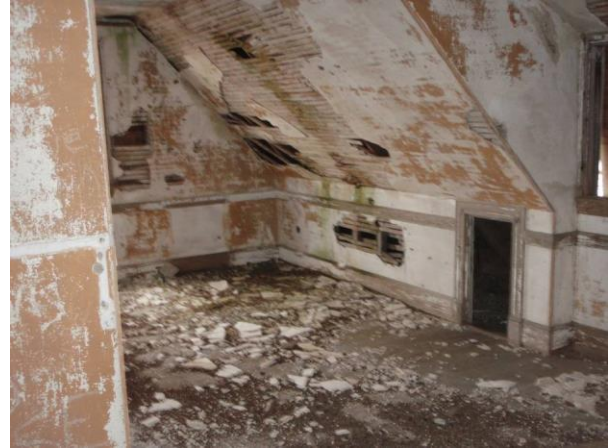
SECOND FLOOR SLEEPING AREA (EAST)

Second level floor joists and flooring are in fair condition, the westerly portion of the building is in better condition than the east sleeping quarters. Access to the cupola/lookout is limited, although portions of the stair stringers are in-place, the treads and risers have been removed; we were only able to access the first level landing of the lookout; access to the top level was not possible.

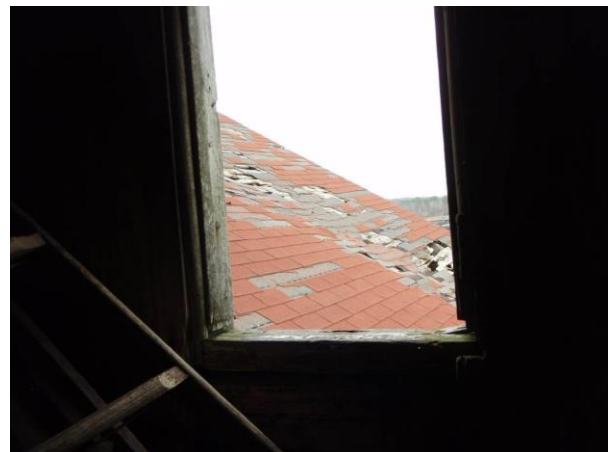
SOUTHEAST ROOF - FROM LOOKOUT STAIR
