Wood Island Feasibility Study

Part One: Study of Site History and Initial Site Assessment

Part Two: Site Assessment and Recommendations

University of New Hampshire, Department of Civil Engineering

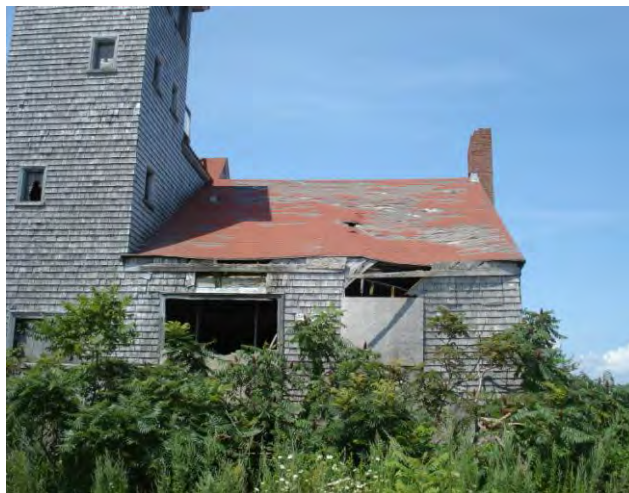
Generally the roof appears to be in good condition; however, a section over the boathouse has partially collapsed. The roof on the southern elevation has approximately fifty-percent of roofing shingles missing. This damage contributes to further deterioration of interior timber frame elements by rainwater.

Figure 6 Collapsed station roof

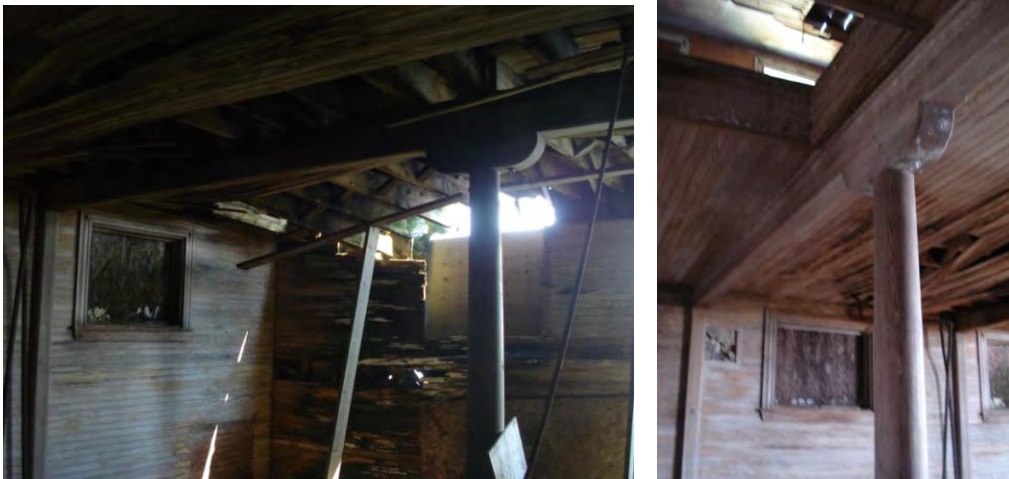
The conditions inside the structure vary depending on the condition of the roof above. Rooms below shingled roof sections are dry and without damage from moisture. The spaces in the boat house section below the roof failure have extensive damage from rotting structural elements. Parts of the floor in the boathouse on the first and second levels have damage and voids. There are dangerous soft spots in these floors. Floor damage is also present near open windows throughout the building.

Figure 8 Interior damage of boathouse

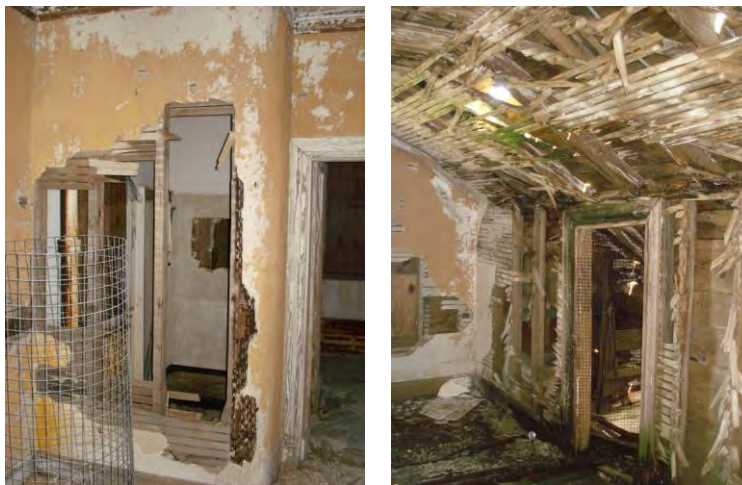
Extensive damage to non-structural elements exists throughout the interior. Wall plaster and gypsum are damaged or missing in most rooms. Entire wall sections, including framing, are also missing in many rooms.

Figure 9 Non-structural interior damage

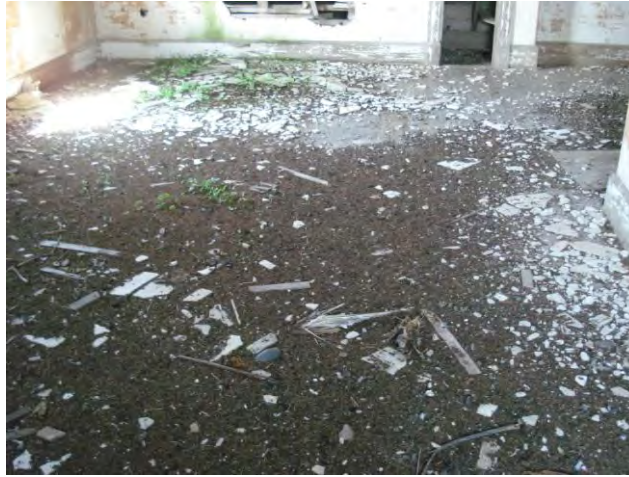
Figure 10 Seagull droppings

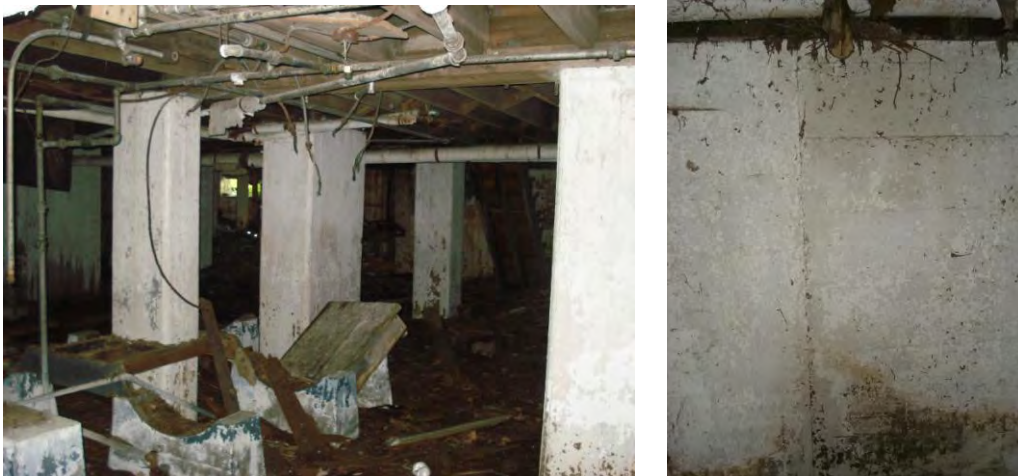
The foundations of the building are in good condition. There are no obvious signs of Alkali-Silica Reaction (ASR) on the structural columns or perimeter foundation in the basement. The smallest columns measure eighteen inches by eighteen inches.

Figure 11 Station foundations

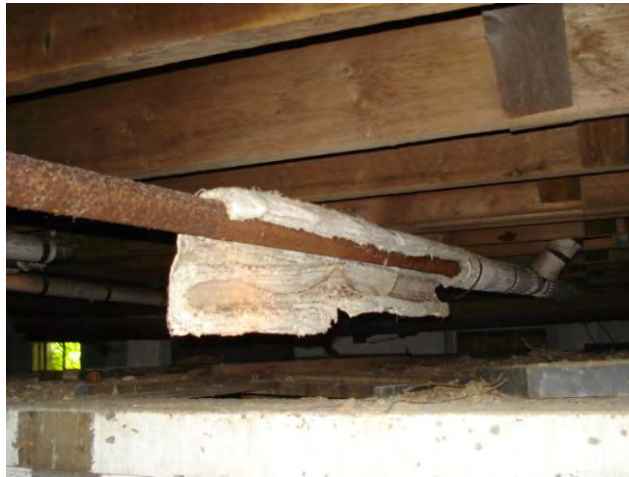
Piping in the basement appears to be covered with asbestos insulation. Only large diameter pipes like those pictured in Figure 16 are insulated.

Figure 12 Fibrous pipe insulation

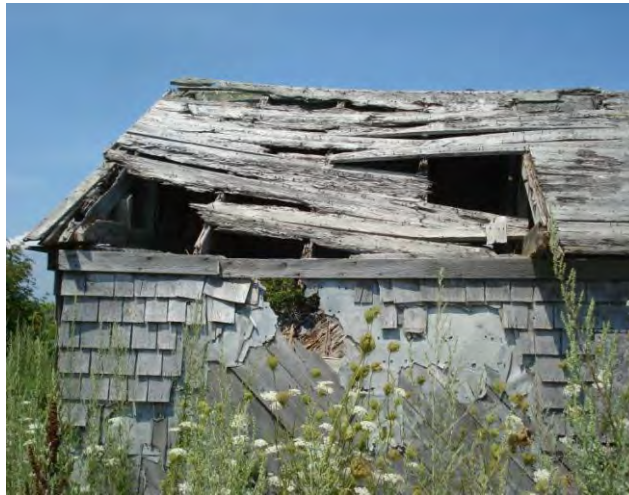
Figure 14 Tool House Building

A section of rafters failed resulting in a partial collapse of the roof. Much of the roof structure is heavily deteriorated and at risk of collapse. A section of the rear wall has been destroyed.

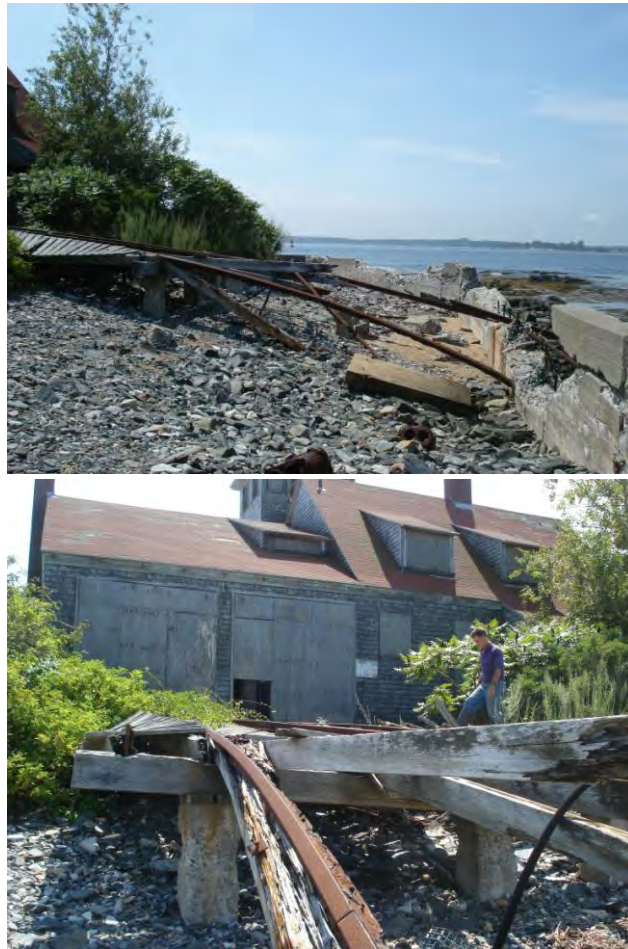
Figure 16 Marine Railway

The railway is badly damaged and unsafe. The railway originally extended several yards beyond the sea wall. The concrete foundation is intact but has degraded and appears damaged. The primary wood beams supporting the rails are partially intact; some secondary beams have collapsed. The rails and wooden decking have also collapsed. Most of the original rails have bent out of shape due to the missing substructure. Sections of the rail are missing.

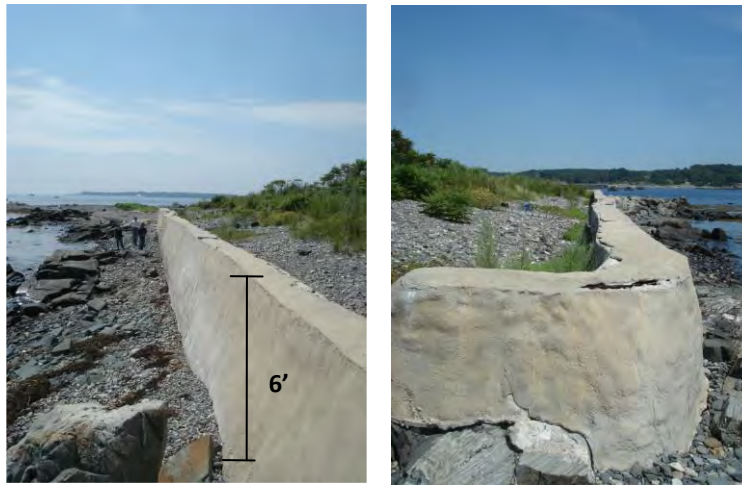
Figure 18 Outer south seawall

By visual inspection, the entire two hundred and fifteen foot wall appeared to have been covered with new concrete. Many sections along the top of the wall have broken away from the steel mesh as seen in Figure 26.

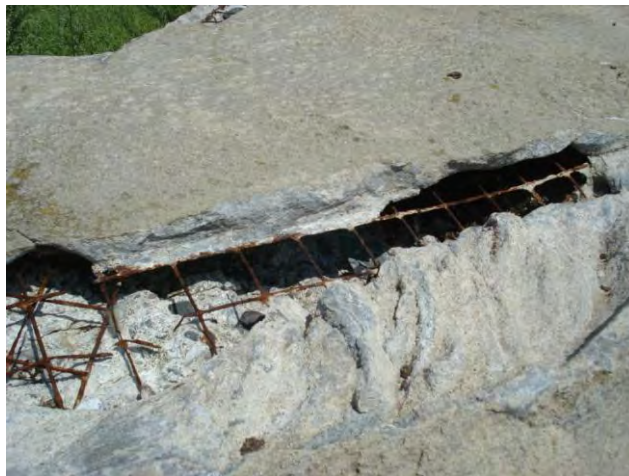
Figure 19 Damaged top section of south seawall

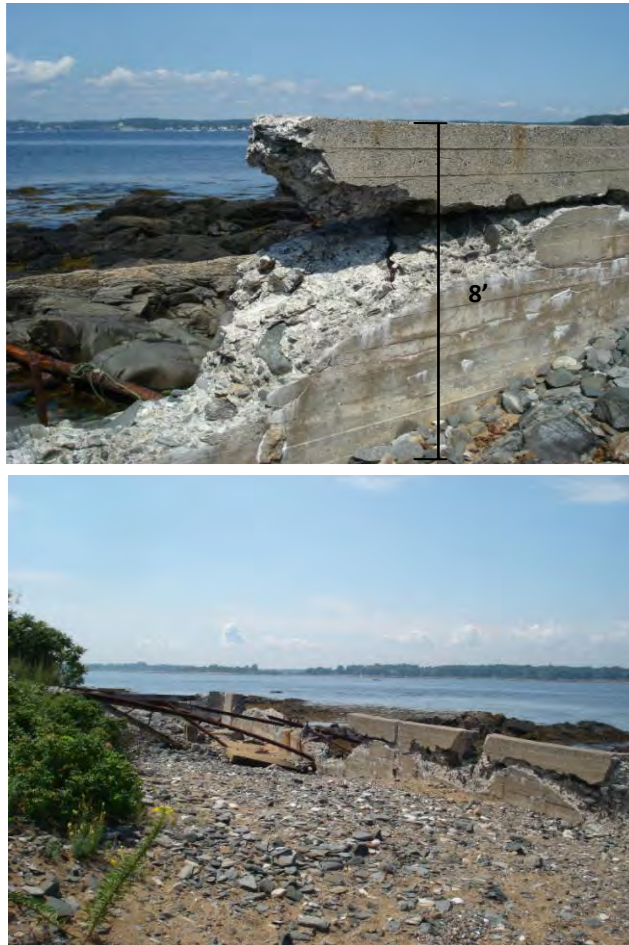
Signs of Alkali-Silica Reaction (ASR) are present along the seawall. ASR will need to be confirmed by laboratory testing. Large wall sections have been destroyed and are missing. Presumably the combination of wave action, ASR expansion and freeze/thaw cycles has reduced the wall to its present state.

Figure 20 Inner north seawall damage

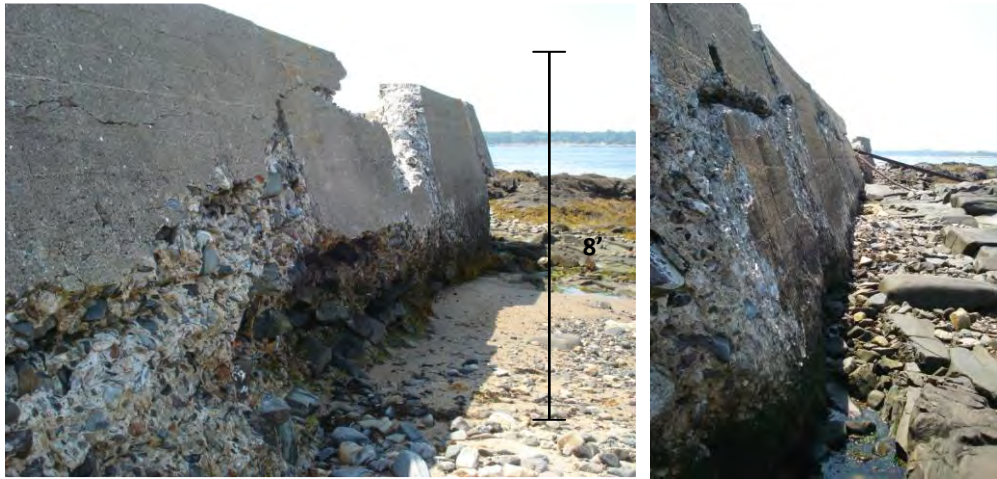
Figure 21 Outer north seawall damage

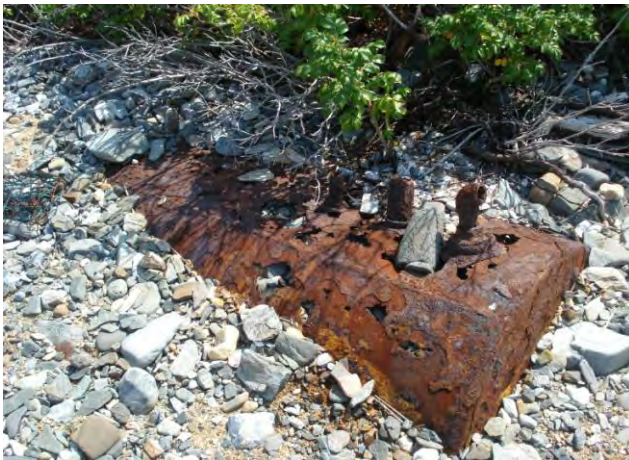
A total of three tanks were found outside near the station and tool house building. A large reservoir (assumed to be for drinking water) was found inside the basement of the station building.

Figure 24 Abandoned tanks

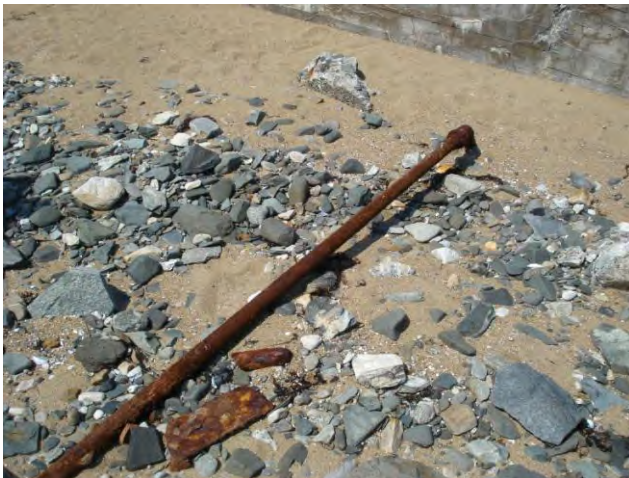
Many large diameter pipes lay scattered on the island. They appear to be damaged and corroded through. There are also several dozen abandoned lobster traps scattered across the island as seen in Figure 38.

Figure 26 Piping

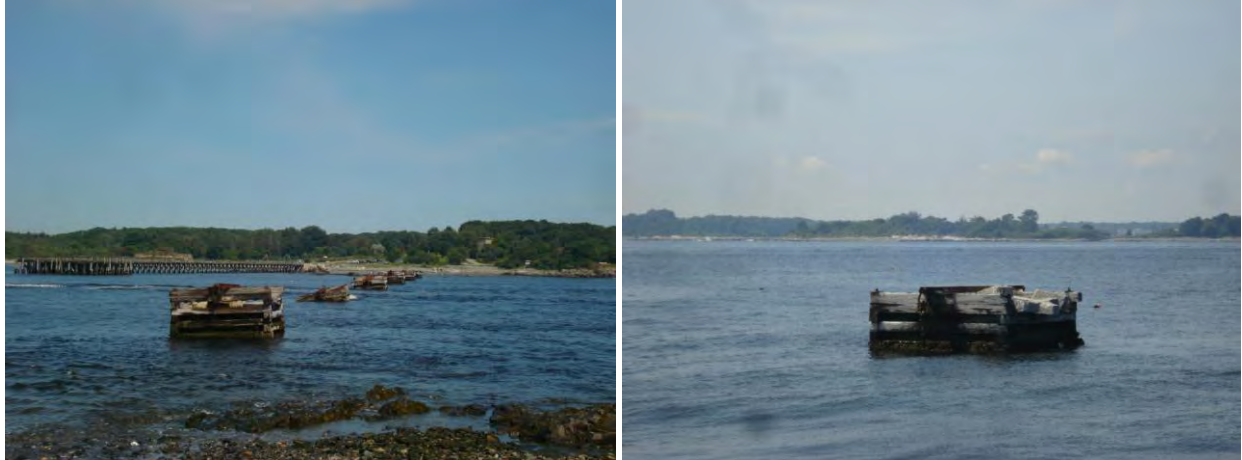
Figure 27 Cribs

Five of the seven cribs appear to be stable. Two of the cribs appear to have collapsed. The structural integrity of each crib may be comprised by wood degradation by marine-borers. A full dive inspection would be required to determine the extent of possible degradation.

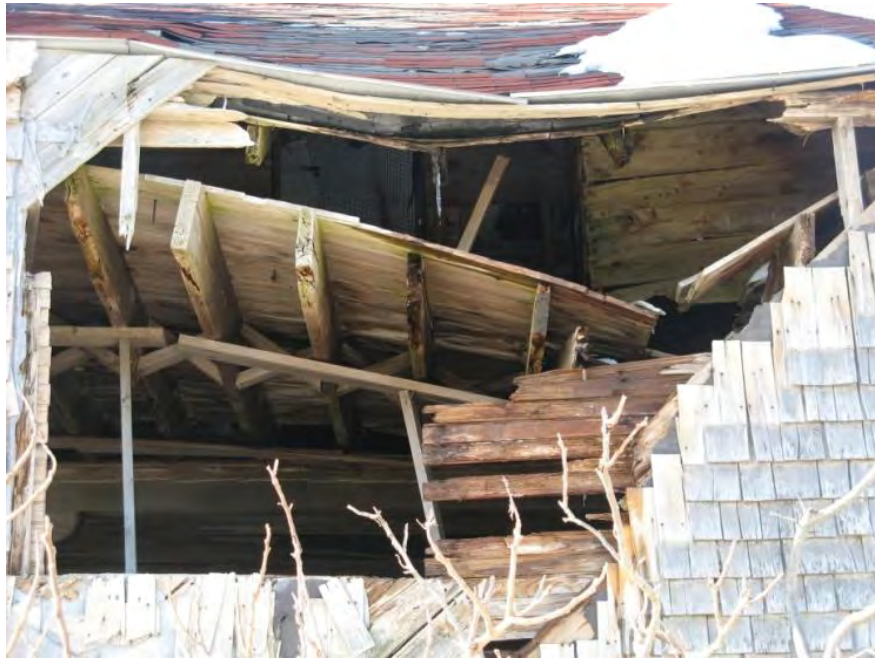
Figure 2: Damage near openings

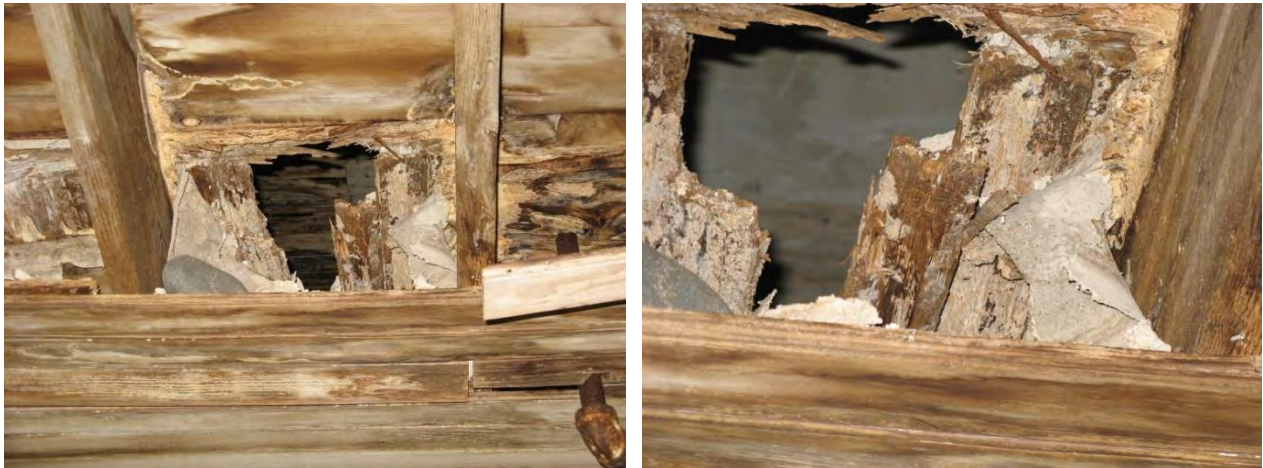
Another suspect asbestos-containing material is the roofing shingles. The roof material was replaced sometime in the 1990s, but without proof of particular material that was selected and installed; the shingles will also need to be tested. If the town of Kittery can provide documentation to disprove the existence of asbestos in the material, this test may not be necessary. The investigation also revealed a paper liner which was used throughout the entire structure, including locations from under the siding to between the floor boards and joists (Figure 4). This paper was assumed to be used as insulation, and is suspected to contain asbestos.

Figure 4: Paper liner within the floors that has been deemed suspect material

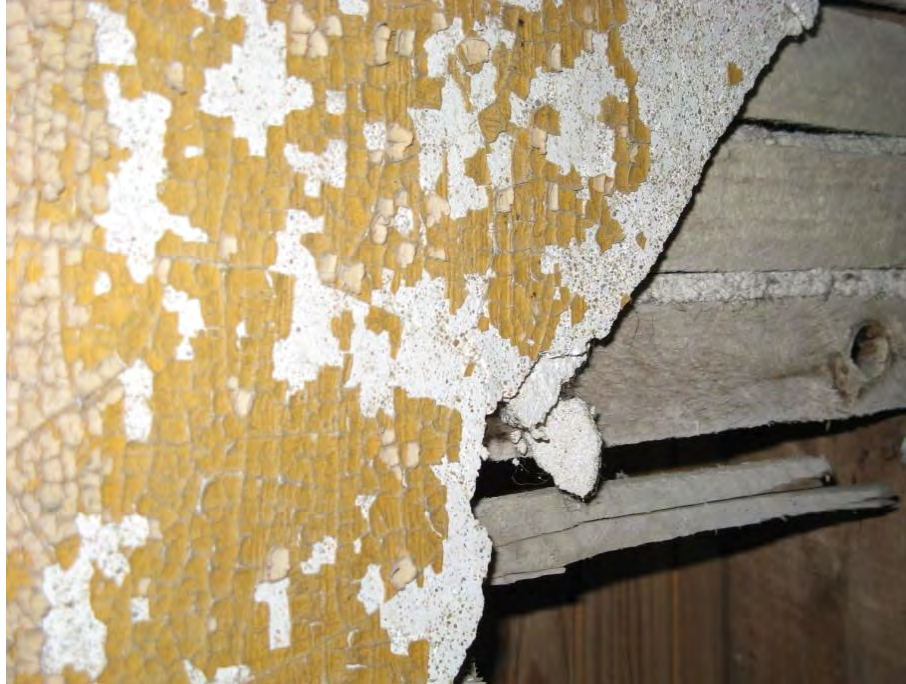
In addition to asbestos, lead paint is suspected to have been applied to the walls within the structure. This paint, as it has been exposed to a good deal of moisture and time, is now chipping off the walls. Although not a hazard unless consumed, the material could require special training for removal. It also could require special disposal. Again, laboratory testing is required before specific remediation or abatement options are considered.

Figure 5: Lead paint chipping off interior walls

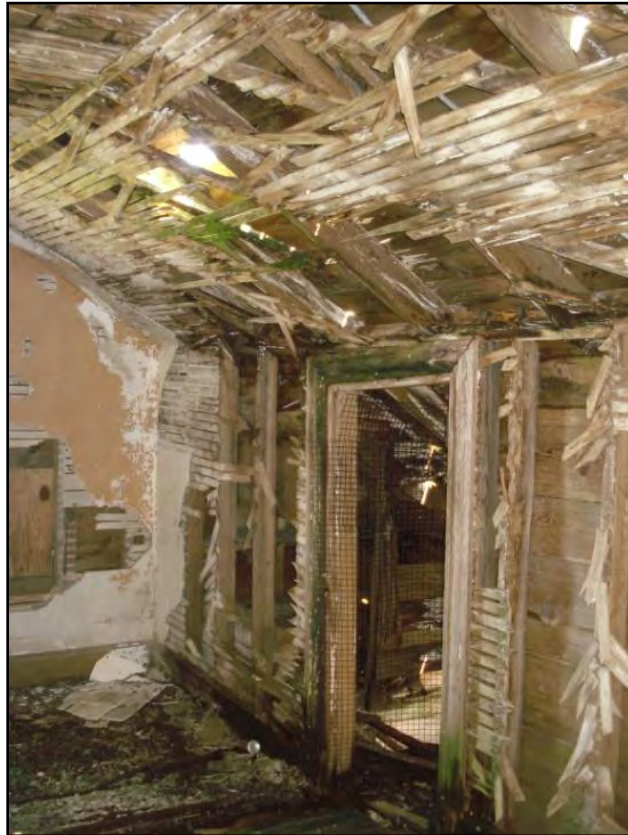
Figure 6: Interior damage to wooden elements

It is of the upmost importance to the survival of the structure that the water damage be prevented. In addition to closing off the structure to prevent further water infiltration, measures should be considered to dry out the current condition.

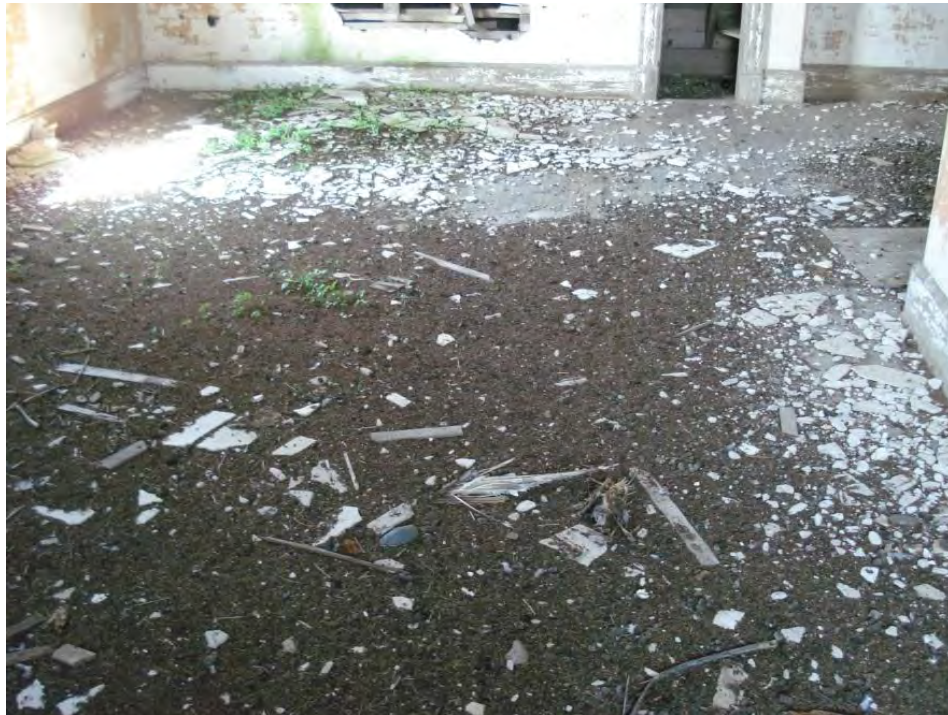
In addition to damage, the birds' presence is causing an unhealthy situation within the building. On one site visit, several dead birds were found inside the structure. These birds had not made the winter, and their carcasses were most likely providing habitat for unwanted bacteria or potential scavenger creatures. Also, bird droppings are found to spread an array of diseases and in enough volume can be considered hazardous waste (Wells, 2007). This is not a healthy environment for Wood Island visitors or maintenance/construction personnel that might need to access the structure for any improvements.

Figure 7: Bird droppings

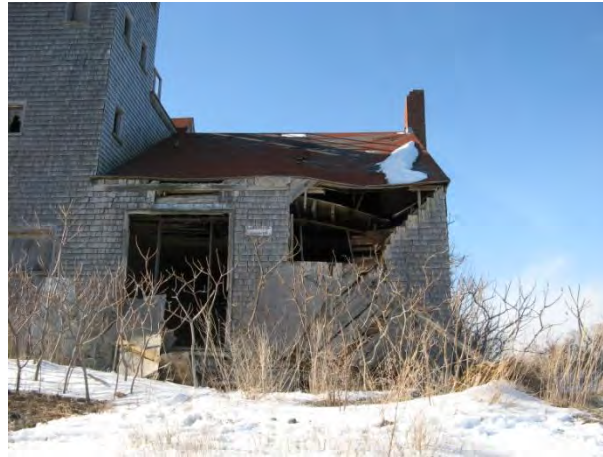
Snow has been taking a large toll on the structure. In particular, the boat house roof, which has been deteriorated by water infiltration, wind effects and bird droppings, is also suffering from increased snow loads. As the roof fails, the snow has more of a tendency to collect within the failed areas. Within the duration of this investigation, it has been evident the deterioration has increased. The increased damage within this past winter is evident in the photographs below.

Figure 8: Increased damage in March 2009

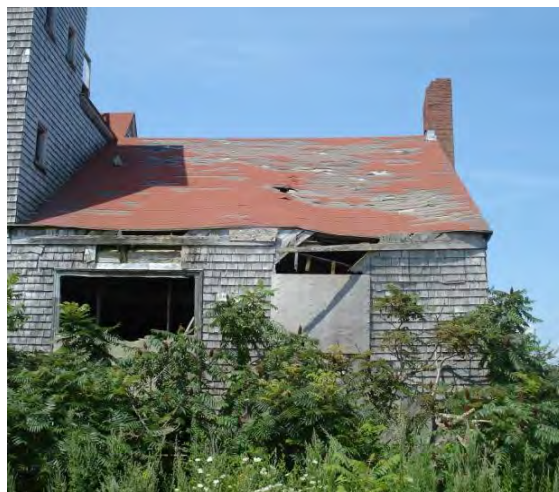
Figure 9: Damage to roof in July 2008

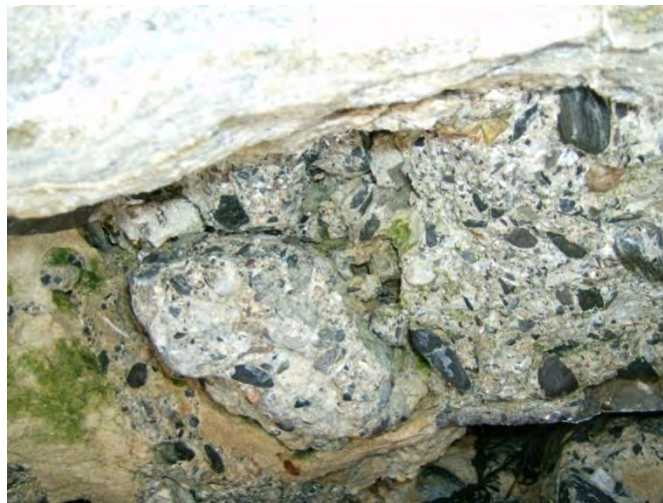
Figure 20: Closer Image of Undercutting of South Seawall

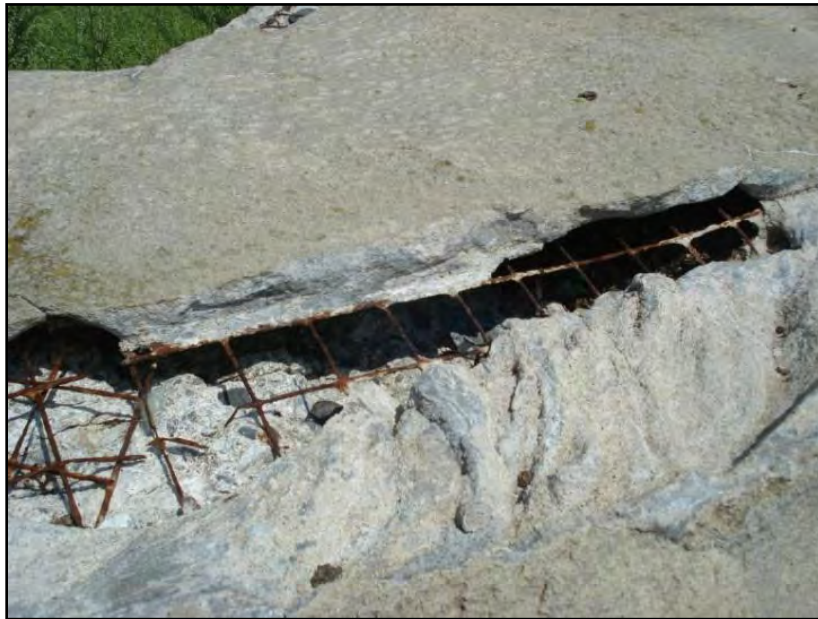
Figure 21: Damaged Top Section of South Seawall

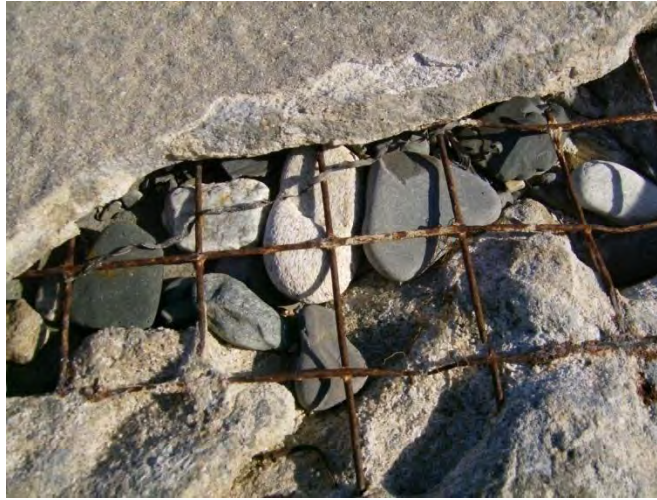
The chain and hammer test was used on the cap to determine the bonding of the shotcrete cap with the original wall. The chain test is where a large chain is dragged over the horizontal surfaces to detect a change in pitch where voids would be present under the surface. From the chain test it was found that the top horizontal face of the wall was not bonded for the entire length of the wall. The hammer test is done on vertical faces of the wall, similar to the chain test. It can determine voids present under the surface through changes in pitch as one bangs on the outside of the wall. The area of concern for bonding was found to be between the two mid-level weepholes on the wall extending to 10 feet on either side of them. In this area, a hollow sound was heard which suggests the cap was not bonded.

Figure 22: Un-bonded Shotcrete Cap of South Seawall with Gravel Fill

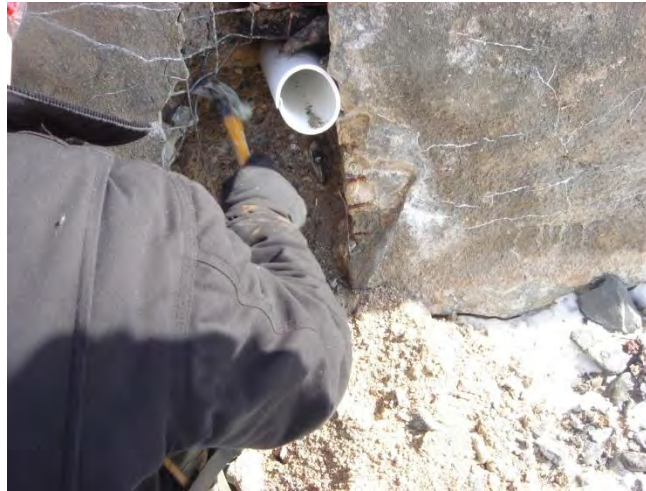
and conditions, but as freeze thaw and Alkali-Silica Reactions occurred, weathering moved internally and has severely weakened the structure.

Figure 24: Chiseling into Original Wall near Weephole Weathering

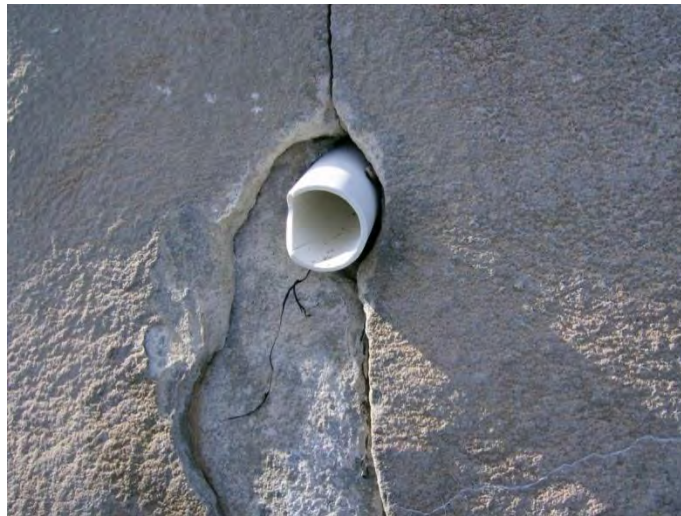
Figure 26: Weephole located halfway up on South Wall

Under Duncan Mellor's guidance from experience on previous projects, it is recommended that weepholes be present in 8 foot intervals horizontally and with 3 foot vertical spacing along the entire length of the wall.

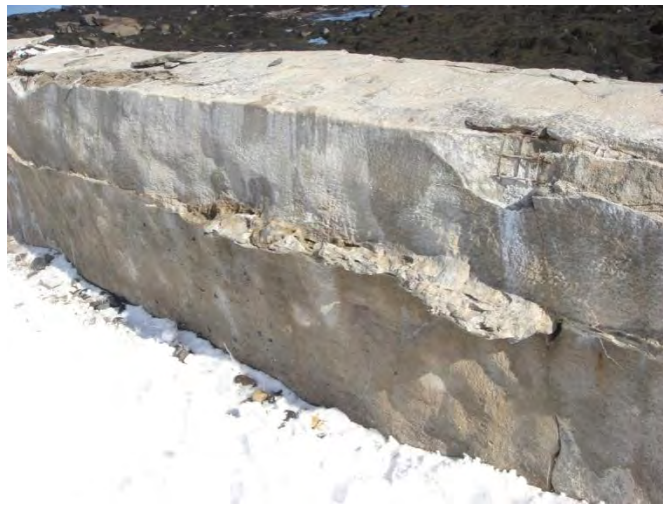
Backfill is added behind seawalls to allow for structure support against wave action as well as providing adequate drainage of waters. It allows water retained behind the wall to migrate towards areas of drainage. Due to the inadequacy of the drainage on the south wall, it was observed that the backfill had significantly eroded along the entire length. Since the wall was shotcreted well after the initial structure had been constructed, a visible line could be seen where the shotcrete had once come to the interface of the backfill which resided behind the wall. Seen in the figure below is a distinct line which indicates the initial position of the backfill, and as seen, this line is now over a foot above the now residing backfill. This clearly shows that the backfill which is integral to the stability of the structure has and is continuing to erode.

Figure 28: Signs of Backfill Weathering

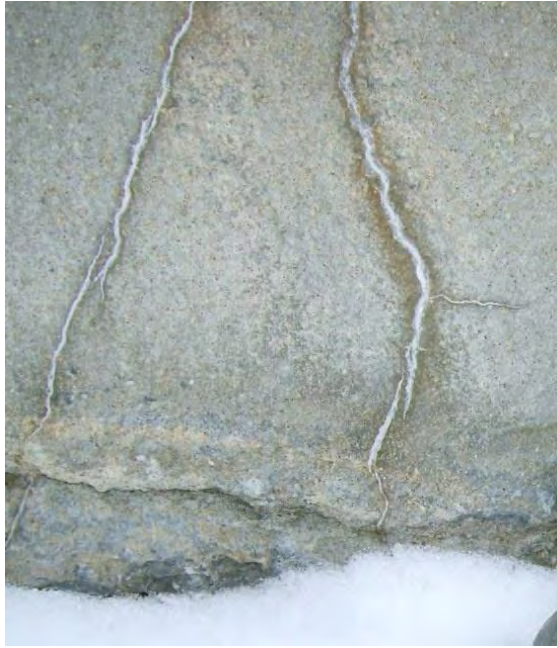
Figure 33: Leaching of Sulfates from South Seawall

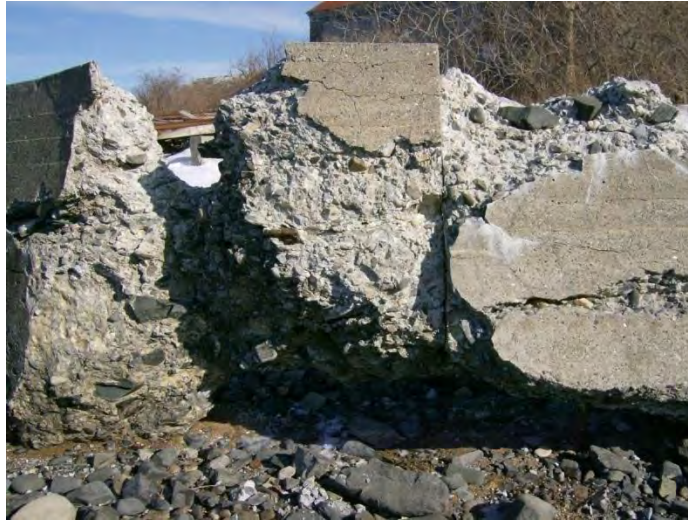
Figure 34: Undercutting of North Seawall (1)

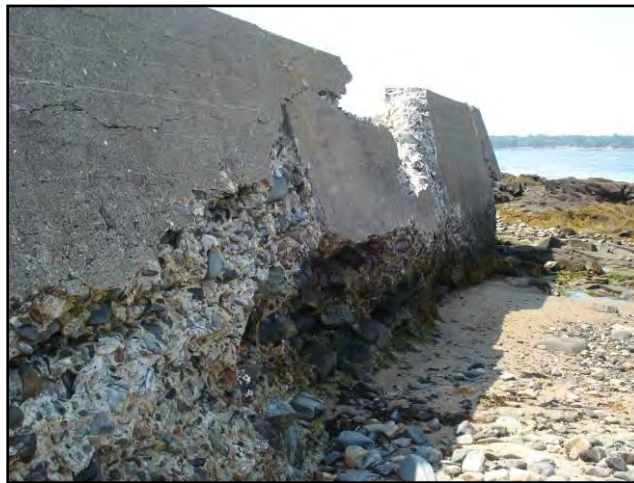
Figure 35: Undercutting of North Seawall (2)

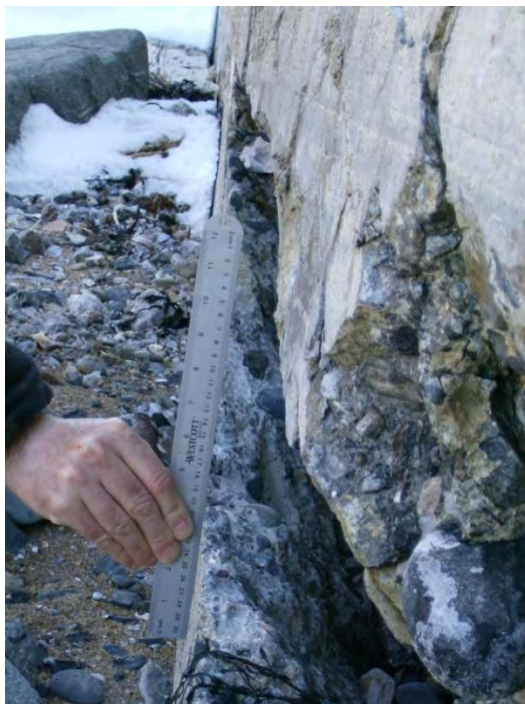
allows for the horizontal and vertical displacement of the structure as it fails and sooner or later will fall over.

Figure 36: Horizontal Displacement and Overturning of North Seawall (1)

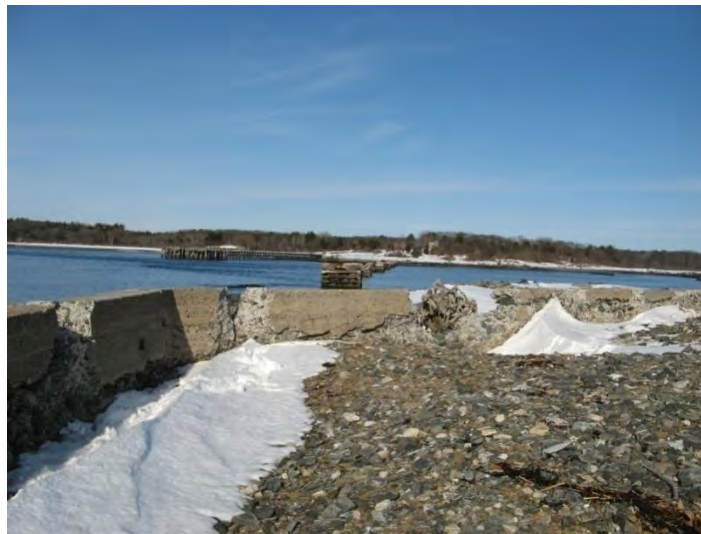
It seems that the north wall was constructed in segments. At locations approximately every 10 ft horizontally it was observed that construction joints lie where one section ended and another began. These construction joints may have served as expansion and contraction joints or rather as paths for drainage, but have since become a localized area for freeze thaw action. As water penetrates the cracks and then freezes, it expands and then puts stresses in between the segments. This pressure slowly forms cracks and as seen in the figure below is the primary region where the most severe weathering has occurred.

Figure 38: Weathering at Locations of Construction Joints along North Seawall

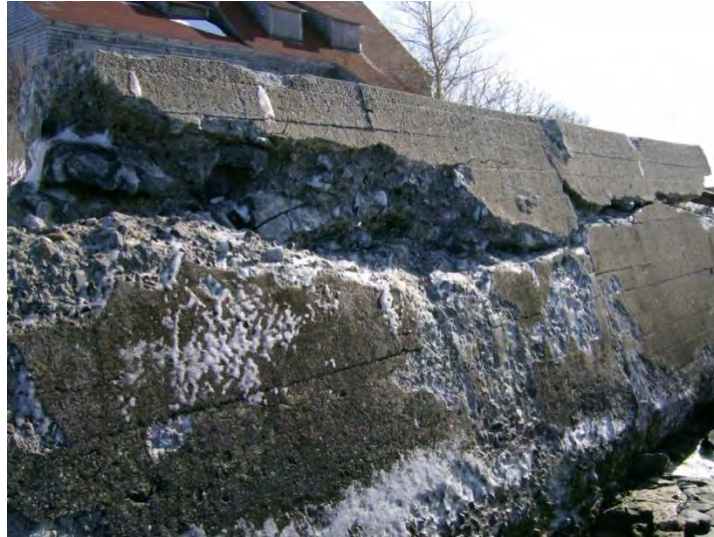
Figure 39: Freeze Thaw Action on North Seawall

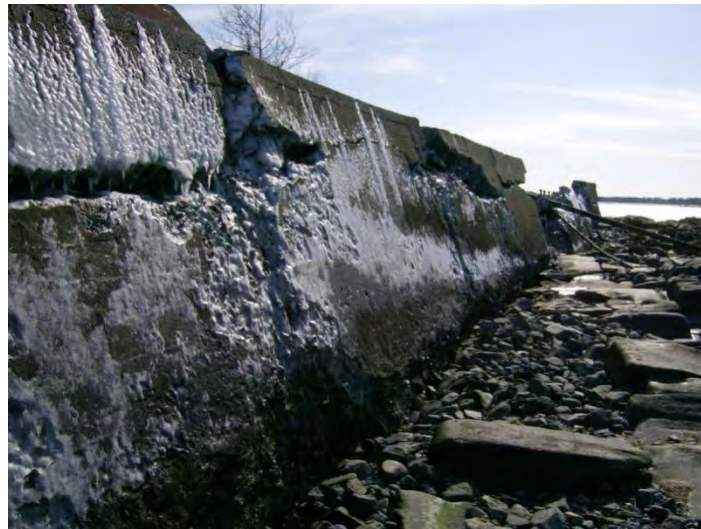
Figure 40: Visible Freeze Thaw on North Seawall

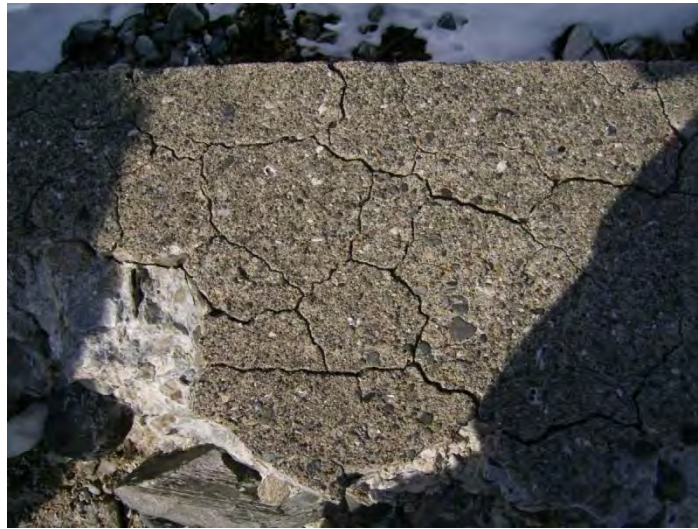
Figure 42: Spider Web Cracking Signs of ASR along North Seawall

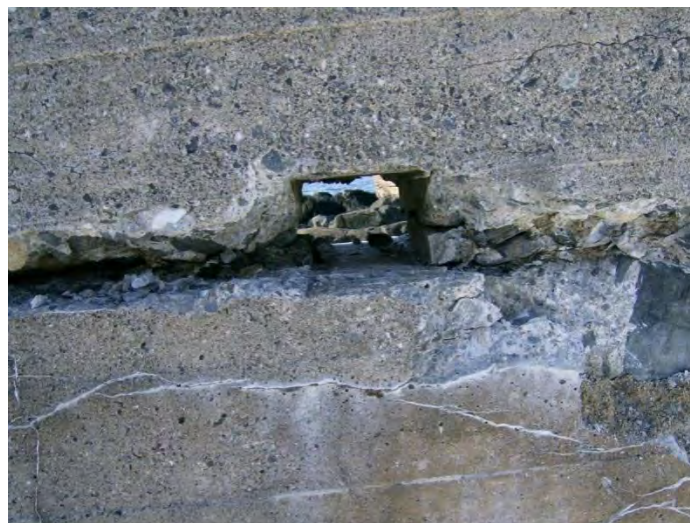
Drainage paths were seen on the north wall as cast in place holes rather than weepholes as the south side had. The drainage holes were about 3 inch by 3inch and had one located at the bottom and one about halfway up the wall for every segment. As seen in the figure below, these were also sites for freeze thaw action to penetrate and form the typical parallel cracking across the walls face.

Figure 43: Cast in Place Drainage along North Seawall

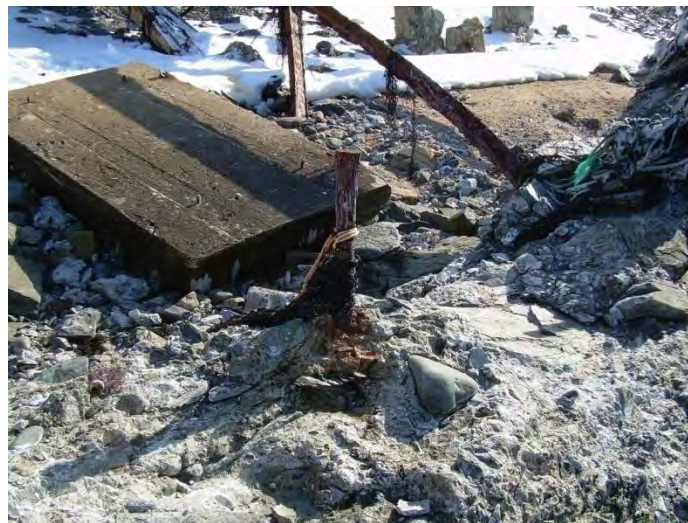
Vertical tie anchors were seen where sections of the wall had collapsed and been washed away. The tie anchors seen, extended about 2 ft vertically from the bedrock and were used to provide stability to the foundation of the original wall. In areas where large portions of the wall were missing, it was seen that tie anchors were spaced about 10 ft horizontally along the length of the wall. Seen in the pictures below are the tie anchors, and serious corrosion has occurred due to the sulfate content of the nearby seawater.

Figure 44: Corrosion of Tie Anchors along North Seawall (1)

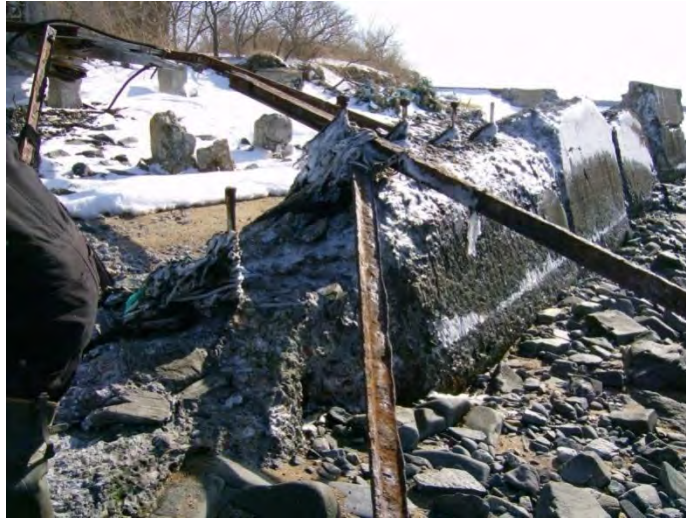
Figure 45: Corrosion of Tie Anchors along North Seawall (2)
