# Government Wharf Condition Assessment

Town of Kittery, ME

June 1, 2017

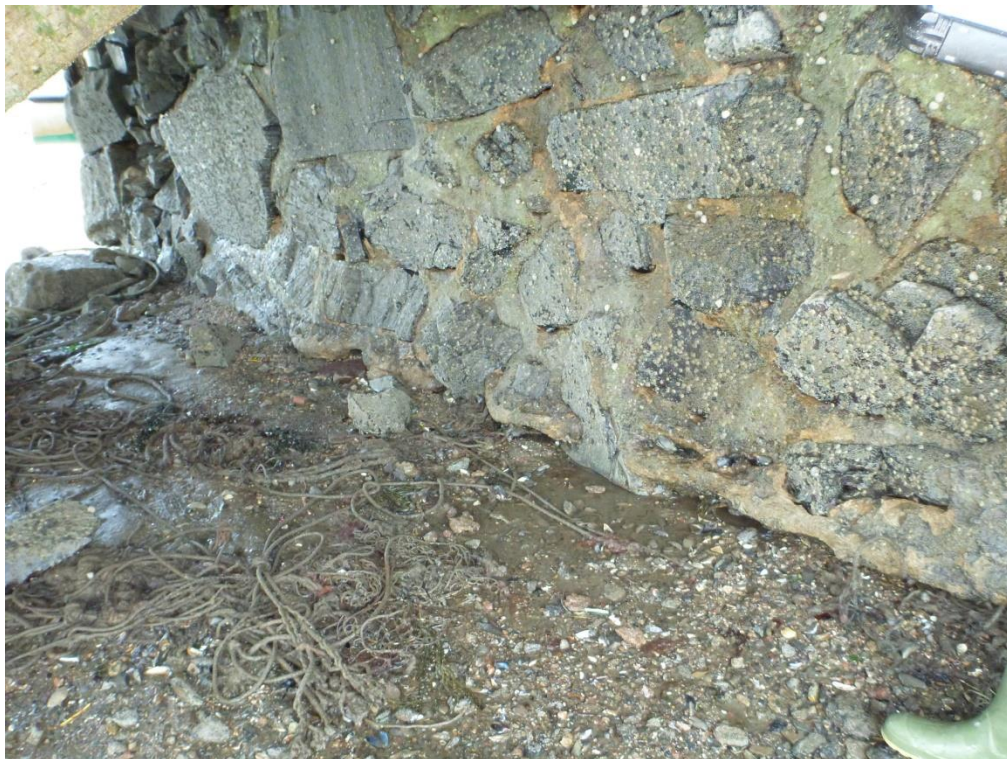
Figure 11 – Stone faced bulkhead. Note: water seepage beneath bulkhead

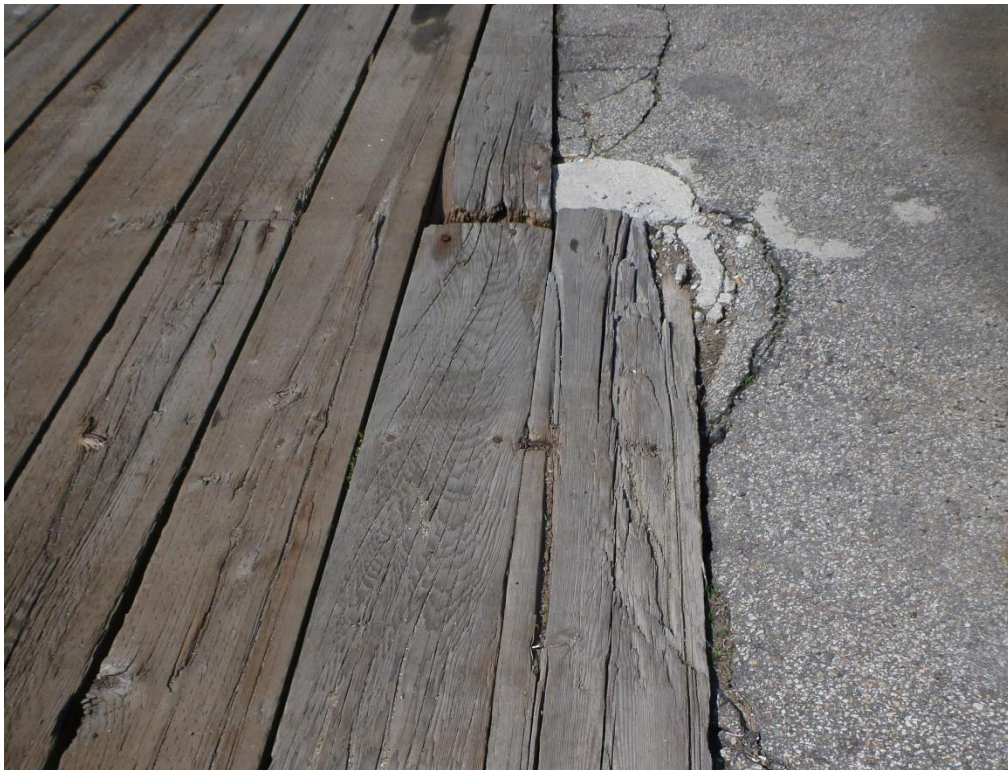
Figure 13 – Decking in poor condition near pavement interface

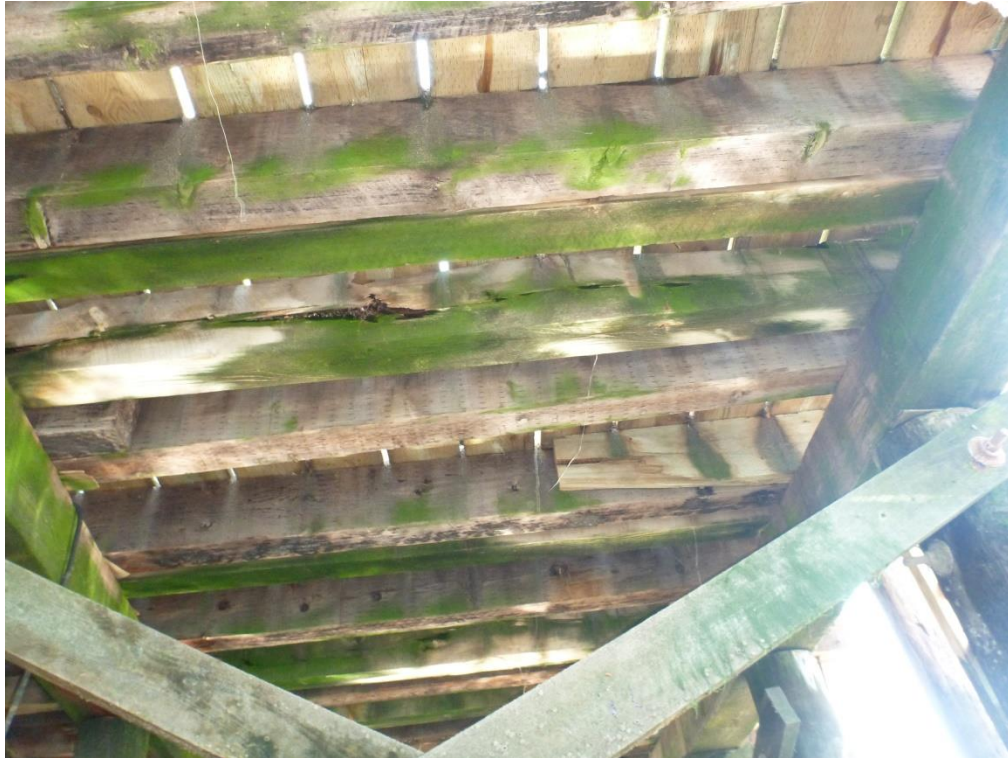
Figure 14 – Pier Stringers (Note: more algae growth and visible rot on older stringers)

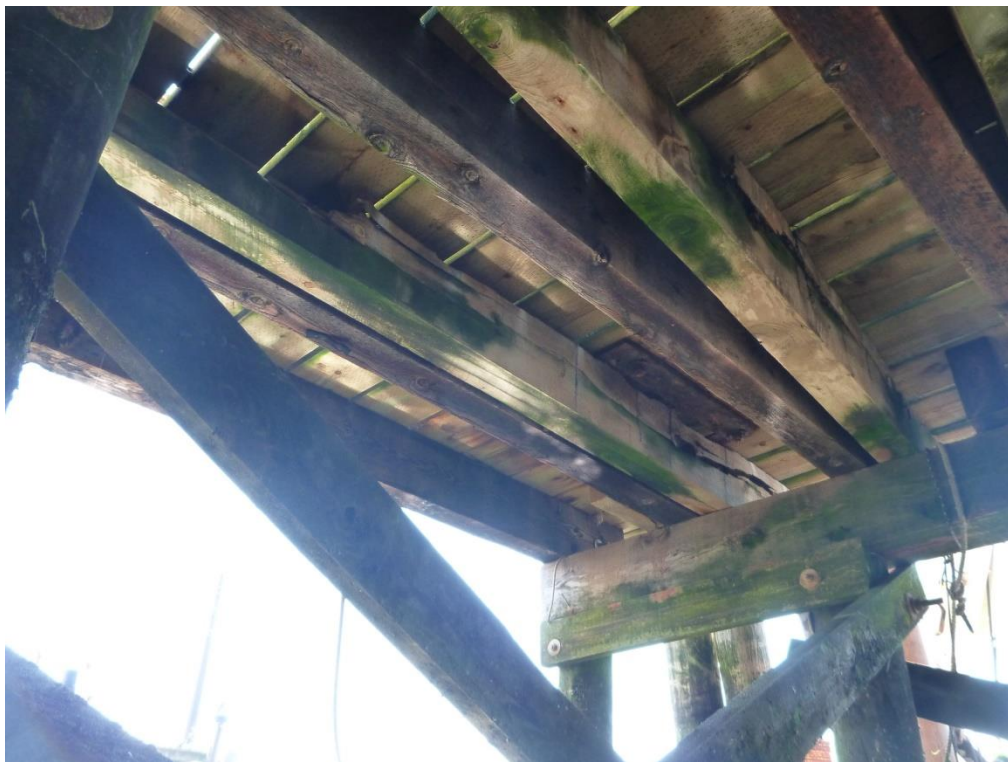
Figure 15 – Pier Stringers (Note: more algae growth and visible rot on older stringers)

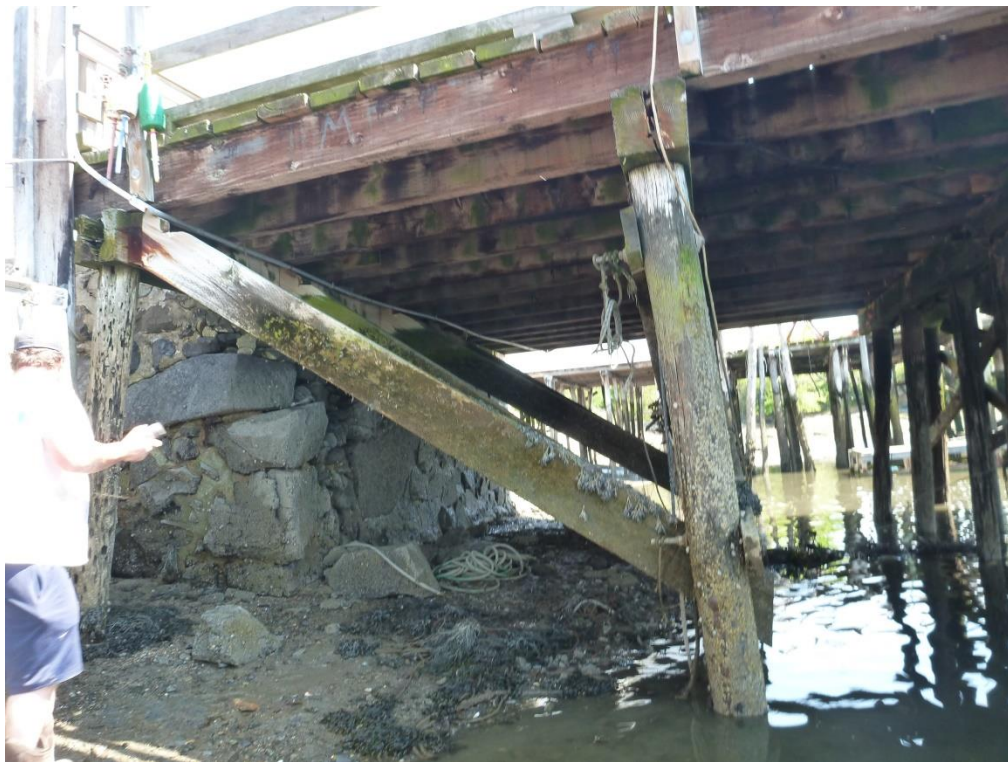
Figure 17 – West end of bents 4 & 5. Note: significant deterioration of pile caps 4 & 5

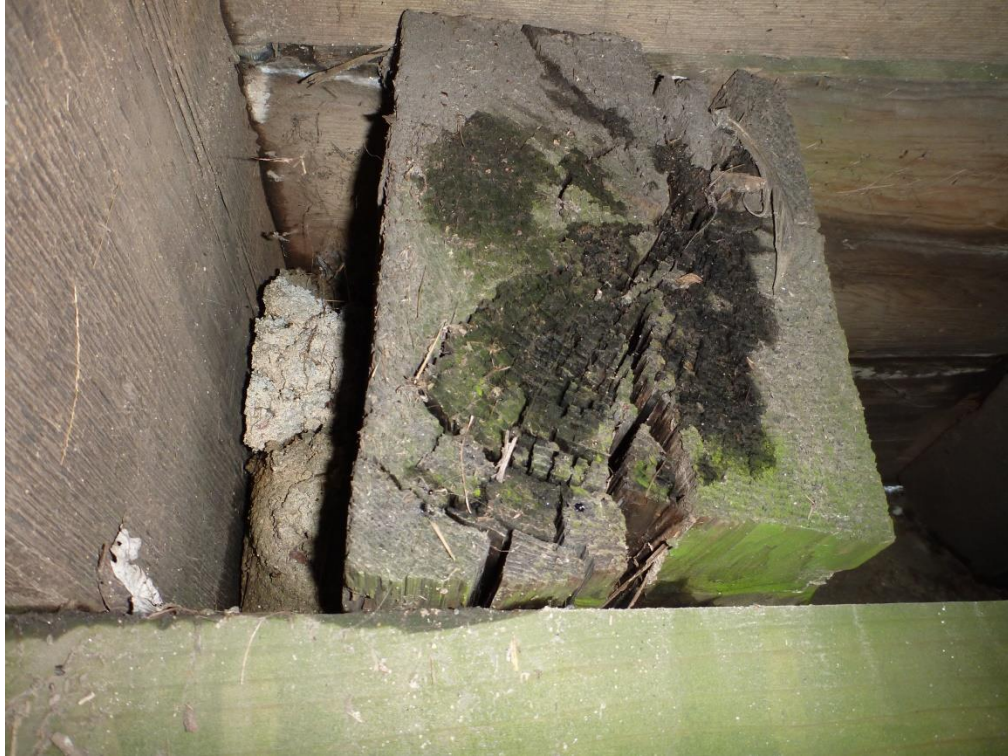
Figure 18 – Significant deterioration of stringer near Line 5

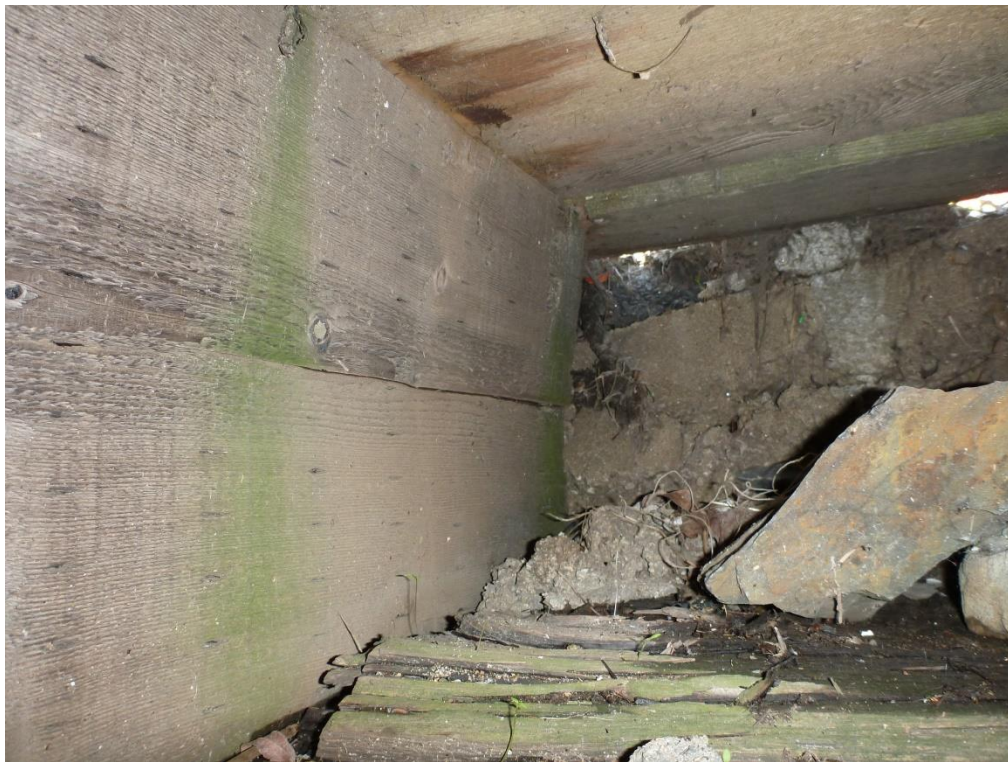
Figure 19 – Failure of stringer at Line 5

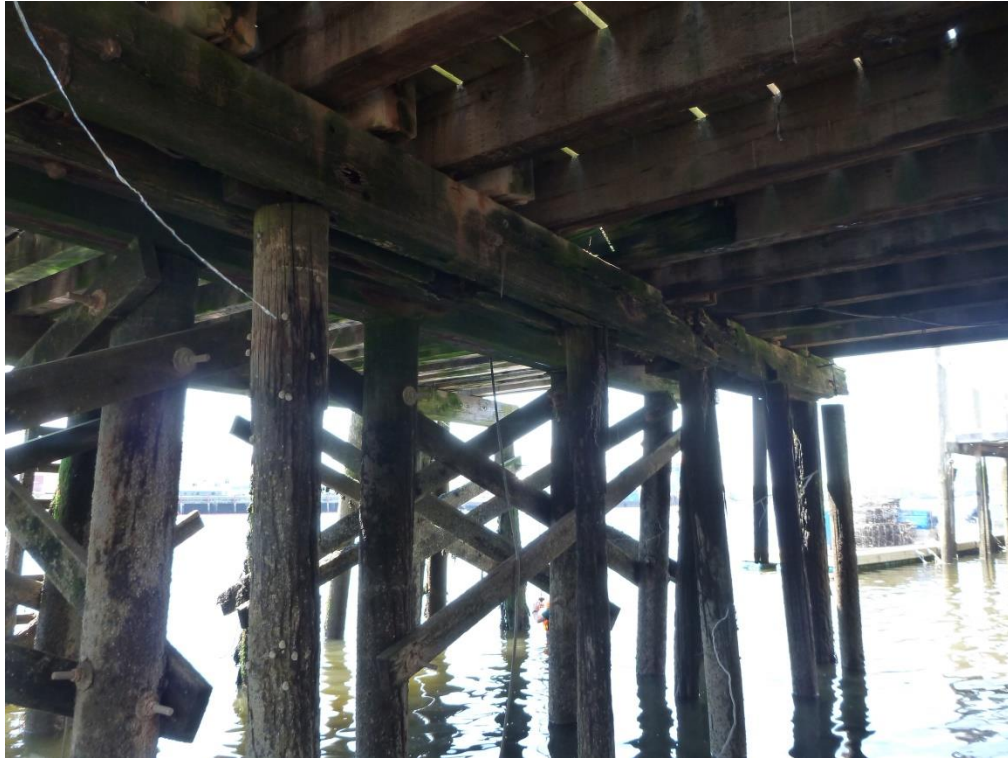
Figure 20 – View of Bent 3 in very poor condition (believed to be abandoned)

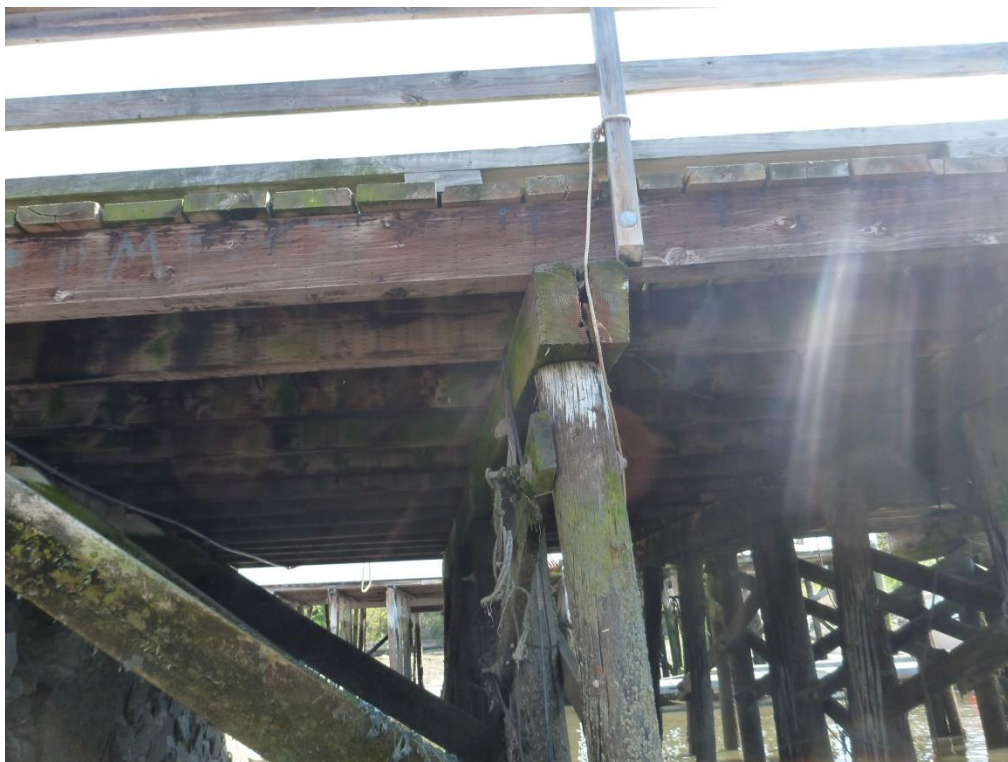
Figure 21 – West end of Bent 4. Note: Split in pile cap, striations in end pile

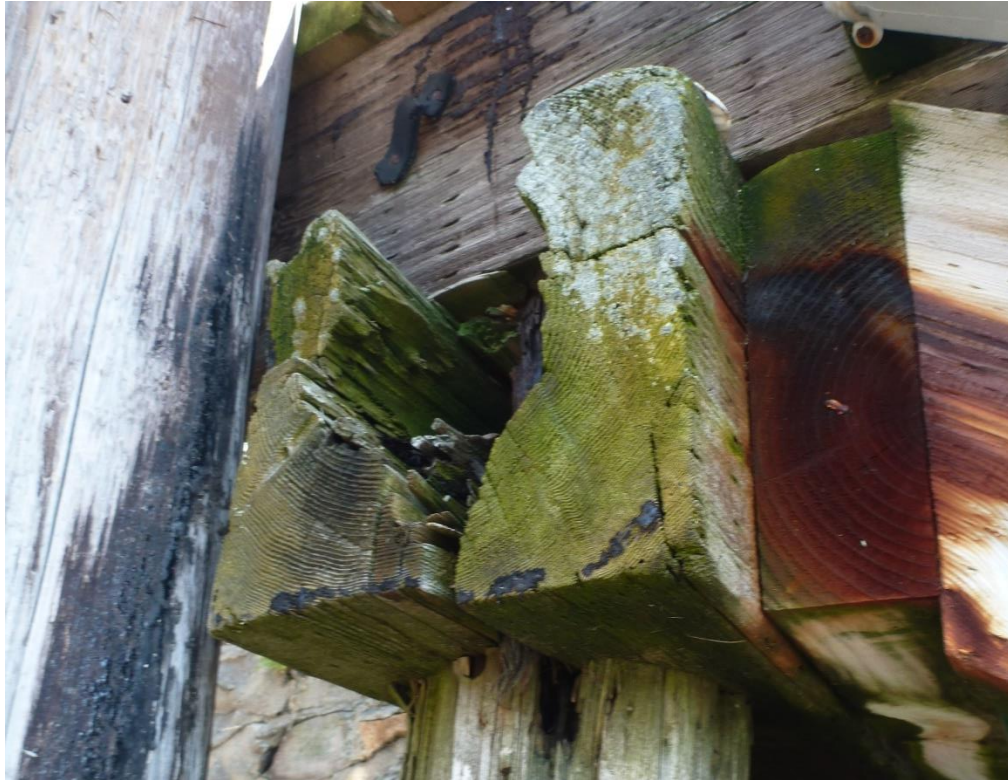
Figure 22 – West end of Bent 5 Pile Cap. Note: Near complete failure of pile cap, significant rot in pile

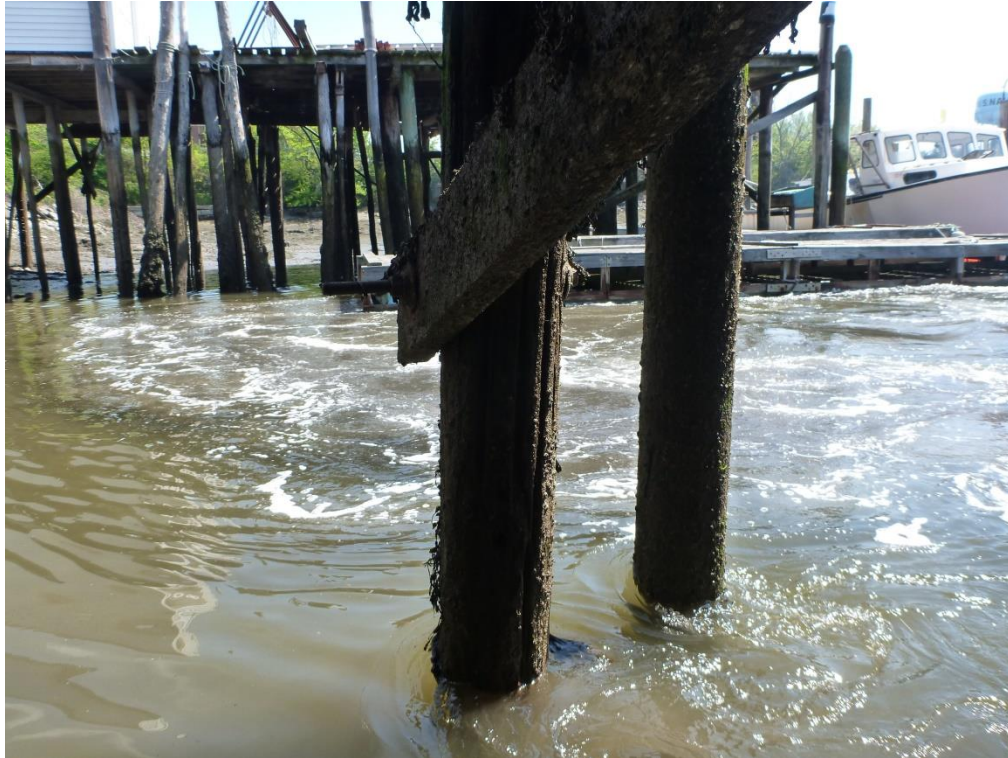
Figure 24 – End pile on Bent 4. Note: More severe deterioration

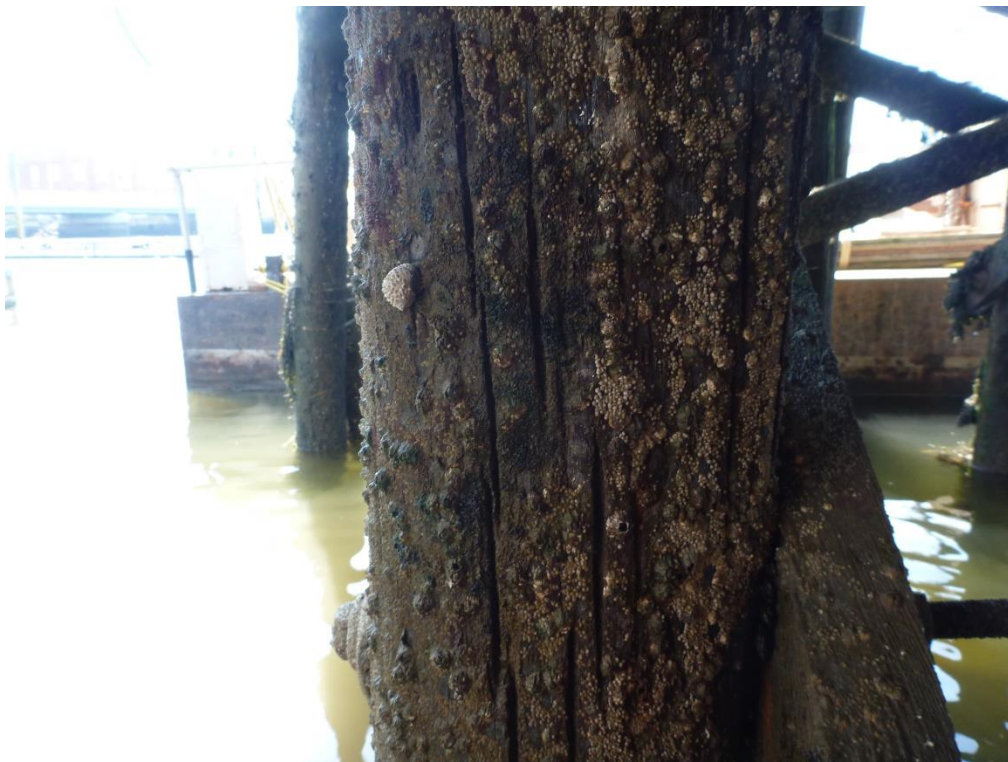
Figure 25 – End pile on Bent 4. Note: more severe deterioration

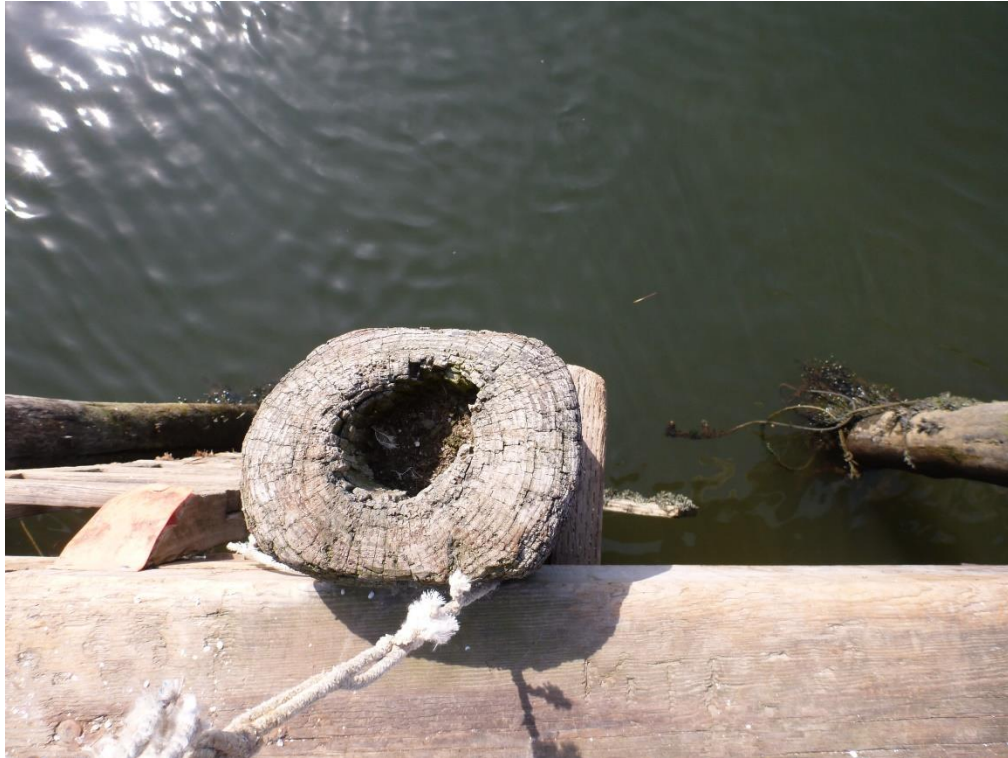
Figure 28 – Fender Pile at working face showing moderate rot

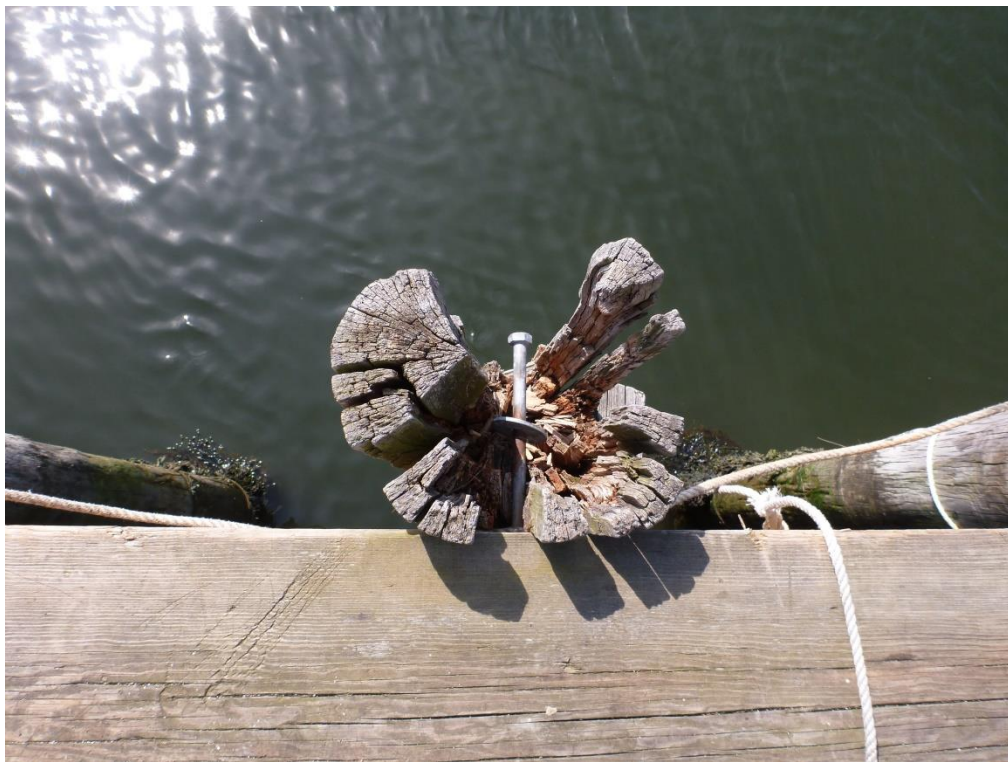
Figure 29 – Fender Pile at working face showing severe rot and connection failure

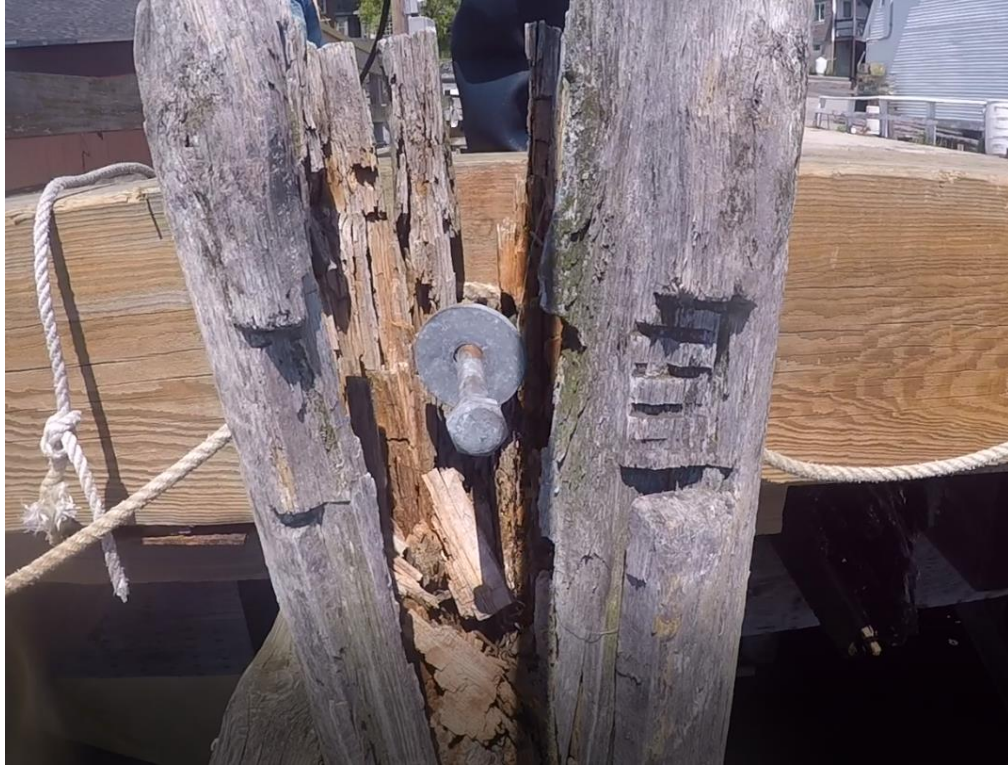
Figure 30 – Fender Pile Deterioration, view from water side

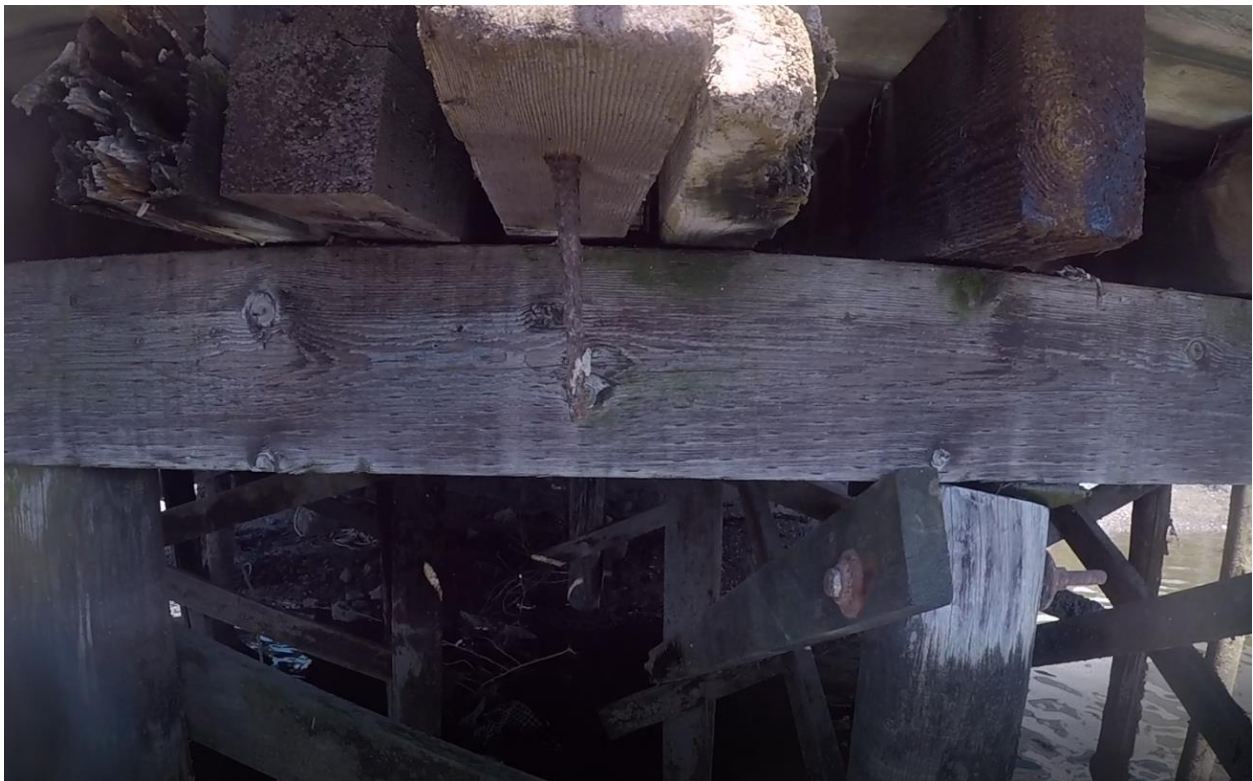
Figure 31 – View of Pier framing from water side, note: multiple generations of closely spaced stringers

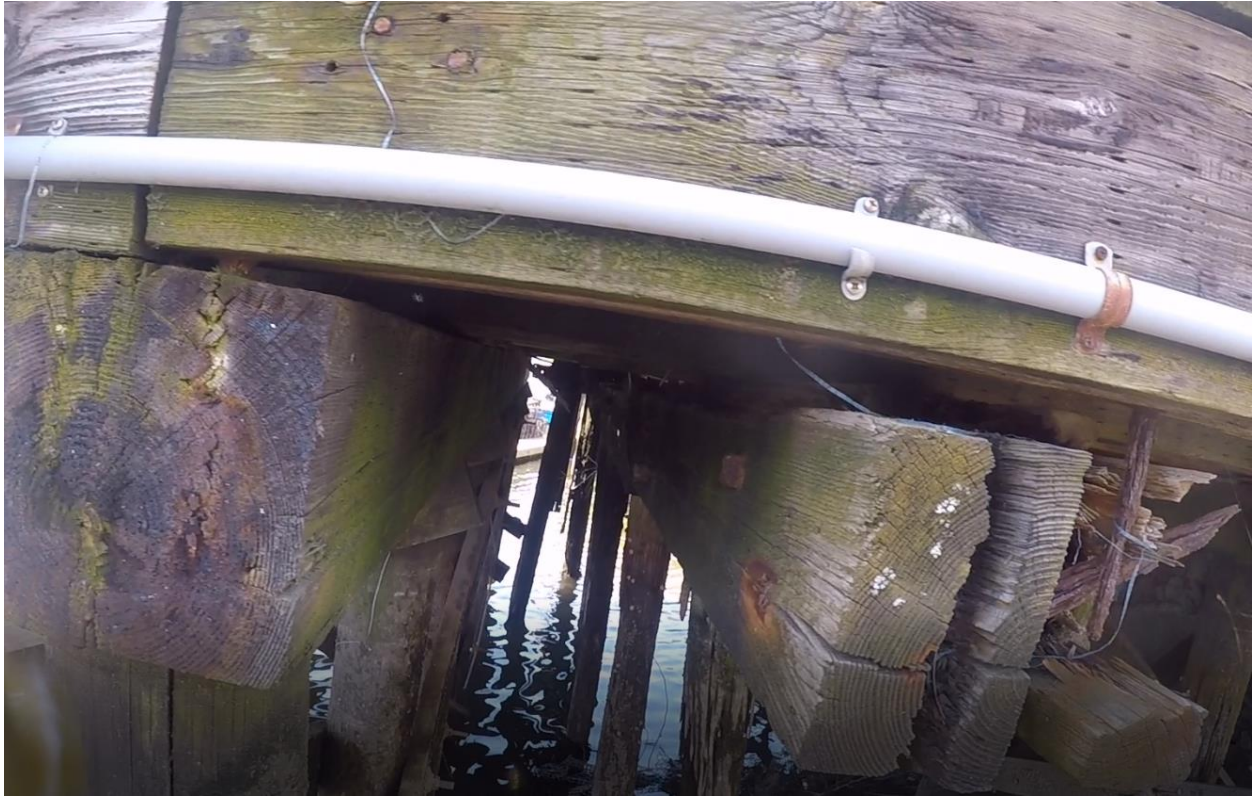
Figure 32 – View of Pier framing on east edge. Note: outer stringer lifted due to hoist tension anchor.

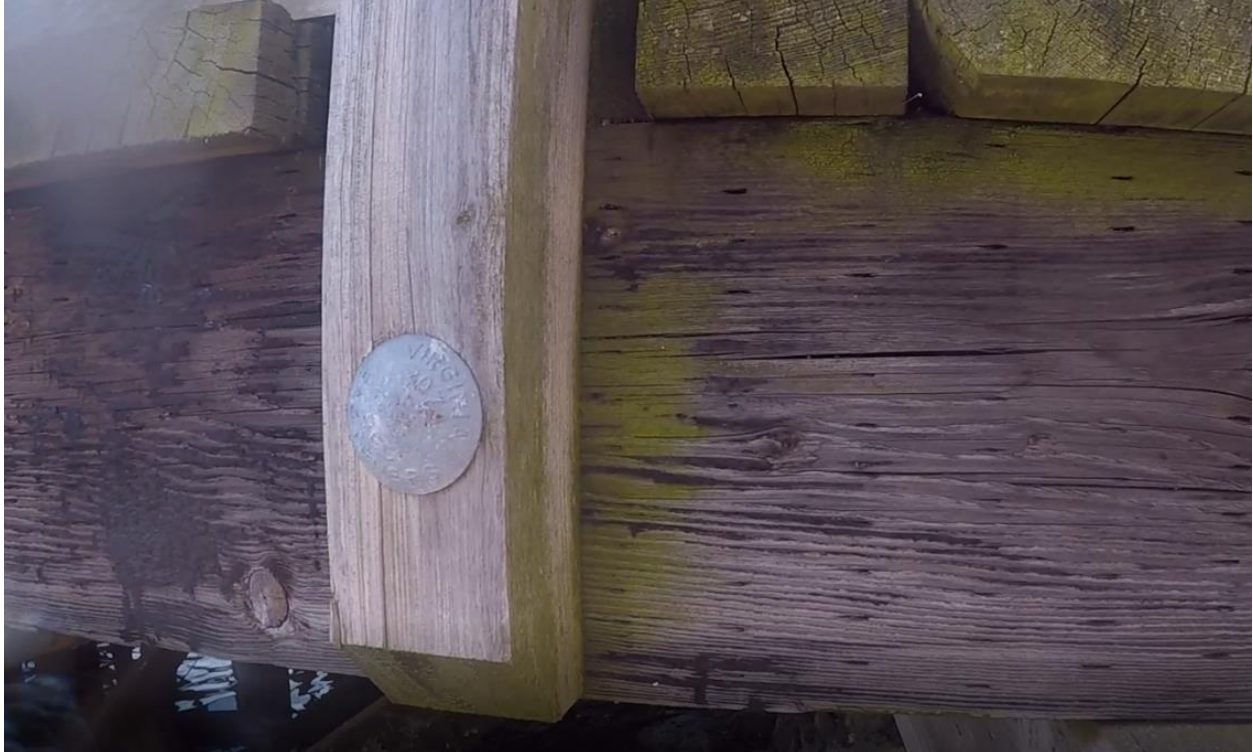
Figure 33 – Typical railing post connection with single timber bolt.

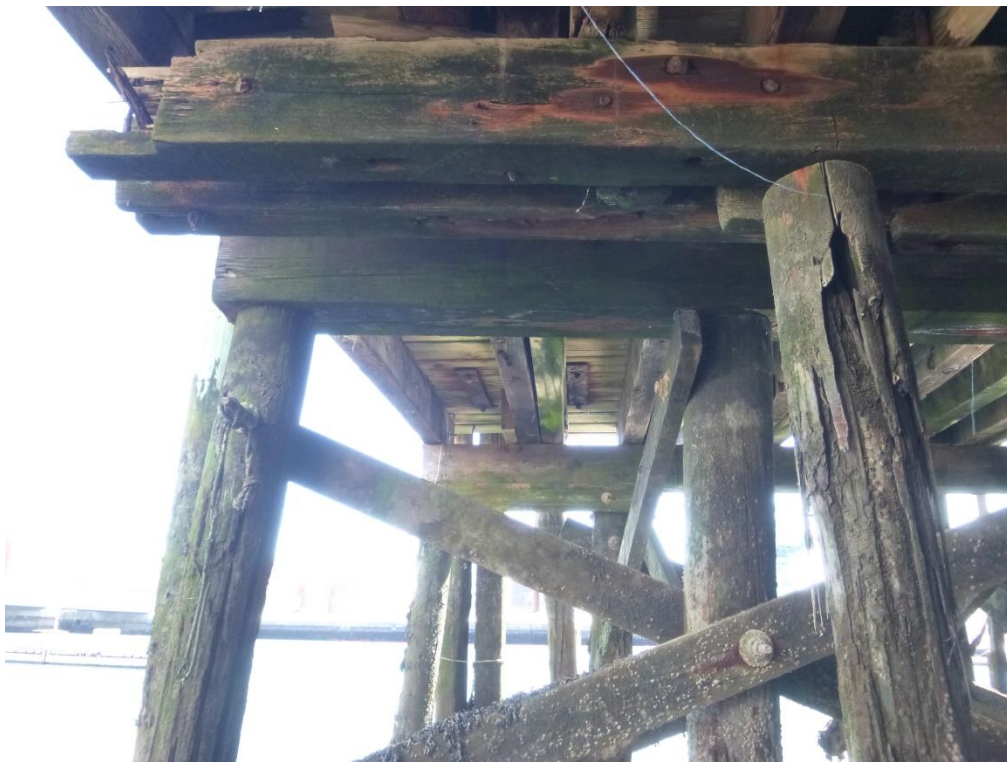
Figure 35 – Underside of southeast corner of pier, note: hoist only fastened to decking

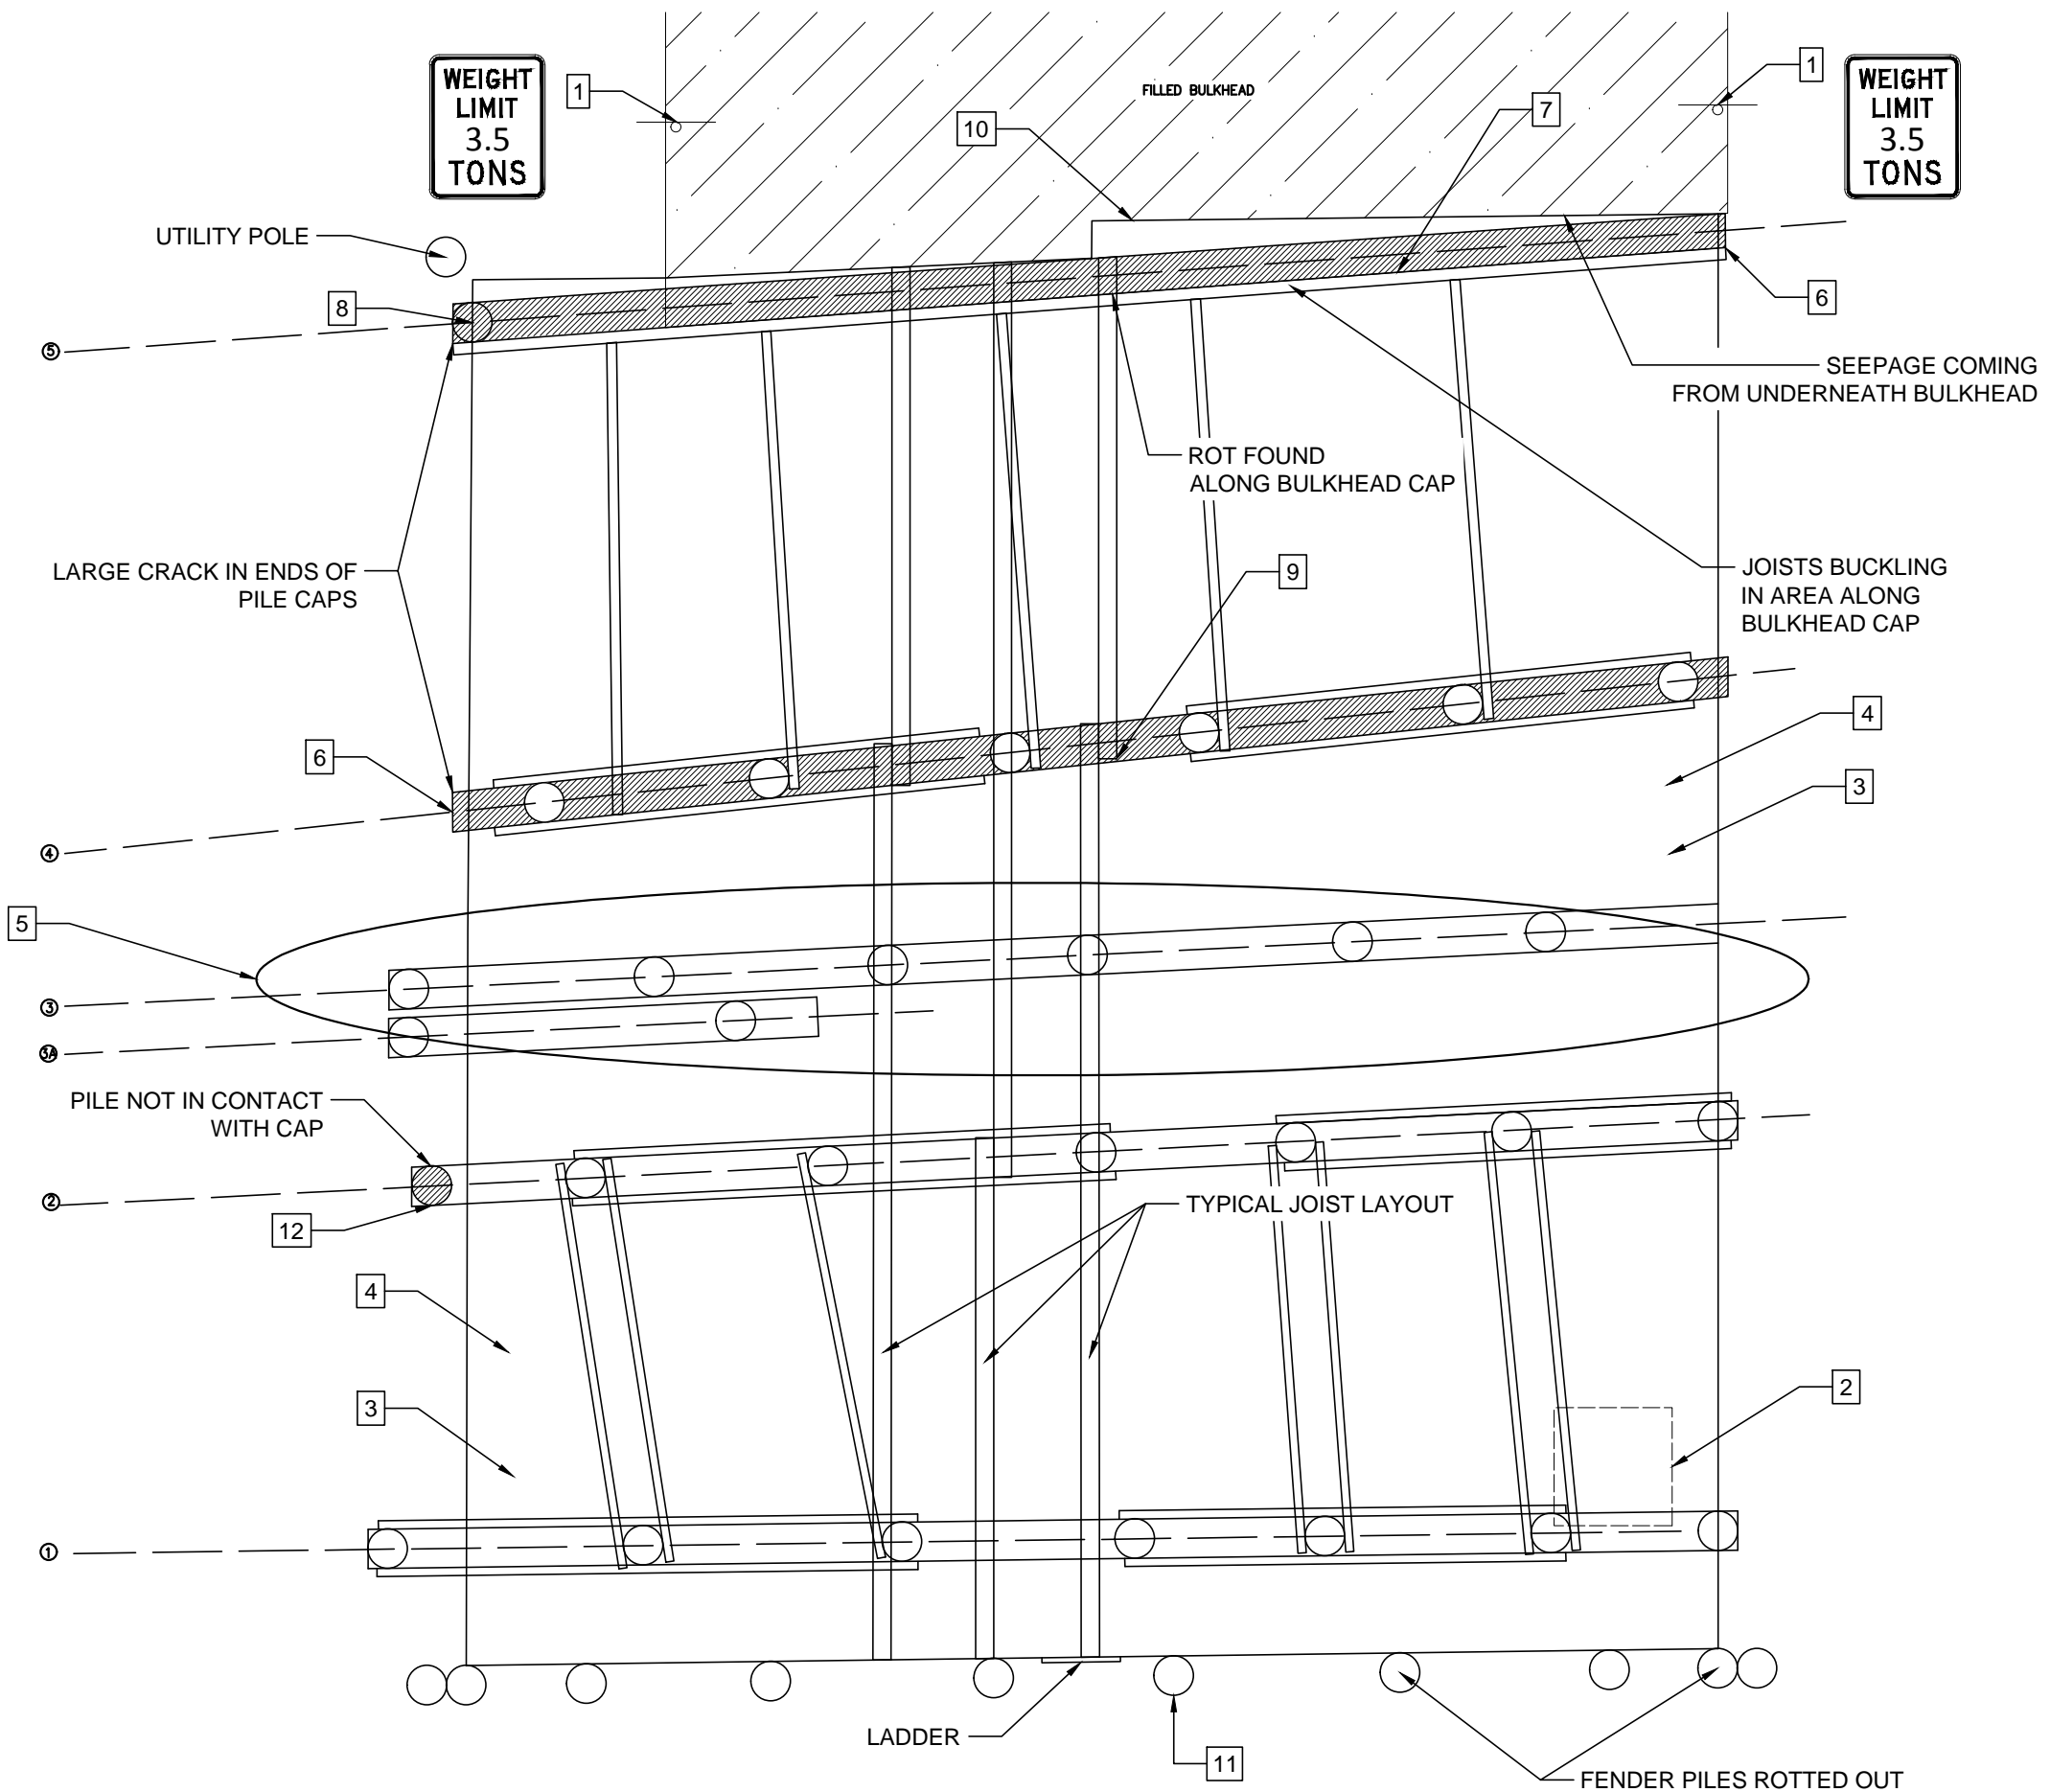
SHEET TITLE: <b>PIER CONDITION NOTES AND RECOMMENDED ACTION</b>	
PROJECT: <b>GOVERNMENT WHARF INSPECTION</b>	
Kittery Port Authority Kittery, Maine	
DATE:	MAY 2017
CONTRACT NO.:	17-08
SHEET NO.:	SK-3
REV.:	A

CONDITION NOTES ARE PER FIELD SURVEY COMPLETED MAY 18, 2017 BY BAKER DESIGN CONSULTANTS

1. INSTALL LOAD RATING SIGNAGE FOR 3.5 TONS
2. STRENGTHEN HOIST BASE CONNECTION AND CABLE ATTACHMENTS
3. UPGRADE RAILING
4. PROVIDE COMPLIANT CURBS TO EAST AND WEST EDGES OF DECK
5. REMOVE GRID LINE 3 AND 3A PILES AND CAPS AND DISPOSE OF OFFSITE
6. REPLACE OR SISTER CAPS ON LINE 4 AND 5
7. CHECK JOIST SUPPORT AT CAP AND SISTER AS REQUIRED
8. REPLACE DETERIORATED PILE AT END OF LINE 5
9. CHECK TOP FACE OF JOISTS AND REPLACE AS NEEDED
10. MONITOR STONE ABUTMENT FOR CRACKS AND FOR SETTLEMENT
11. REPLACE OAK FENDER PILES
12. SHIM ALL PILES WHERE SEPARATION WITH CAP OCCURS
