Rice Public Library Renovation and Addition

Programming and Existing Conditions Report
June 28, 2019

On Thursday 21 February 2019, we visited the Rice Public Library (RPL). The intent of our visit was to review the existing conditions that are readily visible and comment on their conditions. Ms. Lee Perkins, the Library Director, showed us around and provided information on past building upgrades. The visit and review are being done in anticipation of a renovation and an addition that are currently being planned at RPL. The current library building is on the National Register of Historic Places.

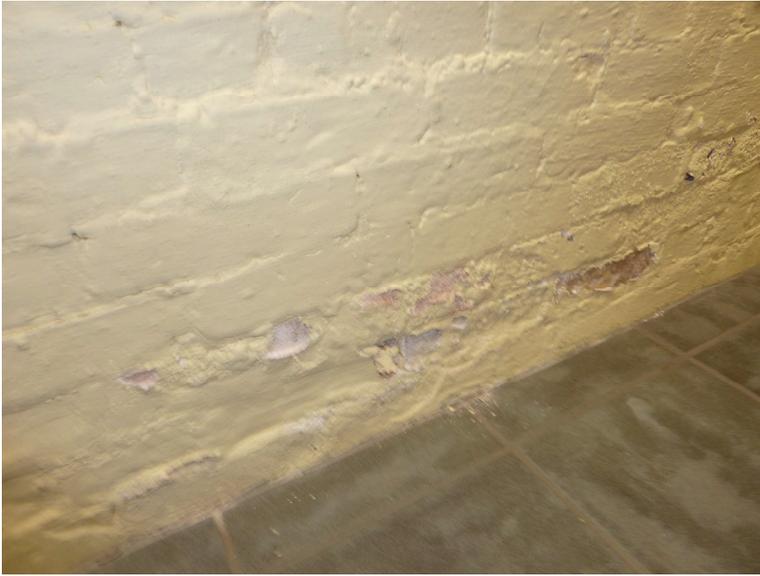
1. Bottom of the brick walls in the basement: We noted damage at the bottom of the brick walls at the basement interior and exterior walls. At the interior walls, the bottom 2ft of the walls appear damaged. In the back of the house areas (boiler, server) the paint is gone, the brick faces are damaged, and some brick appears to be soft (photos 1 and 2). In the more public area (kitchen) the walls have been re-painted, but damage is still visible (photo 3). Similarly, the exterior perimeter walls have damage. Those walls are painted, and the damage appears more sporadic with the paint creating bubbles that eventually burst, exposing damaged brick (photo 4). We note that the bottom of most of the exterior walls are covered with large wood baseboards which hide the brick condition.

The damage is typical of moisture infiltration. At the perimeter walls, it is assumed that moisture travels from the outside through the brick but when it reaches the interior paint, it is trapped and unable to dry. As moisture accumulates between the paint and the brick, it damages the brick. The damage is not exposed until the paint bubble, pops, exposing the damage. The interior walls are also susceptible to moisture most likely wicking up from the foundations. These walls appear built from a mix of fired and unfired bricks which was a common practice for interior walls at the time of construction. The unfired bricks are more susceptible to moisture and deteriorates.

Photo 3: Kitchen area. Close up of interior wall showing paint and brick damage.

The damage to the brick though not a global stability/structural concern at this time, should be stopped before causing more damage. A plan to mitigate the moisture should be included in the renovation design. Such plan could include coating the exterior brick below grade with a waterproofing and installing a perimeter drain, and/or removing the interior paint and leaving the interior brick exposed or painting it with a breathable silica

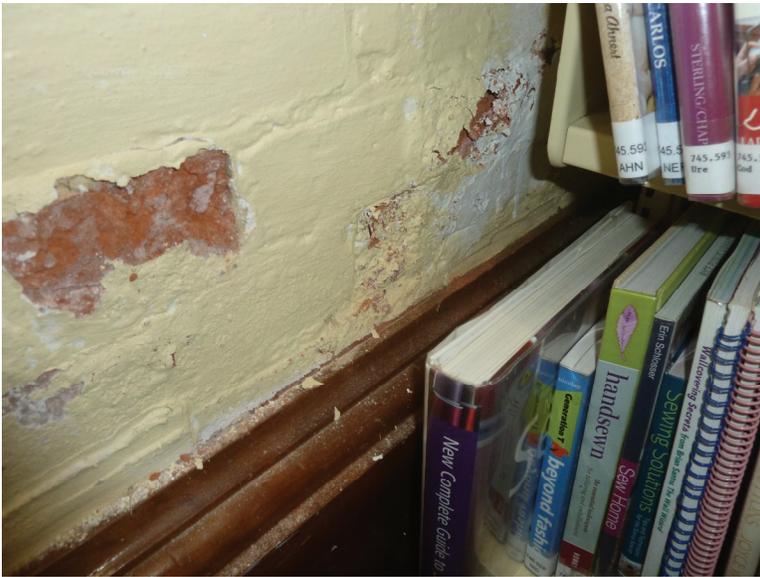
Photo 4: Basement reading room. Close up of exterior wall showing paint and brick damage.

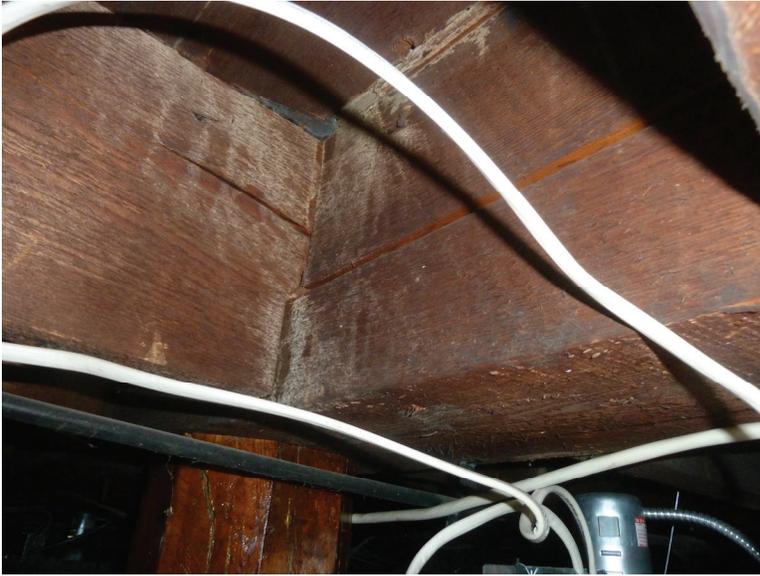
2. First floor wood girders (as observed from basement): the two wood girders supporting the floor in the rear space have some splitting. The splits are horizontal and in line with the bottom of the notches where the joists bear in. The splits do not appear to be through the whole thickness of the girders but were noted on both sides. See photo 5.

Splits are not uncommon and are typically due to wood drying and shrinking. However due to the location of the splits at the support of the joists, they may reduce the girders' capacity. We recommend that the splits be further investigated during the design phase. Additional measurements should be taken to understand the extent and depth of the split so they can be analyzed. If they are found to need repair, epoxy, fasteners, or steel side plates can be added to the beam.

Photo 5: first-floor framing showing wood column, girder and wood joist. Note the horizontal split in the wood girder.

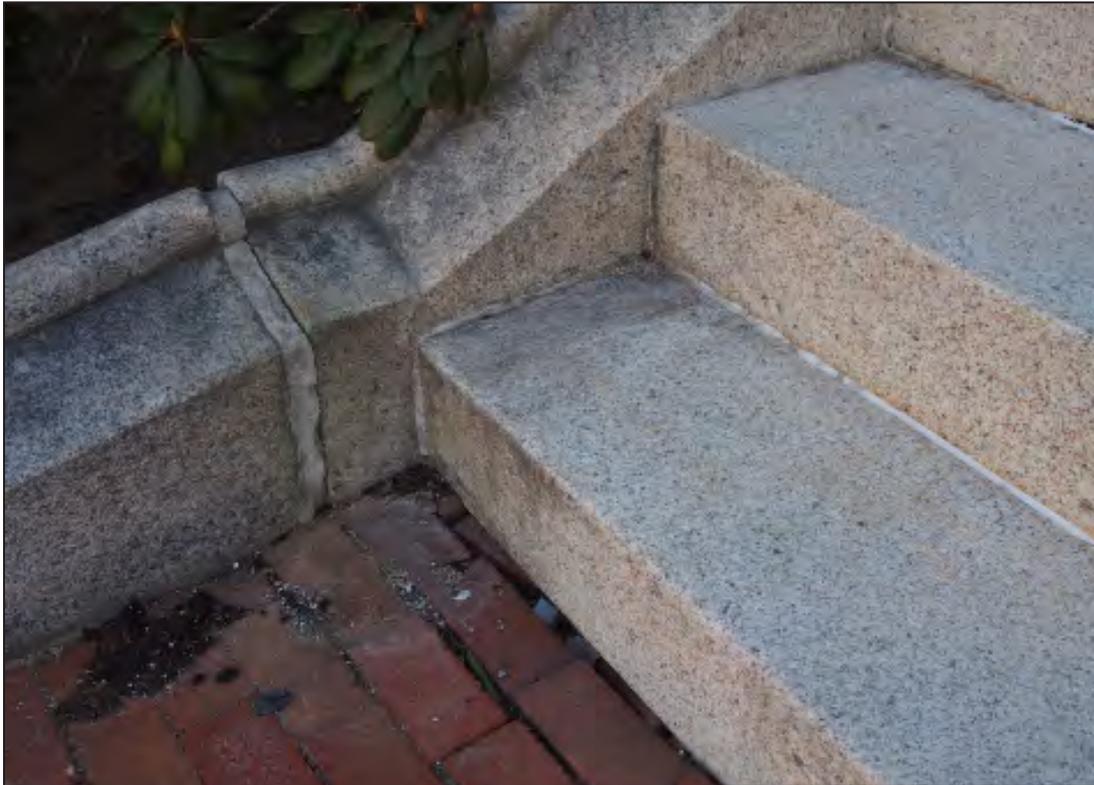
Fig. 2.3 Carved granite urbing on north side of entry stairs. Large joint and cracked mortar indicates settlement of curbstone. (Scattergood Design)

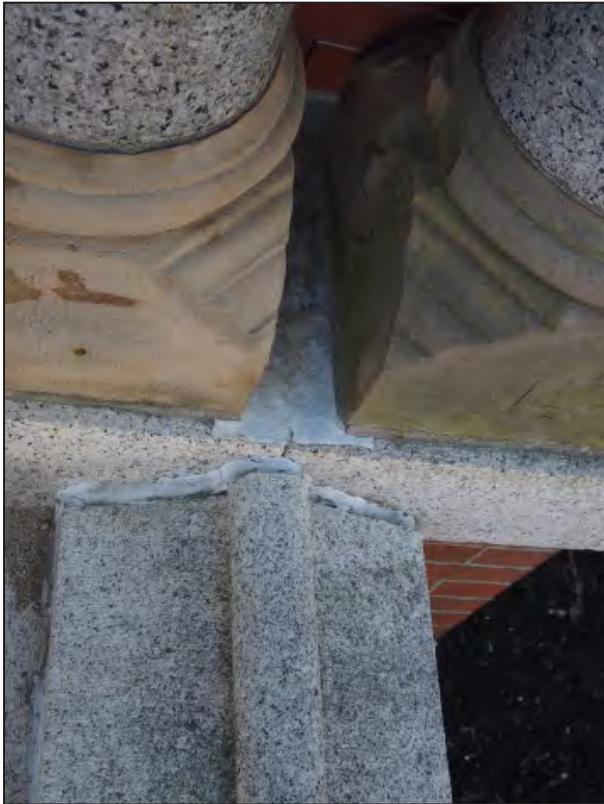
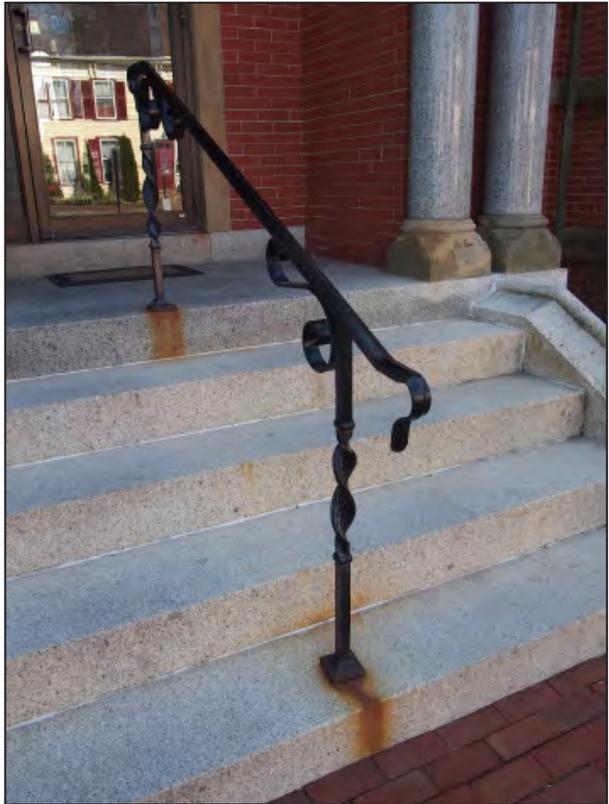
Fig. 2.4 A Joint between stair curbing and pilaster is now filled with caulking..

Fig. 2.4 B Railing is not original. Corrosion prior to recent repainting has stained granite treads. (Scattergood Design)

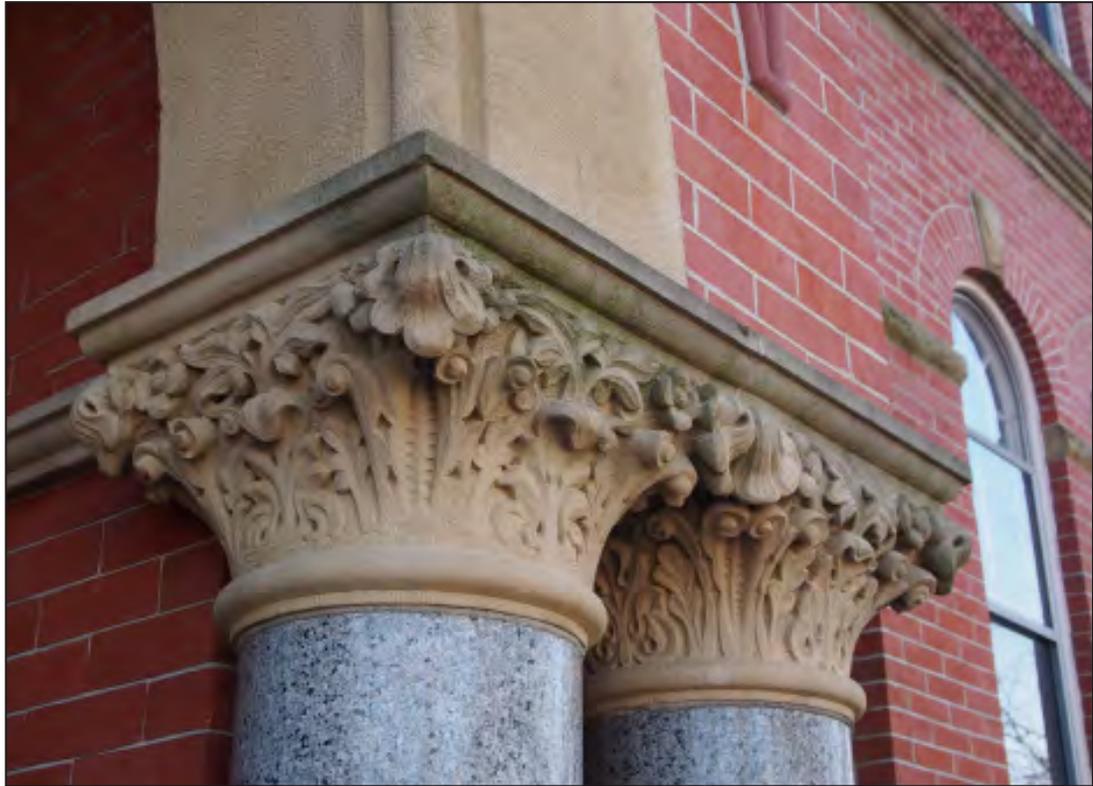
Fig. 2.5 Sandstone capitals have minor erosion. Note soiling on exposed edges (Scattergood Design)

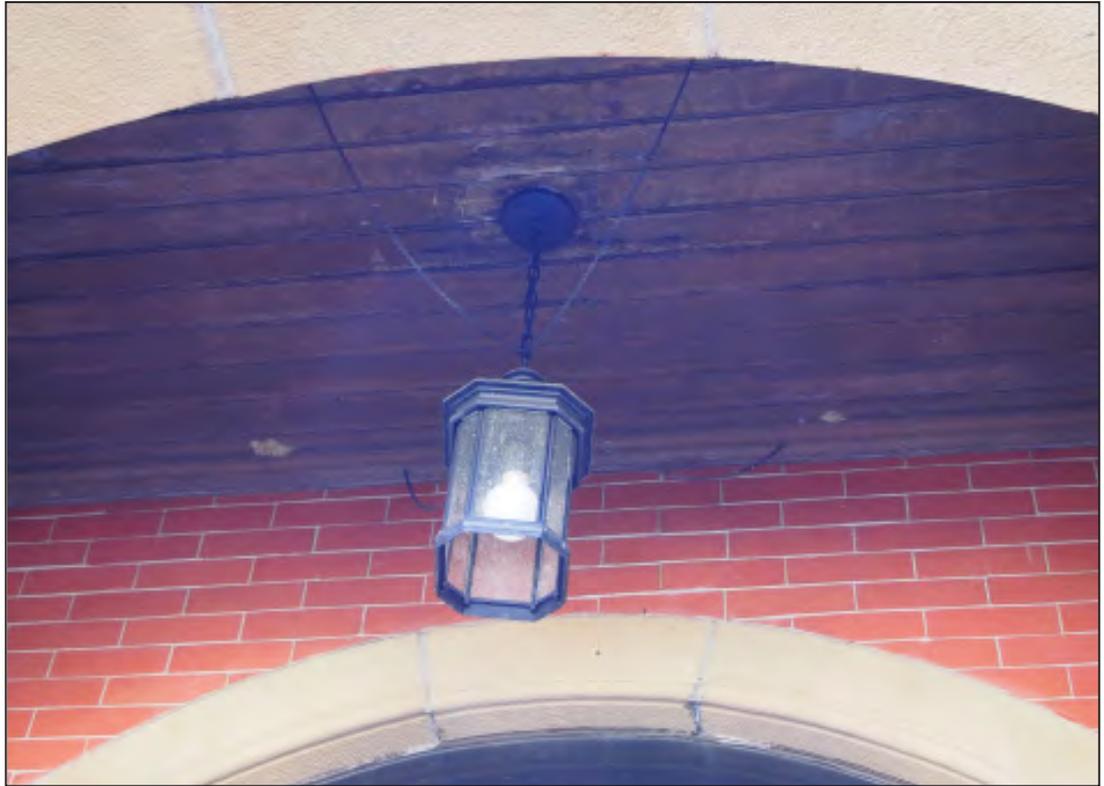
Fig. 2.7 Exterior pendant appears old but is not likely original. Wood beadboard ceiling is in fair condition, with worn finish and some open joints. (Scattergood Design)

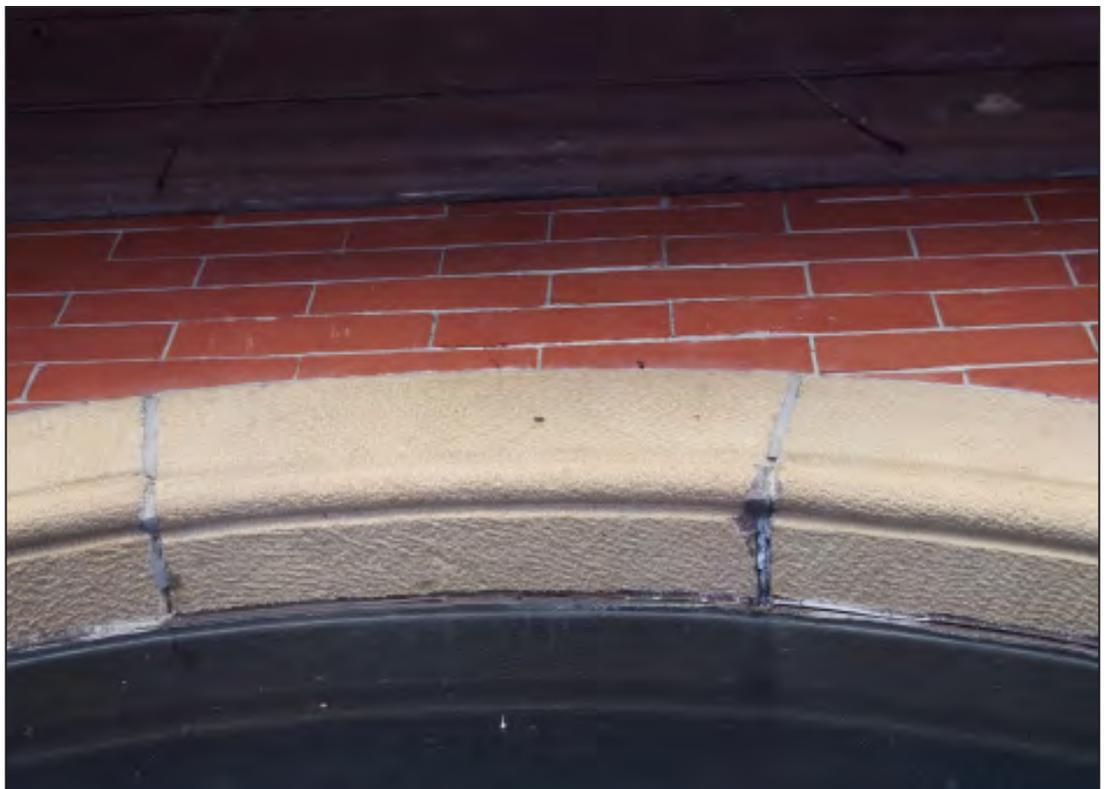
Fig. 2.8 Open joints in sandstone arch over doorway have been partially filled with caulk. Note also sealant loss at door frame. (Scattergood Design)

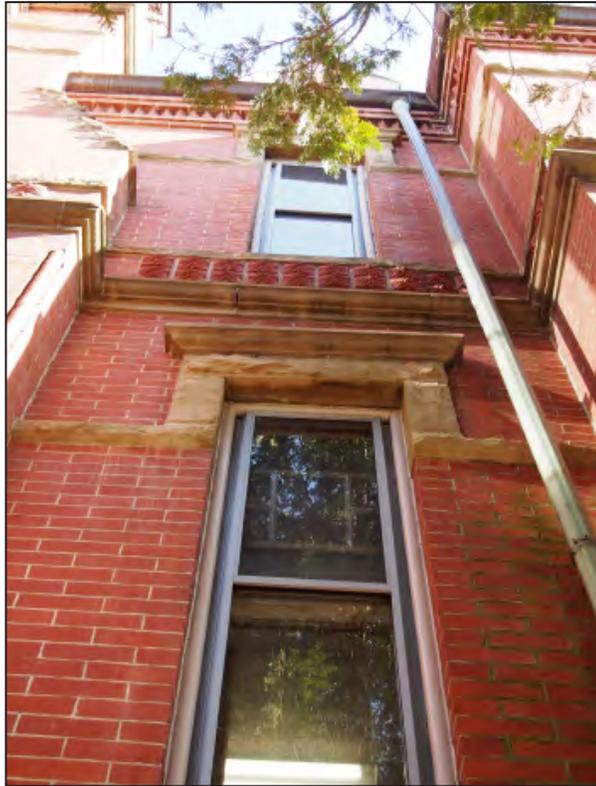
Fig. 2.18 Detail of first floor windows, south side of tower, showing soiled sandstone and brick from condensate dripping at window air conditioners. (Scattergood Design)

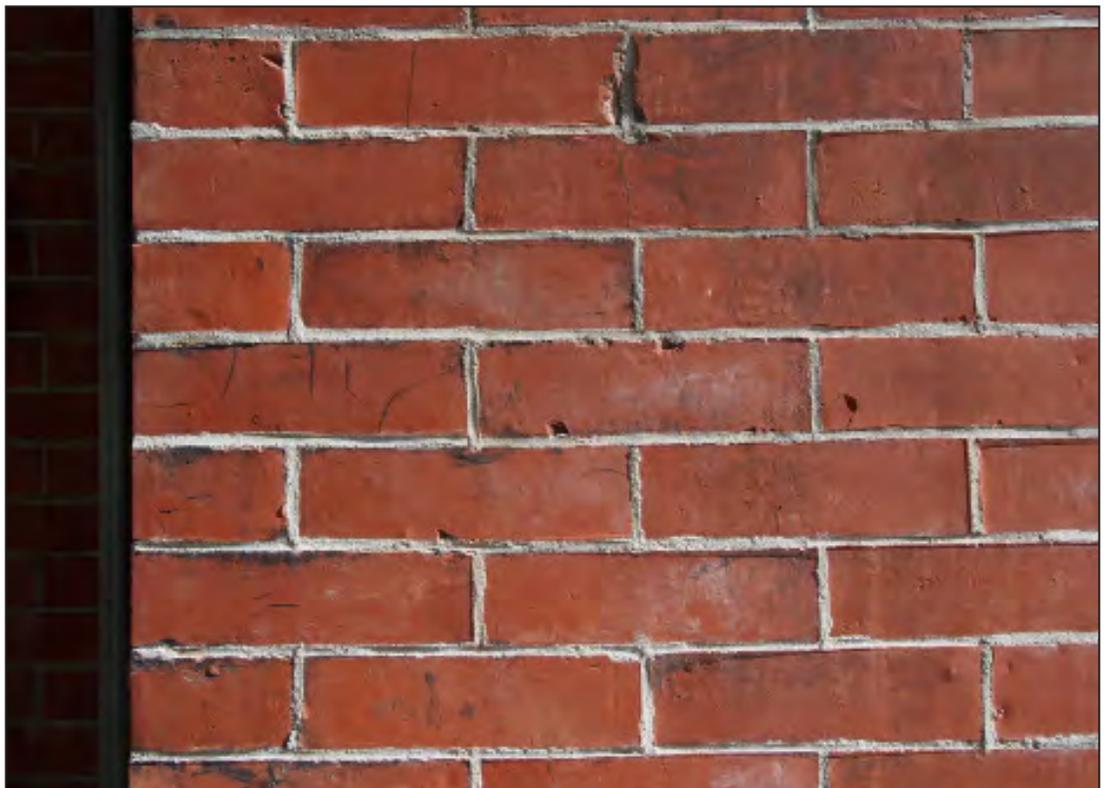
Fig. 2.24 Typical condition of masonry. Brick is high quality and generally sound, with some chipping as a result of improper past joint cutting. Pointing is lightly struck and protrudes slightly beyond edges of brick and in relatively good condition. (Scattergood Design)

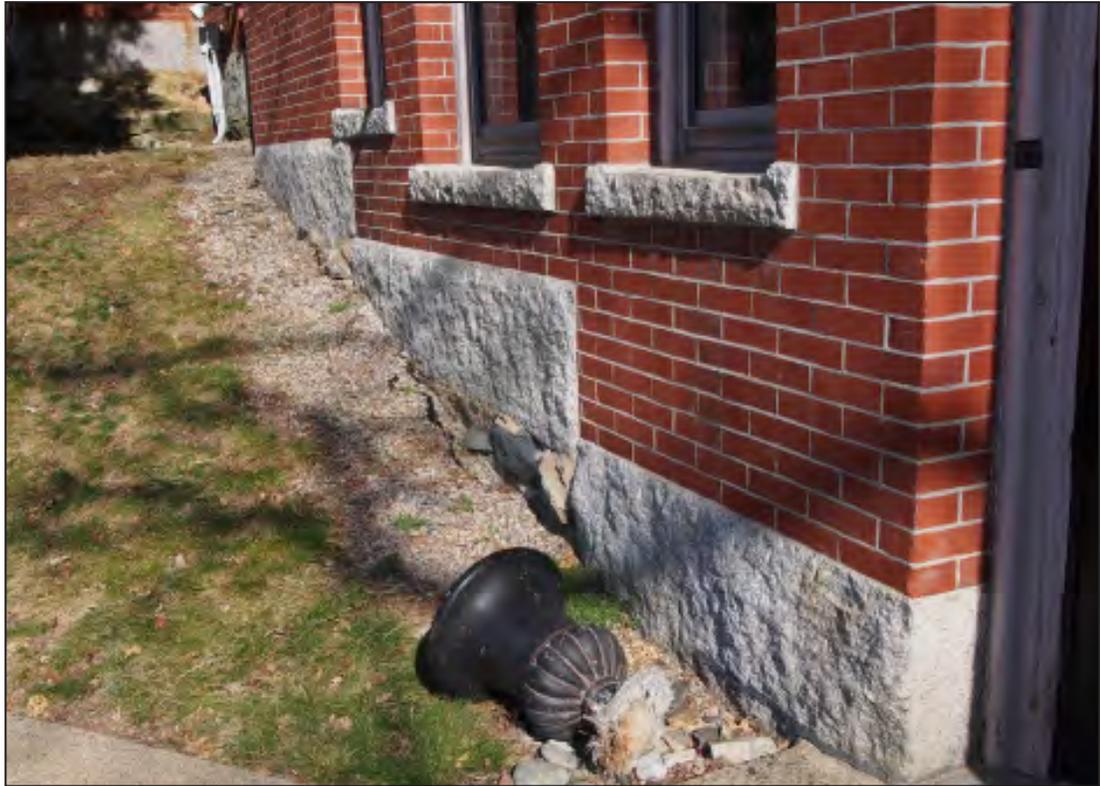
Fig. 2.25 Erosion of grade along South elevation has exposed foundations in some areas. (Scattergood Design)

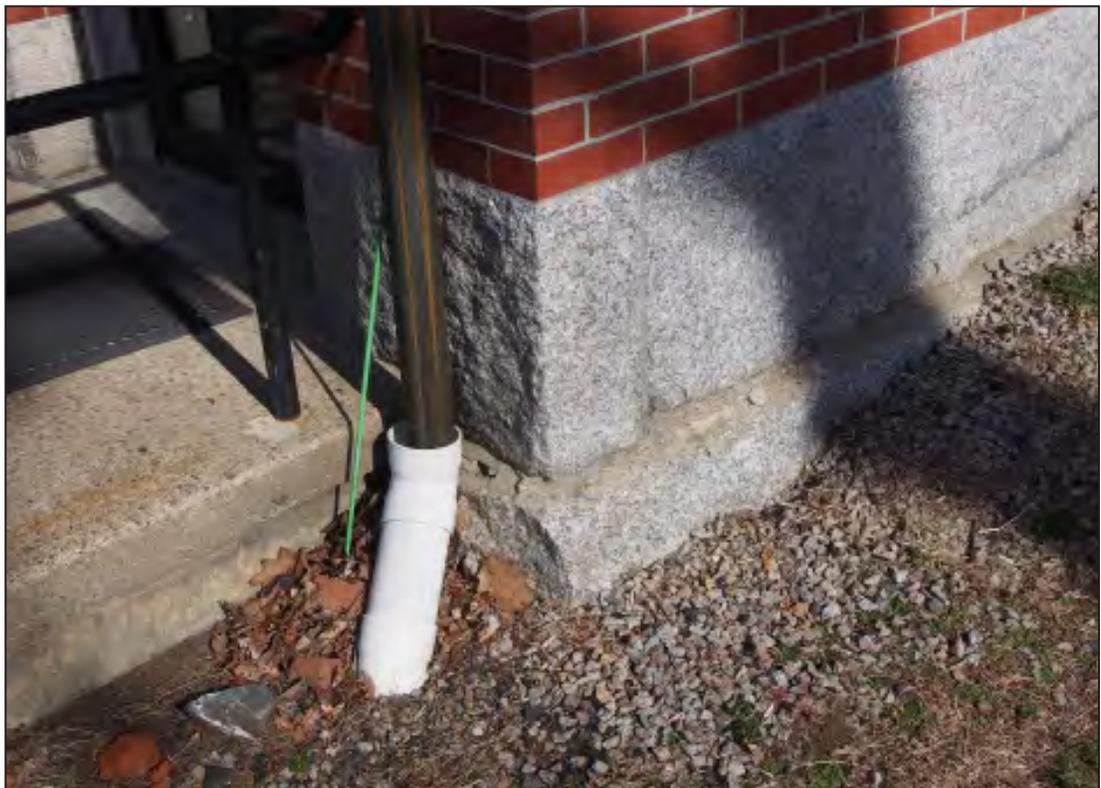
Fig. 2.26 Downspout and drain at southeast corner. Note erosion has exposed wall footings (Scattergood Design)

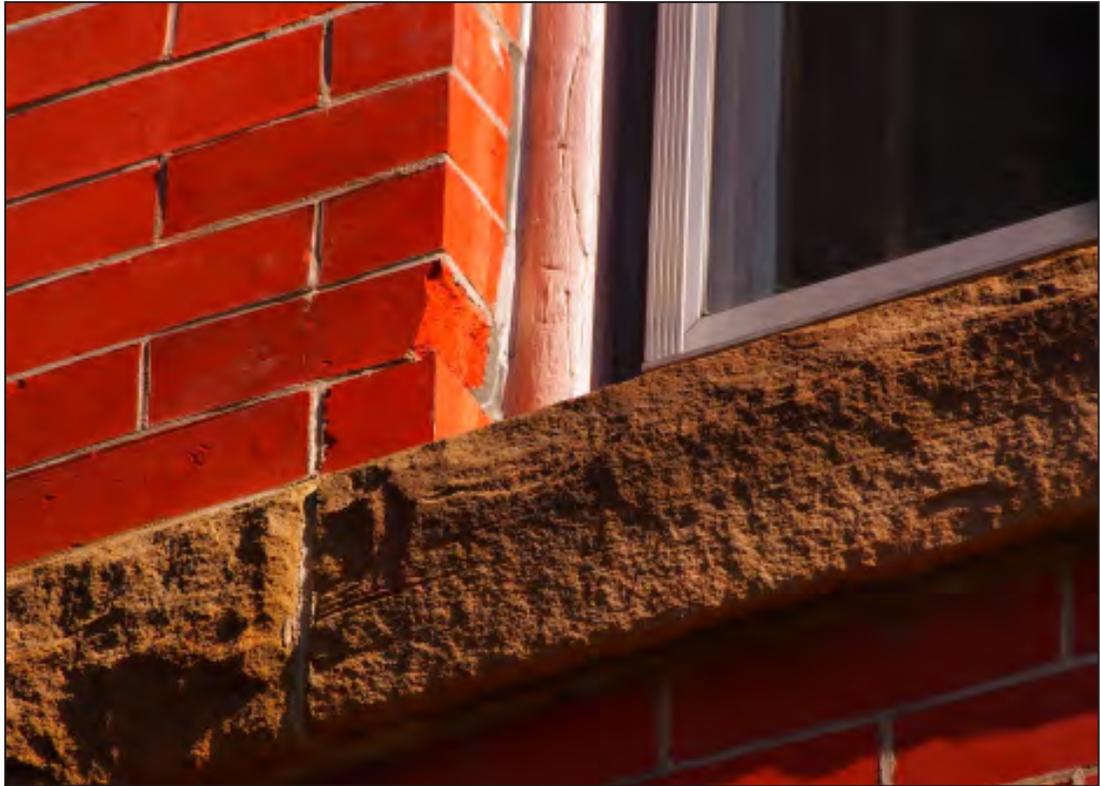
Fig. 2.27 Spalled brick at west window opening on south side of first floor of stacks. (Scattergood Design)

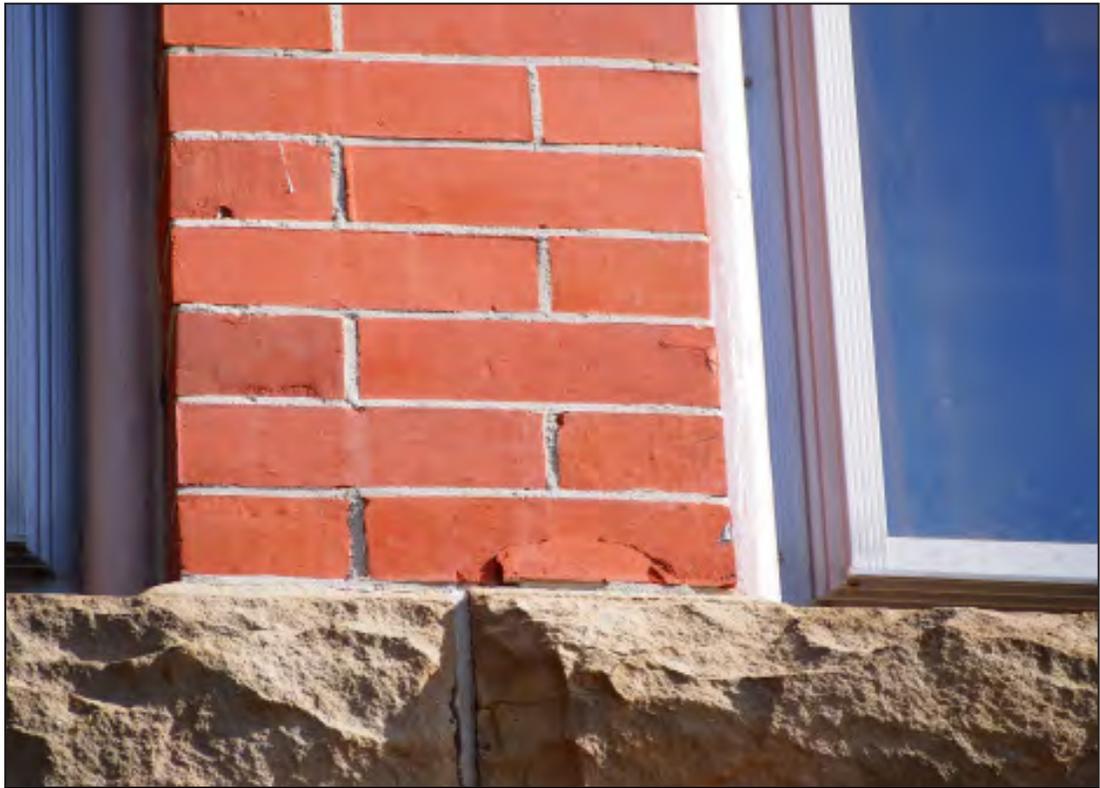
Fig. 2.28 Spalled brick above sill course at east window opening on south side of first floor of stacks. (Scattergood Design)

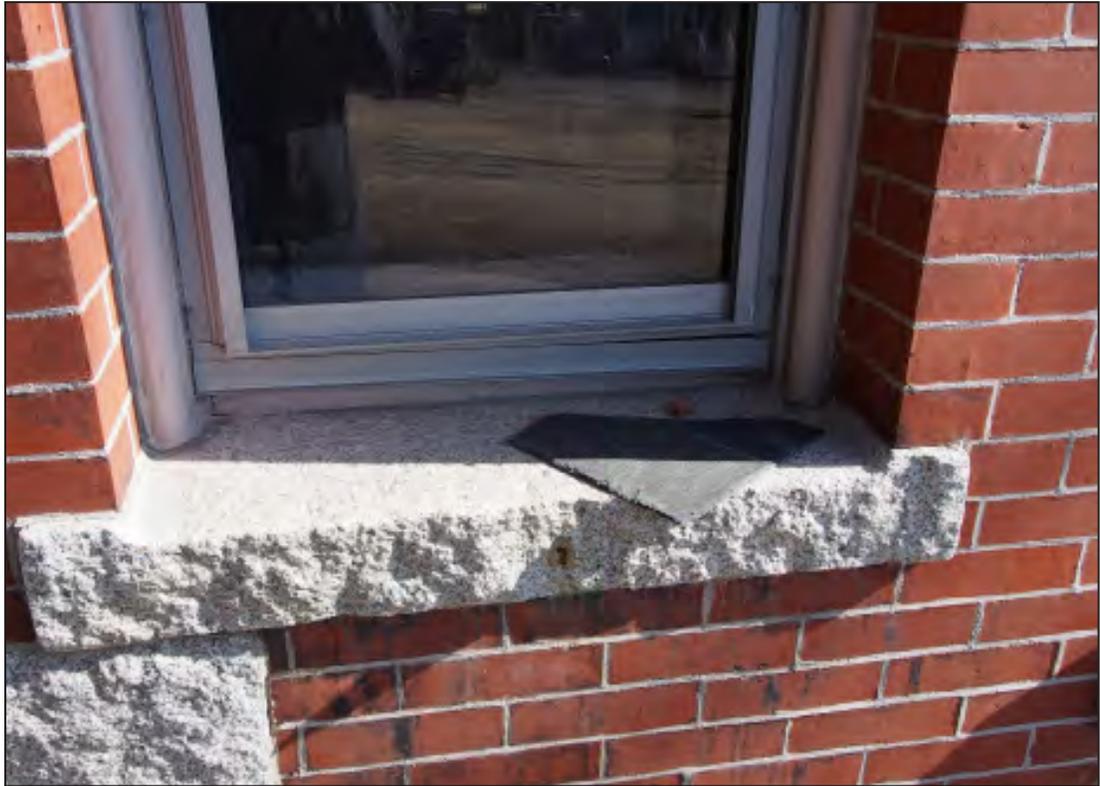
Fig. 2.29 Ground floor window, south elevation, showing typical condition of frames and sill. Note fallen roof slate. (Scattergood Design)

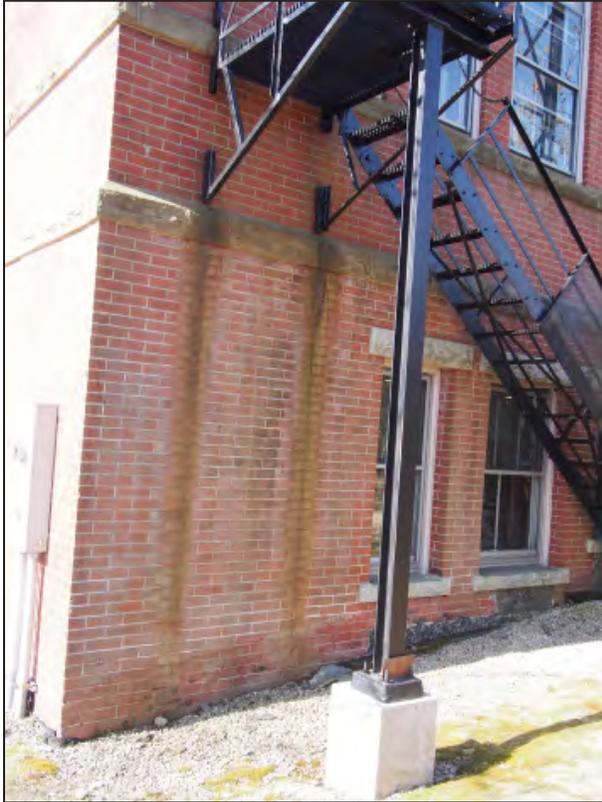
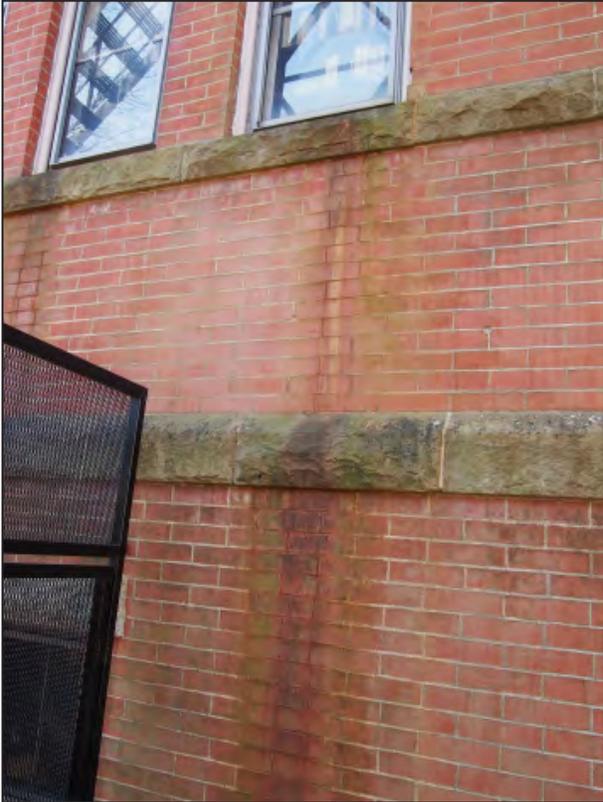
Fig. 2.38A and B Fire escape has been recently repaired and painted, but staining from corrosion remains on masonry. (Scattergood Design)

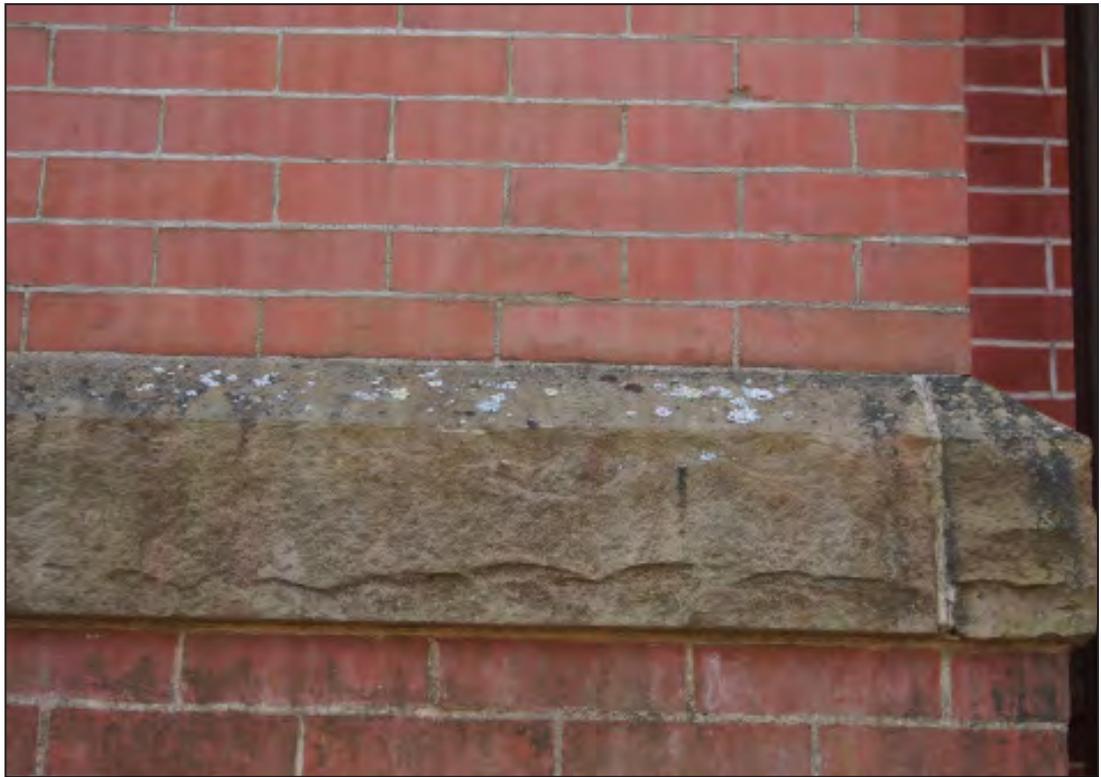
Fig. 2.39 Lichen growth on sandstone band on north elevation. (Scattergood Design)

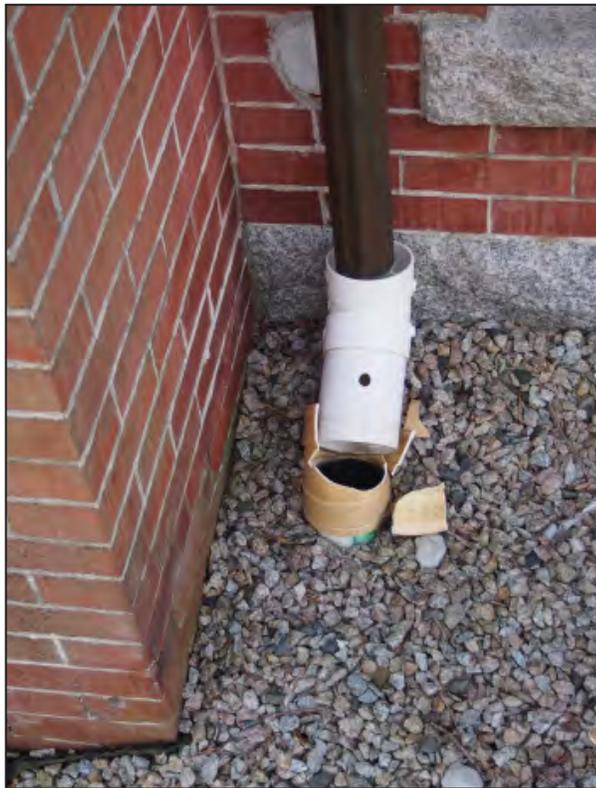
Fig. 2.40 Cracked boot at downspout on north side of entrance portico. (Scattergood Design)

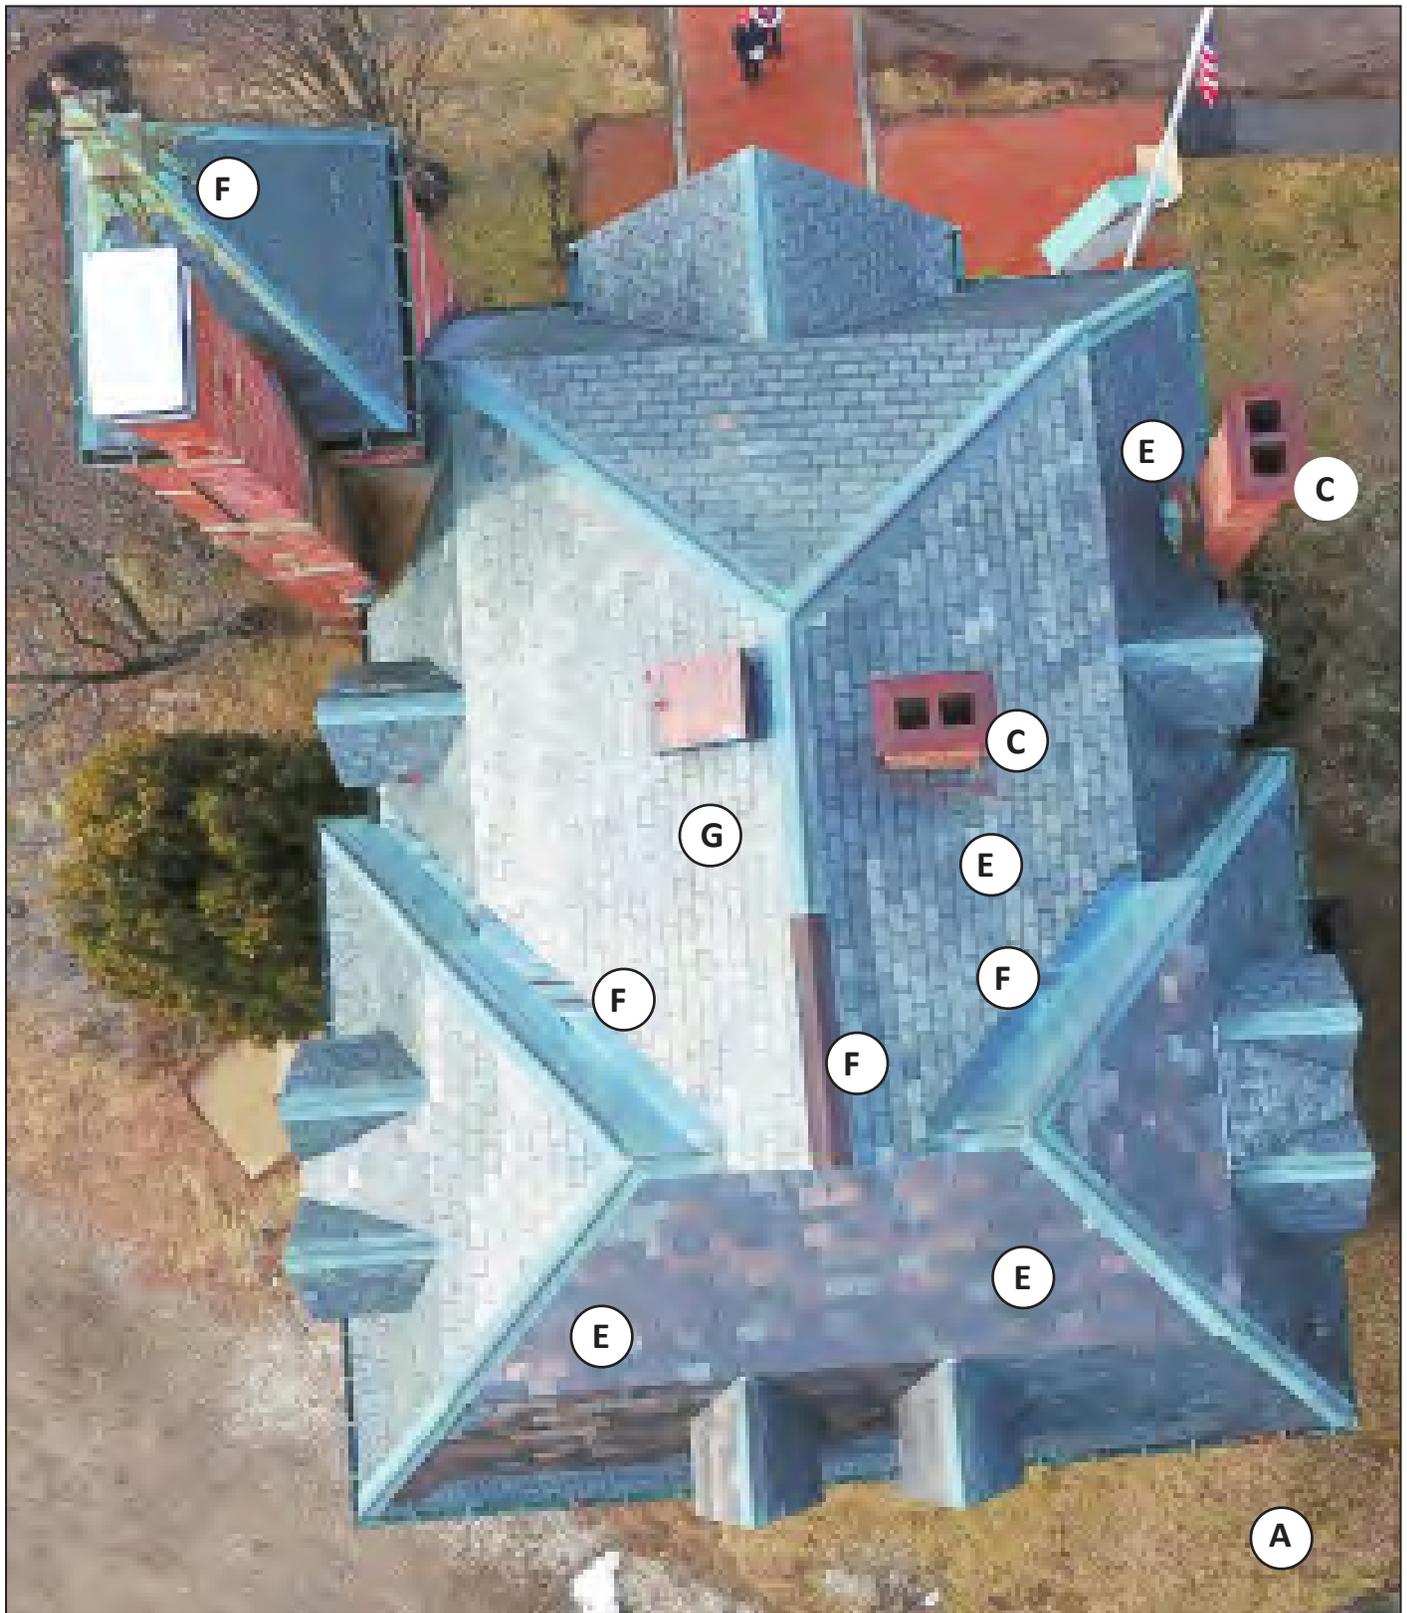
Fig. 2.41 Overall view of roof (west up). (RPL) Note:

| C No chimney cap | F Worn flashing |
| | G Worn covering on roof hatch |

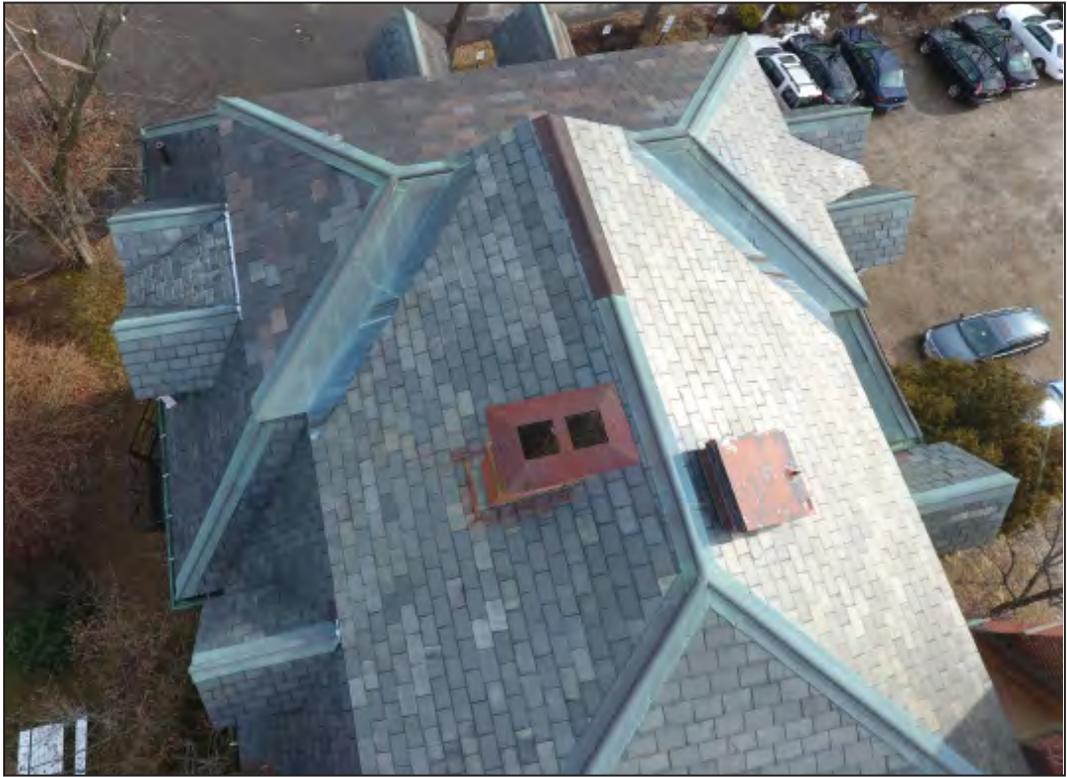
Fig. 2.42 East half of roof. Note lack of cap at chimney, worn cover for roof hatch, worn valley flashing and likely more recent ridge flashing at west end. (RPL)

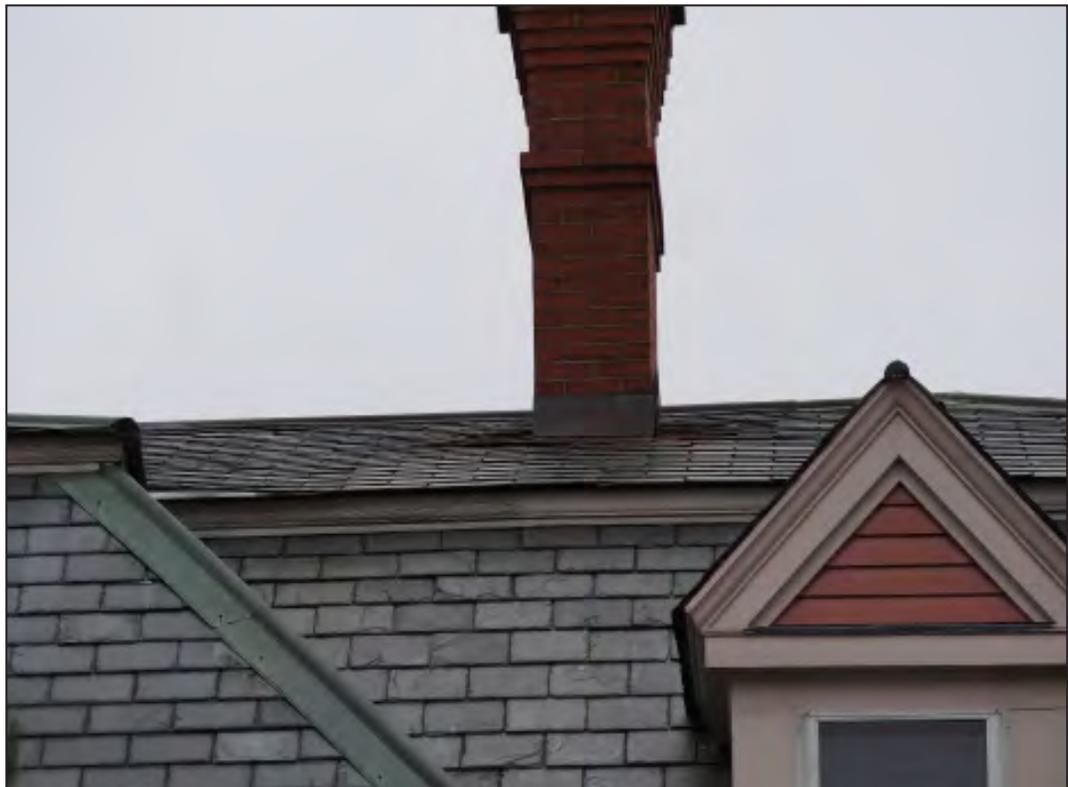
Fig. 2.43 Center of north side roof. Note missing paint and deterioration on wood trim at intersection between roof planes and apparent deformation of roof plane around chimney, which has worn flashing at cricket. (SD)

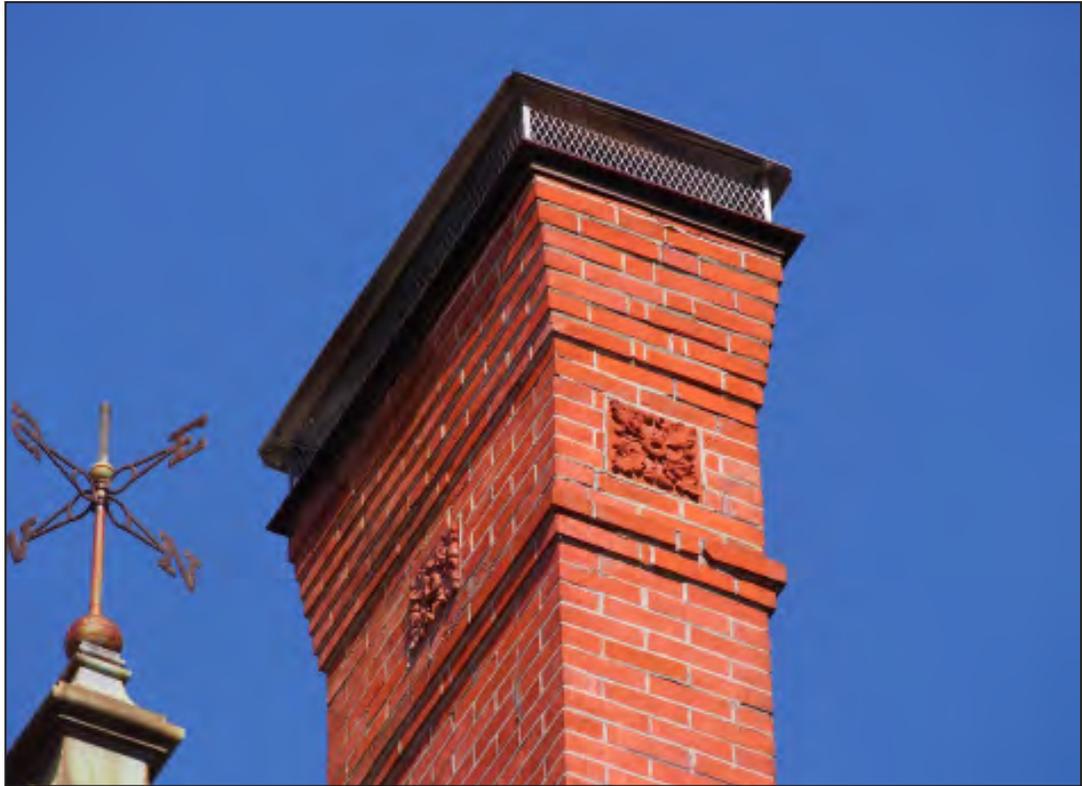
Fig. 2.44 Top of furnace flue chimney. Note open joints and decorative terra cotta panels. (Scattergood Design)

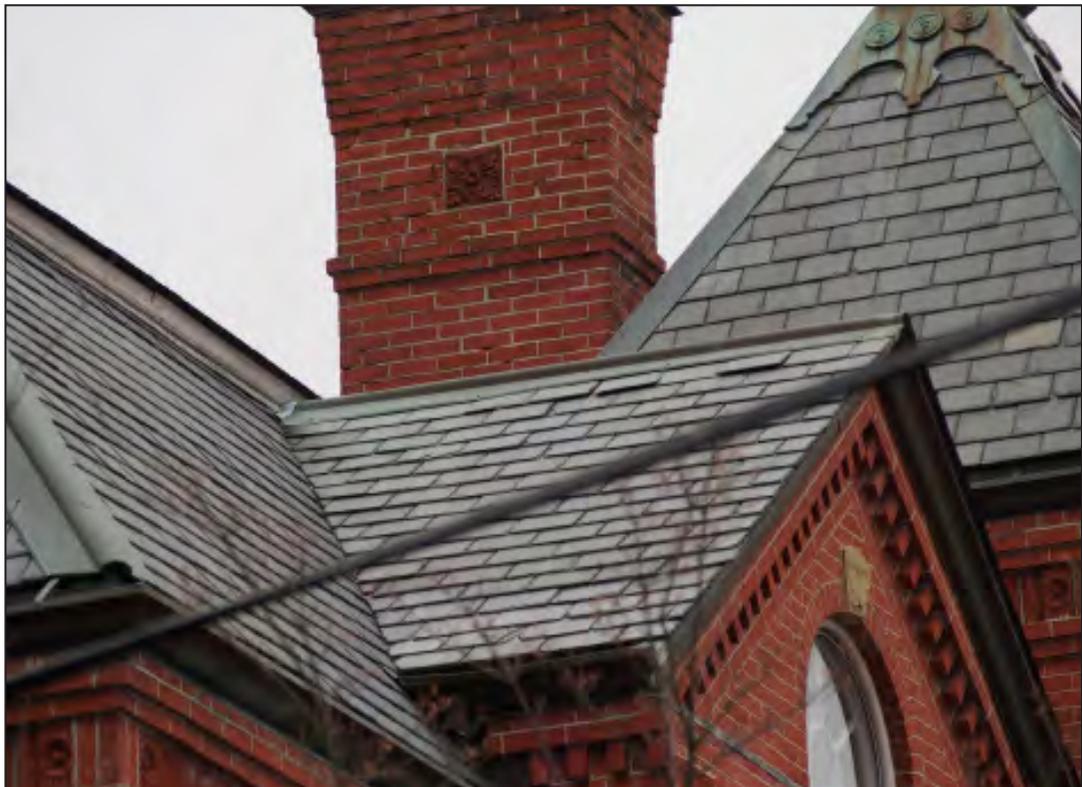
Fig. 2.45 Roof above entry portico. Note loose slates at ridge and open joints in chimney. (Scattergood Design)

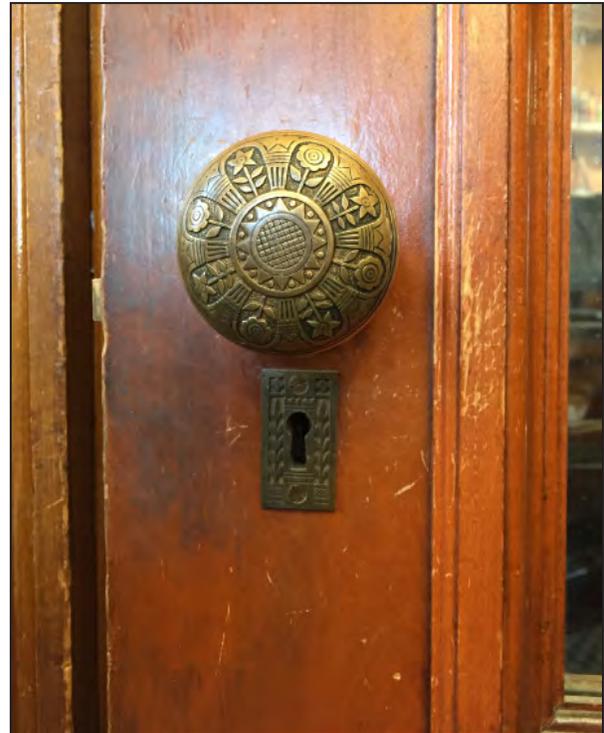
Fig. 2.66 Typical "Eastlake" style door knob and eschutcheons. Note also worn finish around knob. (Scattergood Design)

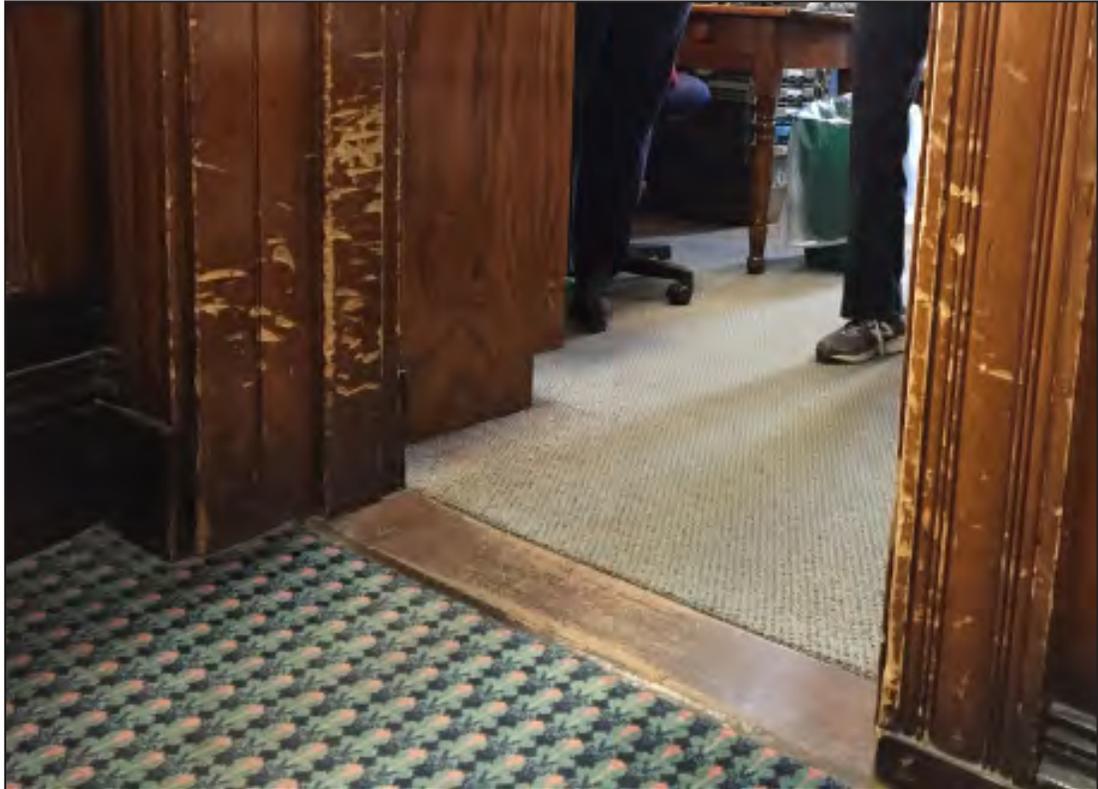
Fig. 2.68 Worn finish and damaged trim resulting from book trucks passing through doorway between . (Scattergood Design)
