Rice Public Library Renovation and Addition

Programming and Existing Conditions Report
June 28, 2019

On Thursday 21 February 2019, we visited the Rice Public Library (RPL). The intent of our visit was to review the existing conditions that are readily visible and comment on their conditions. Ms. Lee Perkins, the Library Director, showed us around and provided information on past building upgrades. The visit and review are being done in anticipation of a renovation and an addition that are currently being planned at RPL. The current library building is on the National Register of Historic Places.

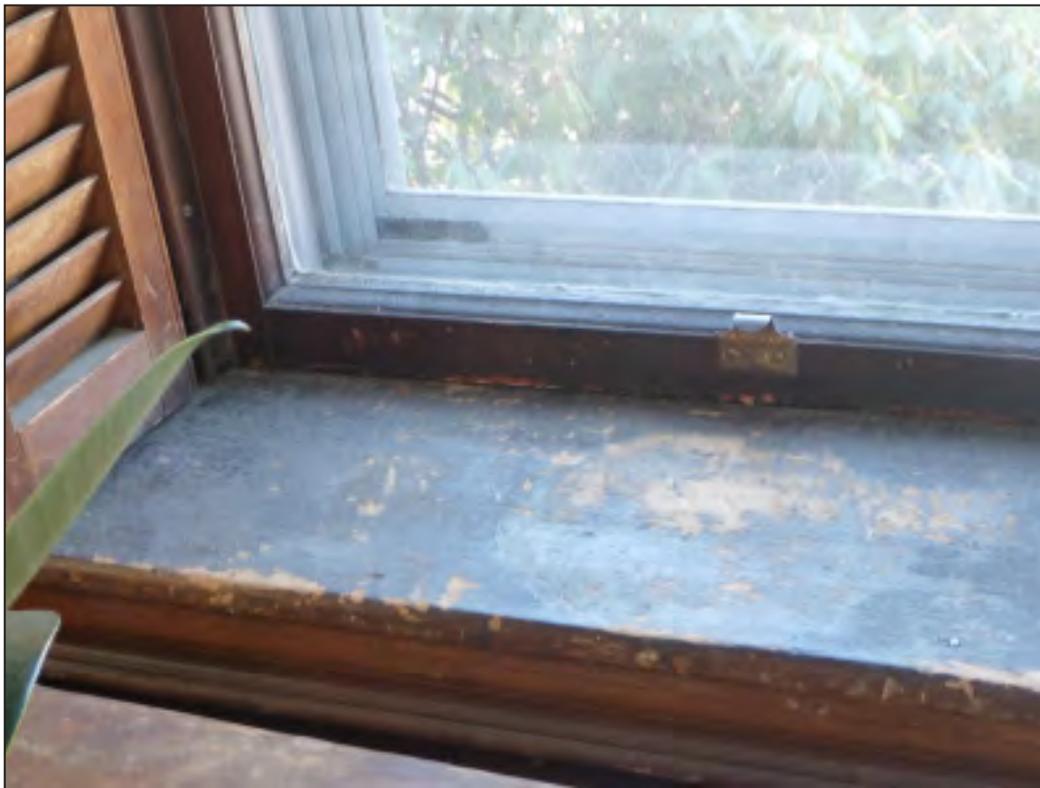
Fig. 2.70 Typical worn finish and scratched wood sill. (Scattergood Design)

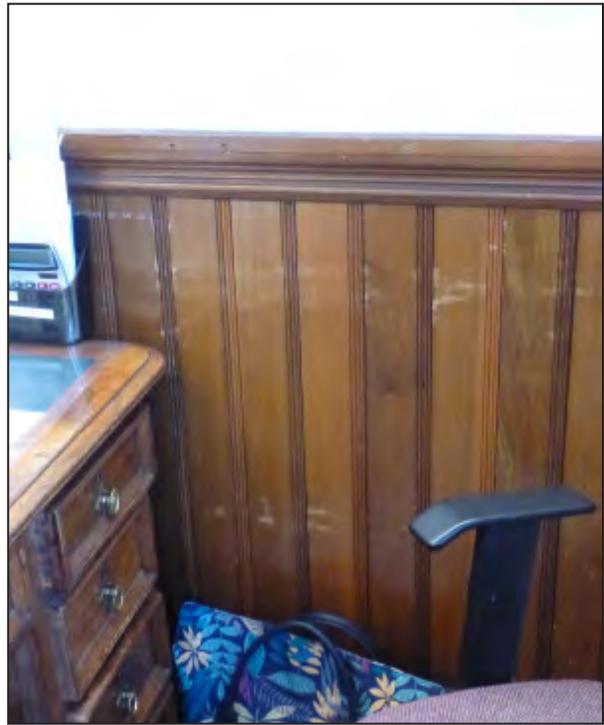
Fig. 2.66 Wood wainscot in Staff Office. Note scratches adjacent to desk chair. (SD)

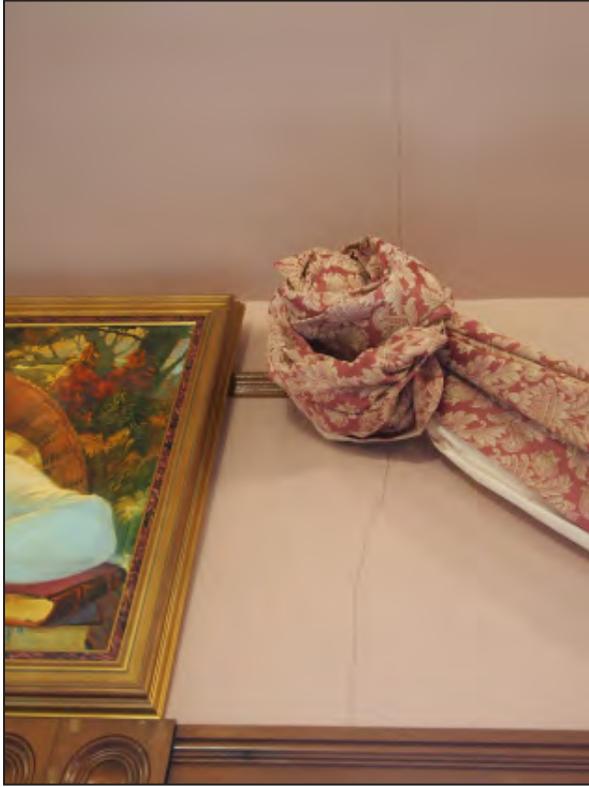
Fig. 2.83A Crack in center of east wall of Roberts Room. (Scattergood Design)

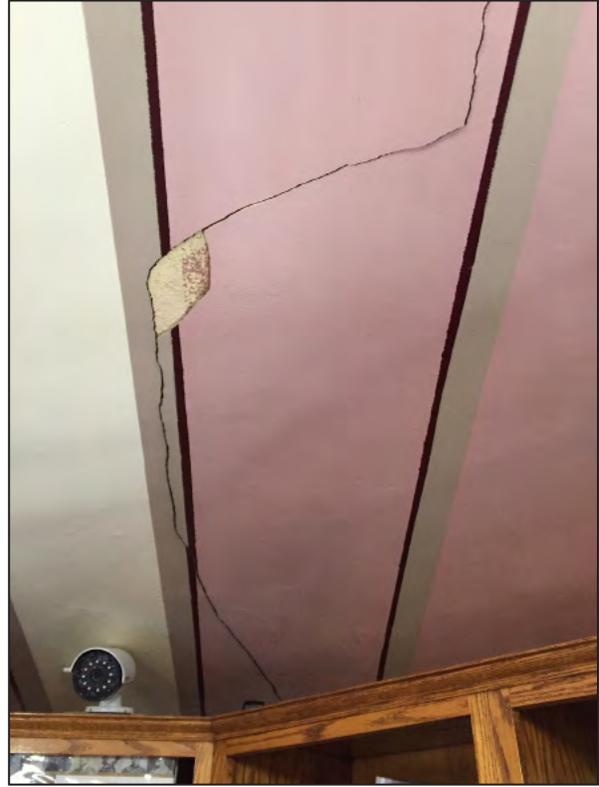
Fig. 2.83B Crack in southeast corner of Roberts Room ceiling. (Scattergood Design)

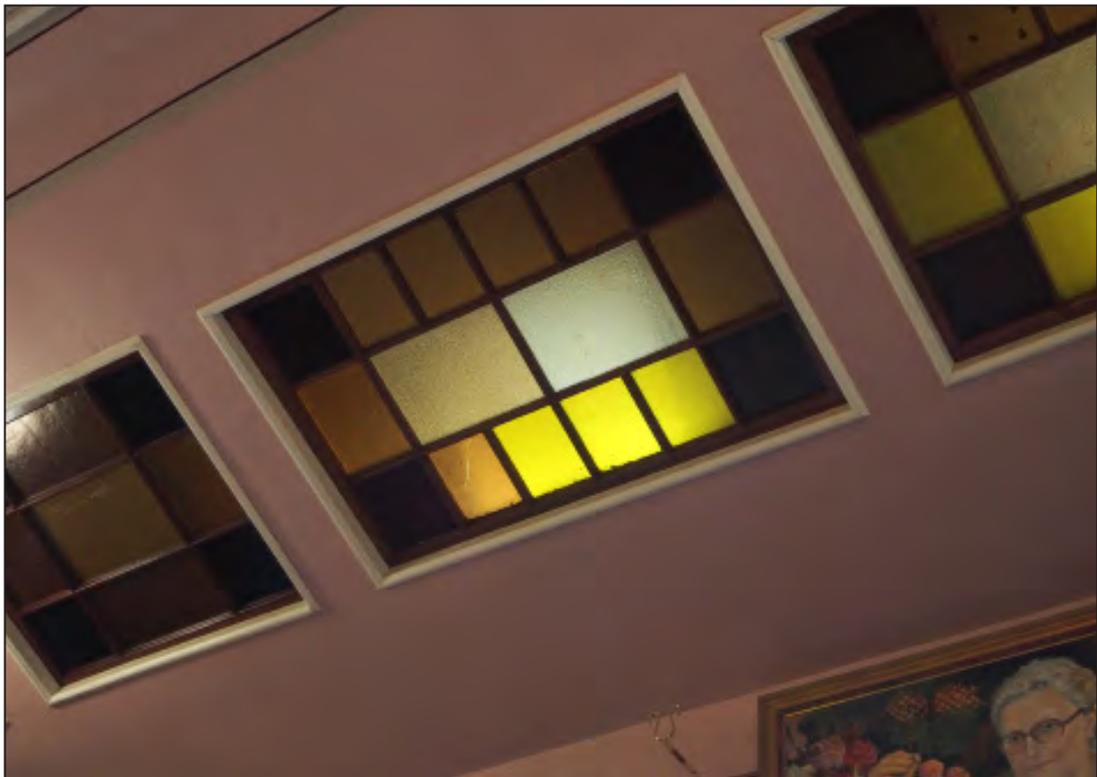
Fig. 2.84 Laylights in Roberts Room, with colored and ribbed glass that matches doors and transoms. Note cracked glass in lower left of center panel. (Scattergood Design)

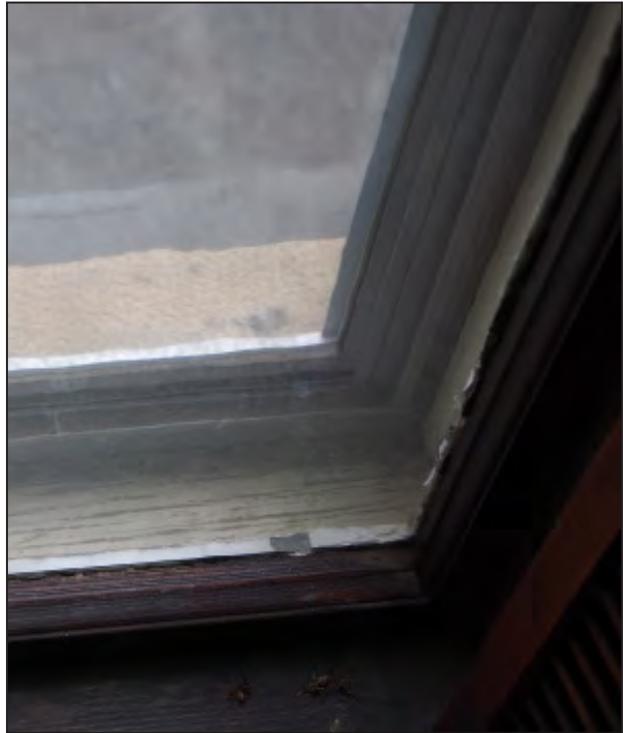
Fig. 2.90B Note split wood at window sill. (Scattergood Design)

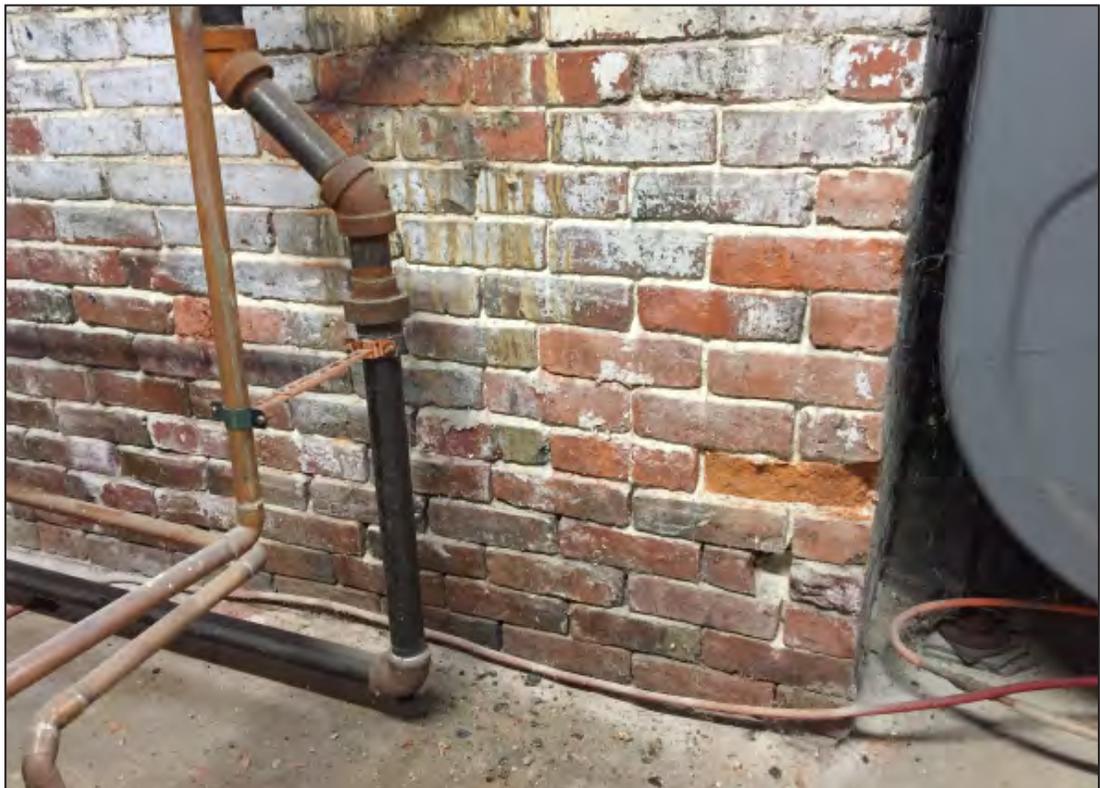
Fig. 2.111 Efflorescence, loss of mortar and spalled brick indicate rising damp and/or moisture penetration through foundation wall. (Scattergood Design)

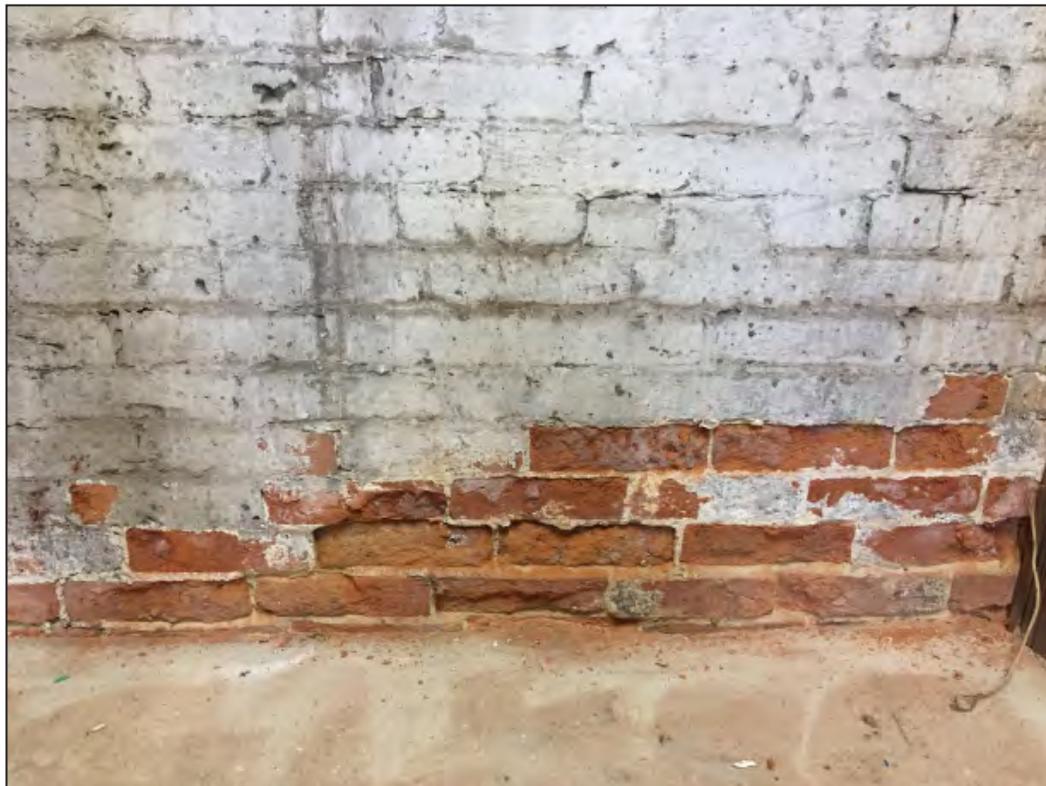
Fig. 2.113 Spalled brick adjacent to sink. (Scattergood Design)

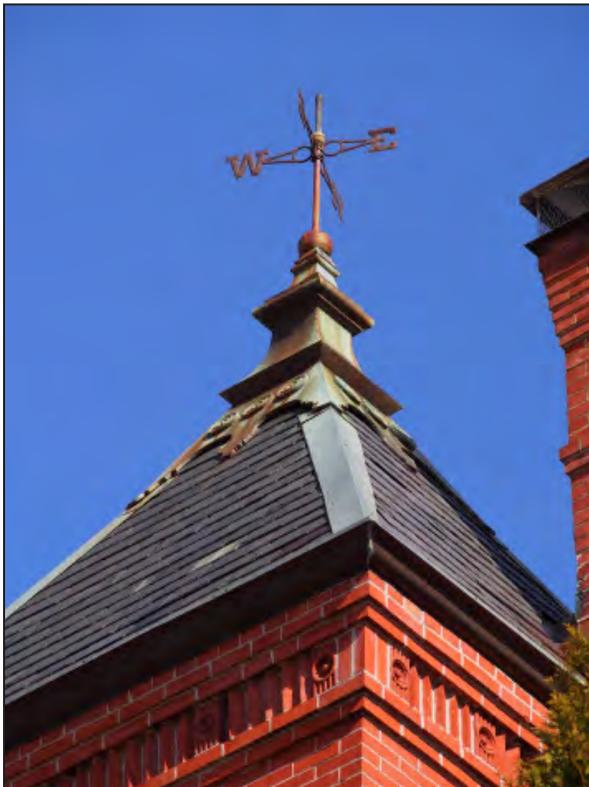
Fig. 2.47A Top of tower. Note worn decorative copper finial. (Scattergood Design)
