Rice Public Library Renovation and Addition

DRAFT Programming and Existing Conditions Report
March 20, 2019

Structural Observation Report
Rice Public Library
8 Wentworth St, Kittery, ME 03904

RICE LIBRARY (MAIN BUILDING) MECHANICAL & PLUMBING EXISTING CONDITIONS REPORT

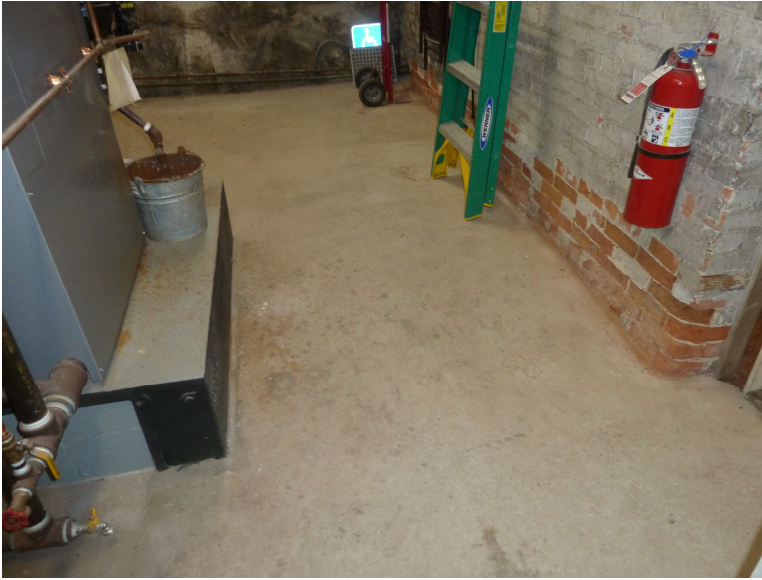
1. Bottom of the brick walls in the basement: We noted damage at the bottom of the brick walls at the basement interior and exterior walls. At the interior walls, the bottom 2ft of the walls appear damaged. In the back of the house areas (boiler, server) the paint is gone, the brick faces are damaged, and some brick appears to be soft (photos 1 and 2). In the more public area (kitchen) the walls have been re-painted, but damage is still visible (photo 3). Similarly, the exterior perimeter walls have damage. Those walls are painted, and the damage appears more sporadic with the paint creating bubbles that eventually burst, exposing damaged brick (photo 4). We note that the bottom of most of the exterior walls are covered with large wood baseboards which hide the brick condition.

The damage is typical of moisture infiltration. At the perimeter walls, it is assumed that moisture travels from the outside through the brick but when it reaches the interior paint, it is trapped and unable to dry. As moisture accumulates between the paint and the brick, it damages the brick. The damage is not exposed until the paint bubble, pops, exposing the damage. The interior walls are also susceptible to moisture most likely wicking up from the foundations. These walls appear built from a mix of fired and unfired bricks which was a common practice for interior walls at the time of construction. The unfired bricks are more susceptible to moisture and deteriorates.

Photo 1: Basement boiler room.

The damage to the brick though not a global stability/structural concern at this time, should be stopped before causing more damage. A plan to mitigate the moisture should be included in the renovation design. Such plan could include coating the exterior brick below grade with a waterproofing and installing a perimeter drain, and/or removing the interior paint and leaving the interior brick exposed or painting it with a breathable silica

based paint or a combination there of. Minor repair (brick replacement and re-pointing) should also be assumed in the renovation budget.

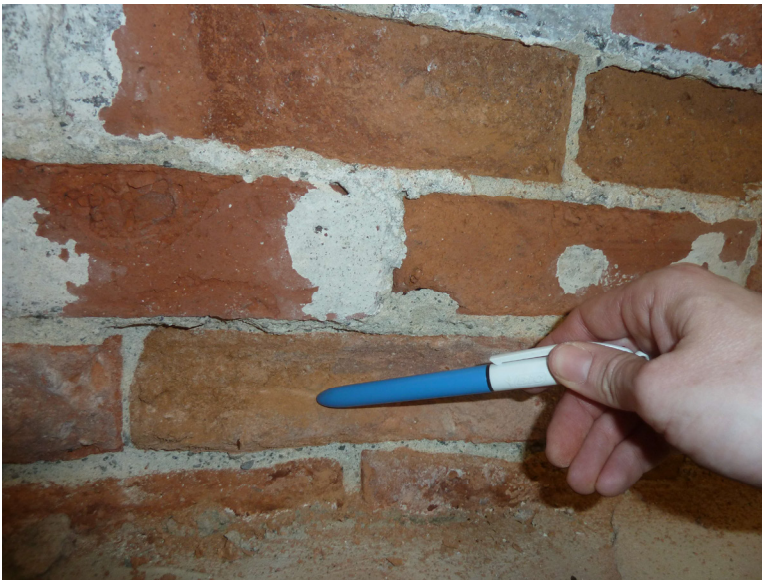
Photo 2: Basement boiler room. Close up of soft brick.

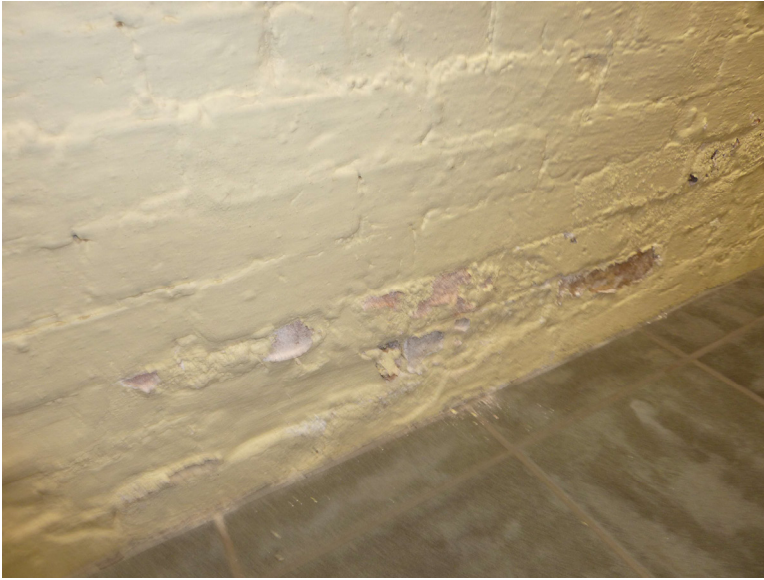
Photo 3: Kitchen area. Close up of interior wall showing paint and brick damage.

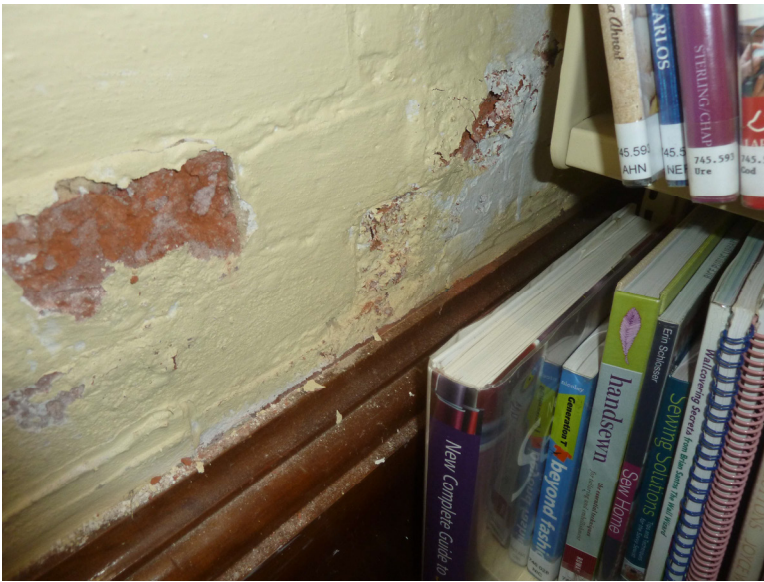
Photo 4: Basement reading room. Close up of exterior wall showing paint and brick damage.

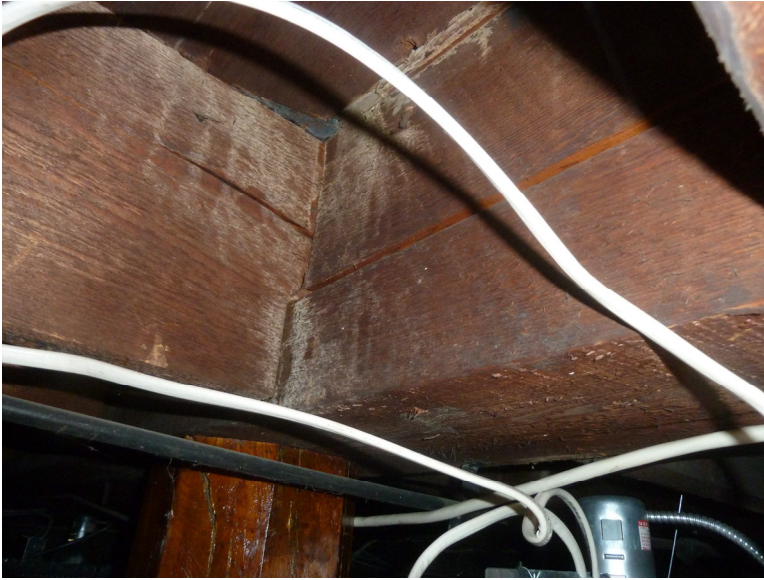
2. First floor wood girders (as observed from basement): the two wood girders supporting the floor in the rear space have some splitting. The splits are horizontal and in line with the bottom of the notches where the joists bear in. The splits do not appear to be through the whole thickness of the girders but were noted on both sides. See photo 5.

Photo 5: first-floor framing showing wood column, girder and wood joist. Note the horizontal split in the wood girder.

Splits are not uncommon and are typically due to wood drying and shrinking. However due to the location of the splits at the support of the joists, they may reduce the girders' capacity. We recommend that the splits be further investigated during the design phase. Additional measurements should be taken to understand the extent and depth of the split so they can be analyzed. If they are found to need repair, epoxy, fasteners, or steel side plates can be added to the beam.

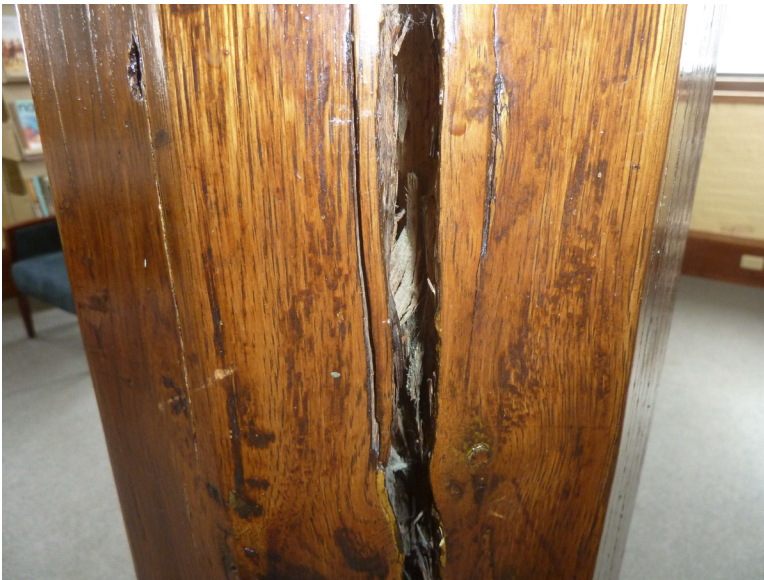
3. Wood octagonal columns at basement: the two octagonal columns in the basement have long checks which open up as wide as $\frac{1}{2}$ " (Photo 6). Checks in compression member are usually not a concern as these do not reduce the capacity or extend to the connections. Ms. Perkins however mentioned that these may be getting larger. As such, we recommend monitoring the checks. If these are in fact getting larger, steel collars should be added intermittently through the height of the columns.

Photo 6: octagon wood column in basement. Note the large checks.

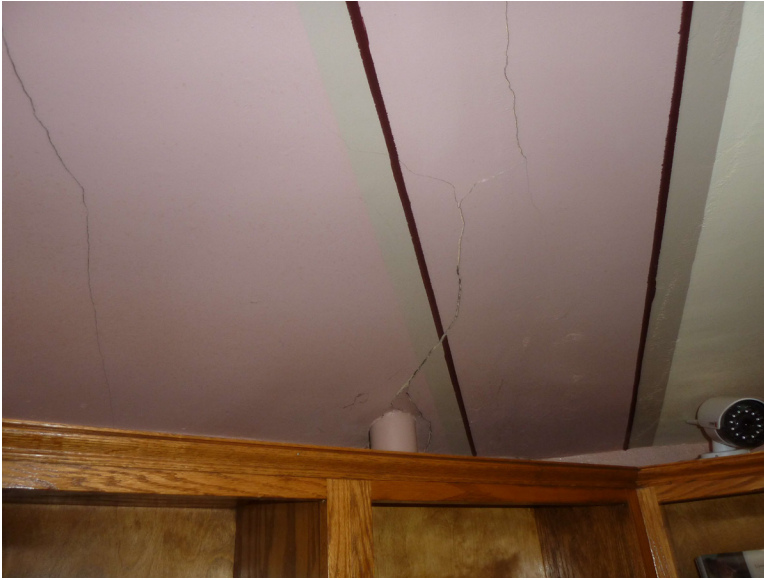
4. Cracks were noted in the corners of the plaster ceiling above the second-floor large reading room (Photo 7). In this area, the ceiling is directly supported from the roof structure. As the roof was recently insulated, it is possible that more snow is accumulating on the roof and increasing deflections. The cracks should be monitor and if found to becoming worse, additional roof investigation/analysis should be performed.

Photo 7: Second floor plaster ceiling. Note the cracks in the plaster.

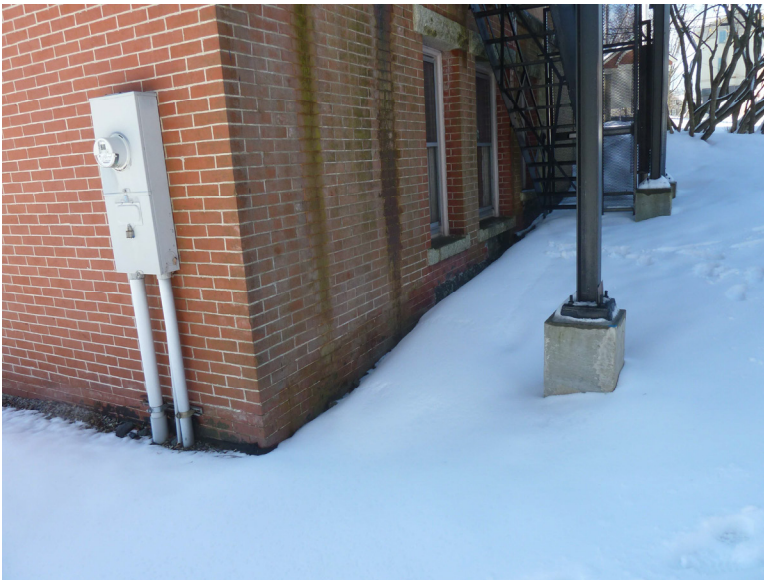
5. Exterior: the exterior walls are in good condition. Very few areas were noted having issues. Some dirt is visible at the north elevation, below the fire staircase. The base of the brick wall at the north-east corner appear to have some efflorescence (Photo 8). The brick in those areas should be cleaned and repointed.

Photo 8: North east corner of building. Note the dirt below the fire escape and some minor effervescence at the base of the wall.

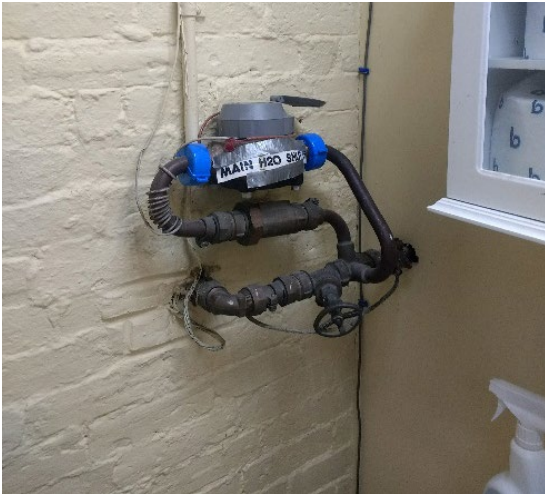
Figure 1 - Water Entry

The water entry was in the Staff Bathroom on the Basement Level. Service size was $\frac{3}{4}$ ". The meter was inside the building. The piping was exposed and not insulated. There was a Flood Master FM-080-1 Water Main Shut-off System installed in the Staff Bathroom on the Basement Level, designed to shut-off the water service upon detection of a leak.

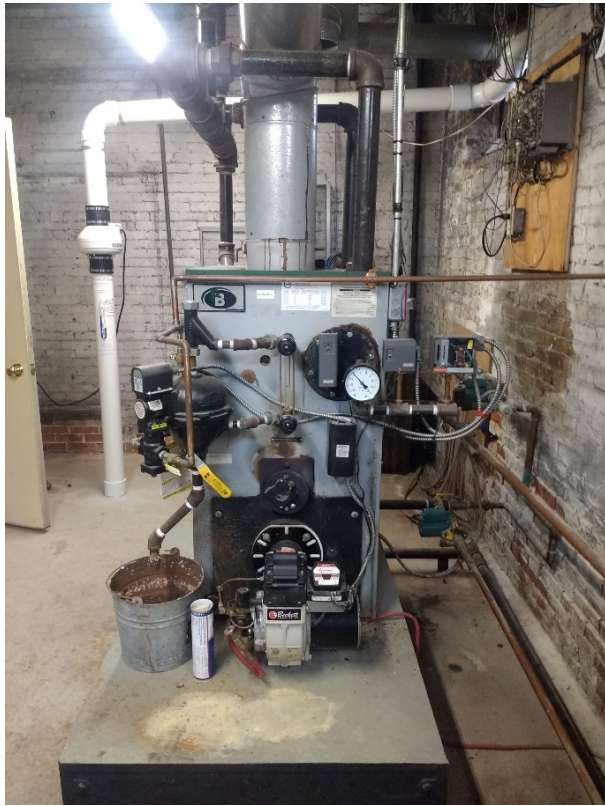
Figure 5 – Oil Fired Boiler

The only source of heat in the building was a Peerless Boiler SCT-o6-W/S 6-section oil-fired cast-iron forced-draft steam boiler with a Beckett oil burner in the Mechanical Room. The steam boiler served steam radiators on the First and Second floors; hydronic fin tube radiators and hydronic radiant floor on the Basement Level. The boiler was in good condition and had been replaced in 2011. The rated DOE Gross Output of the boiler was 405 MBH (Steam/Water); the Net I=B=R rating output of the boiler was 304 MBH (Steam) and 352 MBH (Water).

The steam heating system was clean, well maintained and in good condition with a steam boiler that was less than 10 years old. The steam radiators were all functioning with no noise or control complaints. The Library Director noted anecdotally that during very cold weather, sometimes the system had trouble maintaining setpoint at night.

Based on the good condition and historic nature of the existing heating system RIPCORDER recommends keeping it in place if possible unless new design requirements dictate otherwise.
