#### HAZARDOUS MATERIALS INVENTORY FORMER UNITED STATES LIFE SAVING STATION WOOD ISLAND; KITTERY, MAINE

> Project R081.06097.017 September 8, 2010

Hazardous Materials Inventory Former United States Life Saving Station Wood Island Kittery, Maine

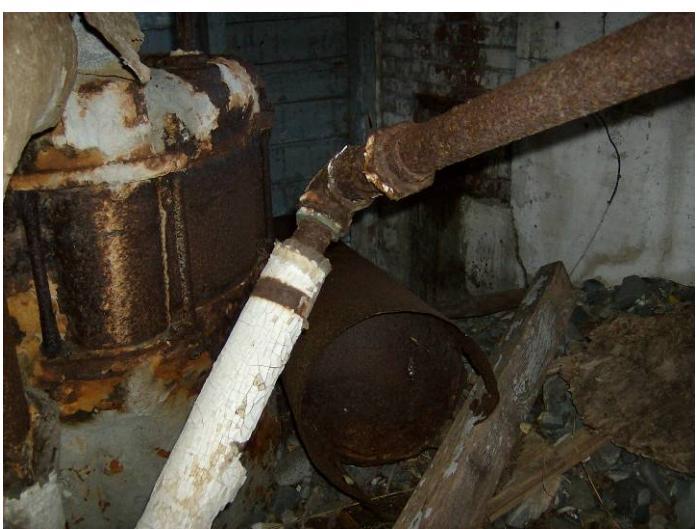
Asbestos-Containing Pipe Insulation (Sample ASB-01A)

ACM abatement should be performed using approved methods in accordance with applicable regulations established by the U.S EPA, OSHA, and the State of Maine. ACM must be removed by a licensed asbestos abatement contractor and in accordance with a project design prepared by a certified Abatement Project Designer.

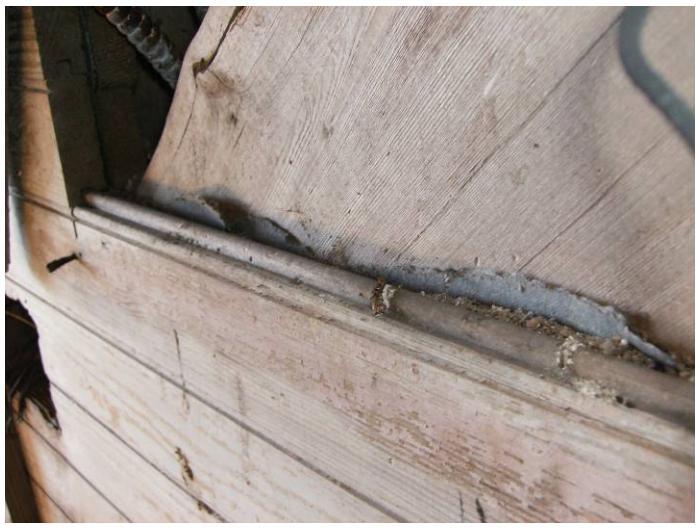
Asbestos-Containing Interior Siding Paper (ASB-04A)

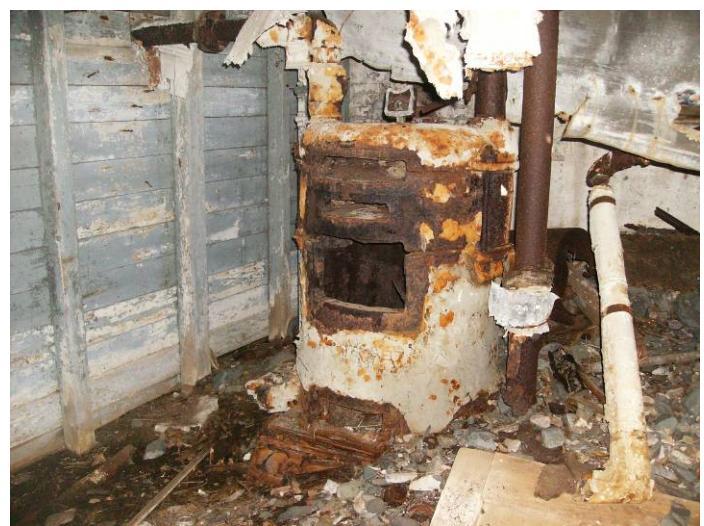
Asbestos-Containing Boiler Insulation (Sample ASB-11A)

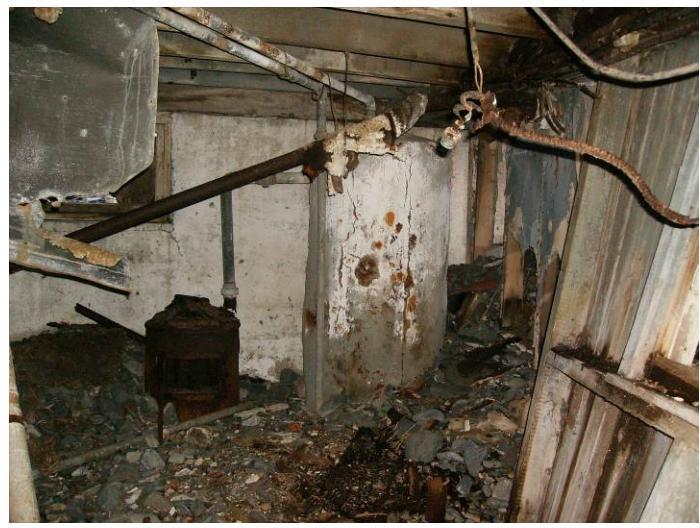
Asbestos-Containing Tank Insulation (Sample 12A)

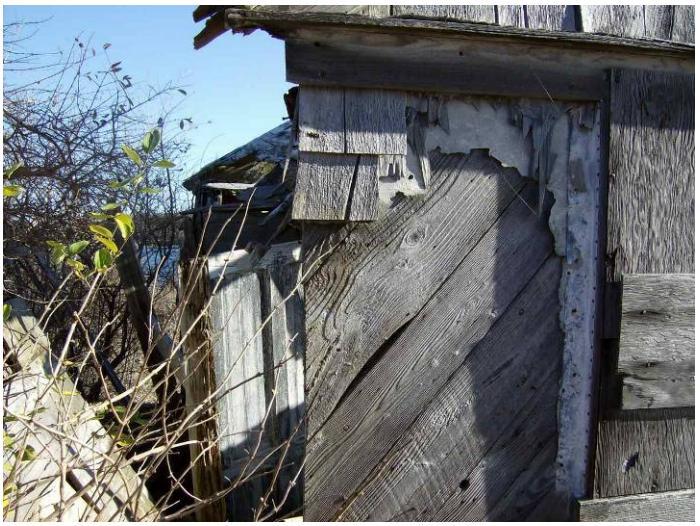
Asbestos-Containing Exterior Siding Paper on Main Building (Sample ASB-14A)

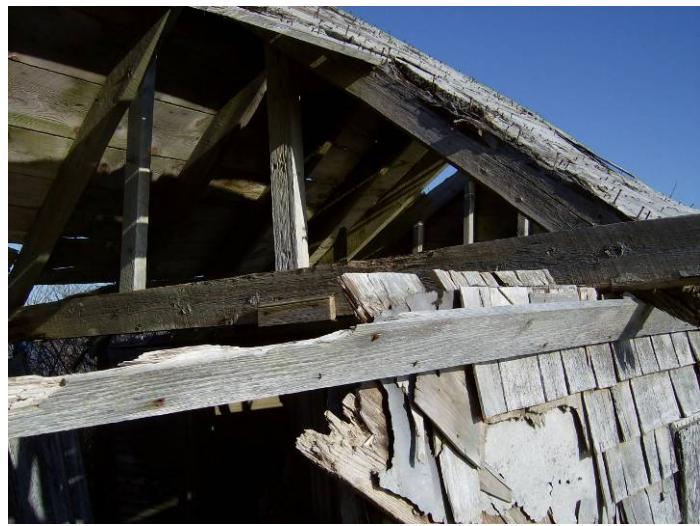
Asbestos-Containing Exterior Siding Paper on Tool Shed (ASB-15A)

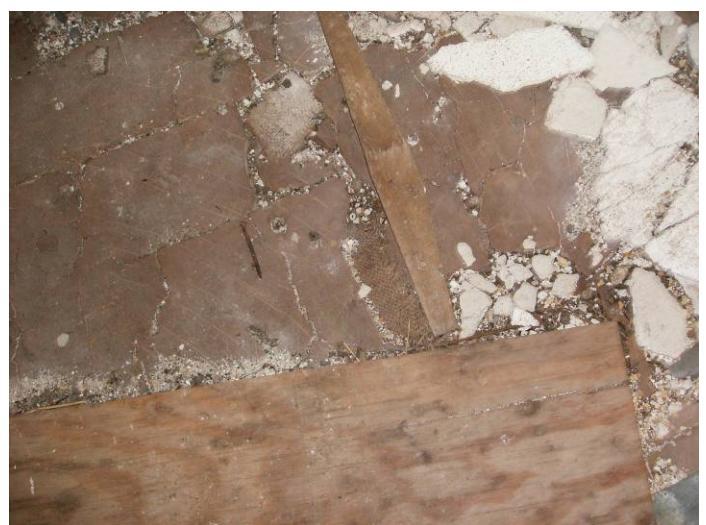
Asbestos-Containing Flooring Paper in Main Building (ASB-16A and ASB-17A)

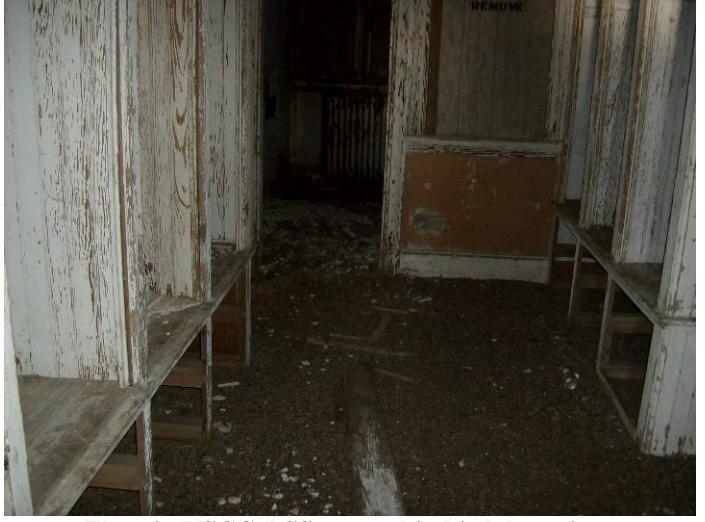
Ransom observed bird droppings throughout the USCG LSS building. Accumulations of bird droppings create a nitrogen rich environment favorable to the growth of the fungus *H. capsulatum*. Spores from *H. capsulatum* can lead to histoplasmosis a respiratory disease. The National Institute for Occupational Safety and Health (NIOSH) recommends that individuals avoid creating dust in areas where there is accumulated bird droppings. Dust control practices include use of high efficiency particulate air (HEPA) filtered vacuums, misting material prior to shoveling, and avoid dry sweeping or use of compressed air. The NIOSH also recommends that at a minimum, workers wear respirators and protective clothing when removing material that may contain *H. capsulatum*. Workers should be informed of the potential of encountering bird droppings and to avoid creating dust. Bird droppings are not a regulated waste.

Floor in USCG-LSS covered in bird droppings

Ransom recommends that the bird droppings be removed in conjunction with the removal of asbestos-containing pipe insulation. Since the removal of ACM requires a regulated area and workers with respiratory protection. The cost for removal of the observed bird droppings can range from \$5,000 to \$7,500.

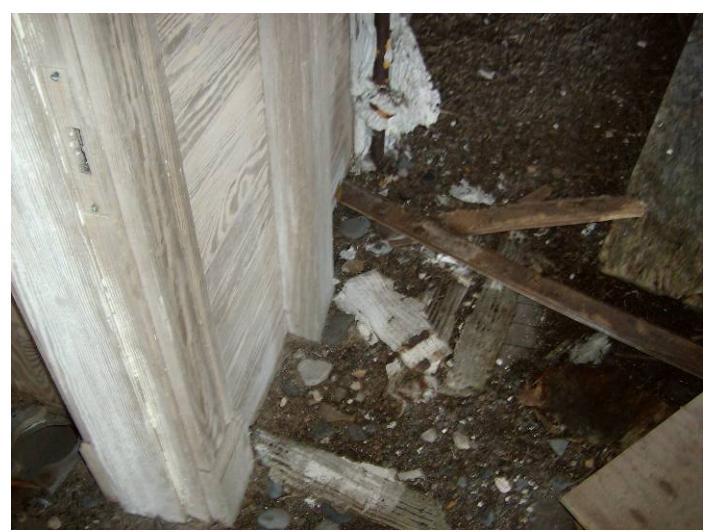
Bird droppings and asbestos debris on floor in USCG-LSS

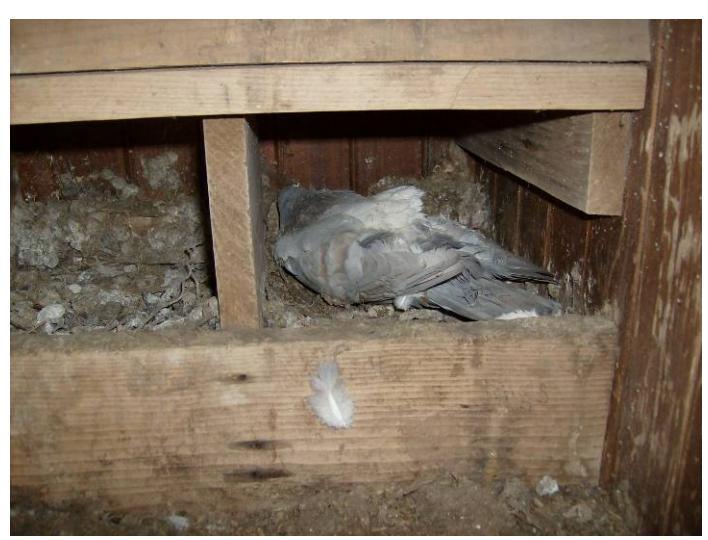
Dead bird in roost
