# BACTERIA SOURCE TRACKING IN KITTERY, MAINE

## FINAL REPORT

DECEMBER 2012

Prepared by:  
**FB Environmental Associates**  
1950 Lafayette Road, Suite 102  
Portsmouth, NH 03801

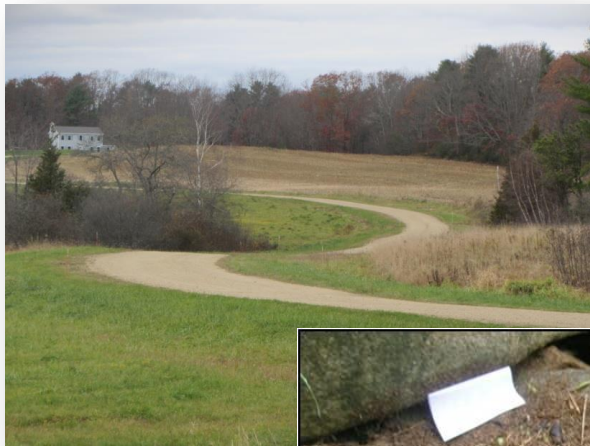
*Picott Farm*

- Picott Farm: This site is located at the culvert on Seward Farm Lane. A large agricultural field is located directly adjacent to the sampling location.

- Runoff from the agricultural field at the farm on Seward Farm Road. The field was treated with manure in preparation for the season's crop.
- Stormwater runoff from Picott Road.
- Runoff from the small animal farm near the outlet of the stream.
- Malfunctioning septic systems near the downstream sampling location.

1. Determine the actual source of bacteria using microbial source tracking. This type of test would allow for more targeted remediation efforts.
2. Work with the owners of Picott Farm to install agricultural BMPs including increasing the width of vegetative stream buffer and minimizing use of manure.

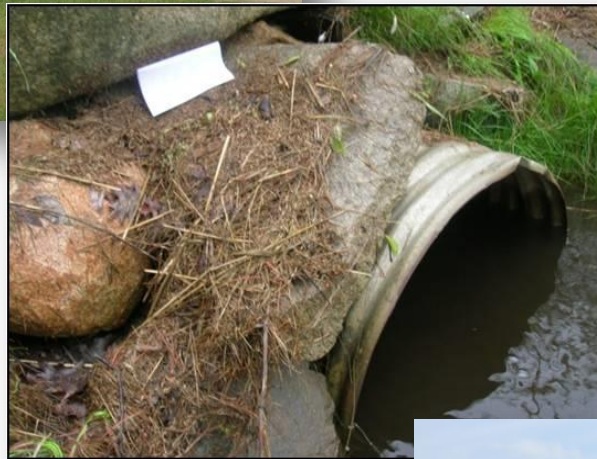
*Picott Culvert*

- Picott Culvert: This site is located at the culvert on Picott Road.

3. Investigate locations along Picott Road near the Picott Culvert to install stormwater BMPs to treat road runoff.
4. Work with the owners of the small animal farm adjacent to the Picott Downstream location to install agricultural BMPs including a vegetative stream buffer.

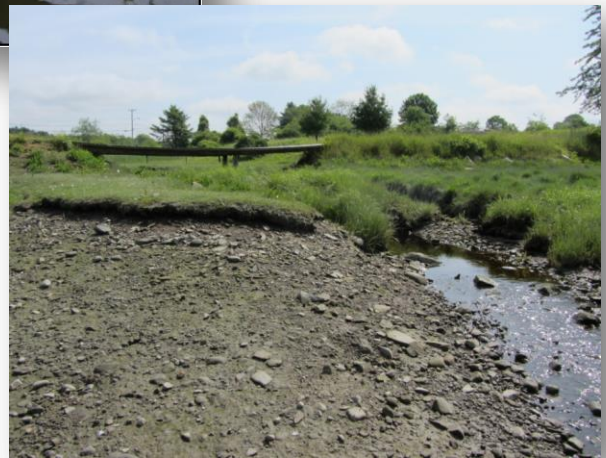
*Picott Downstream*

- Picott Downstream: This site is located at the outlet of the stream to Spruce Creek. A small animal farm including goats, geese, and chickens is located directly adjacent to this sampling location.

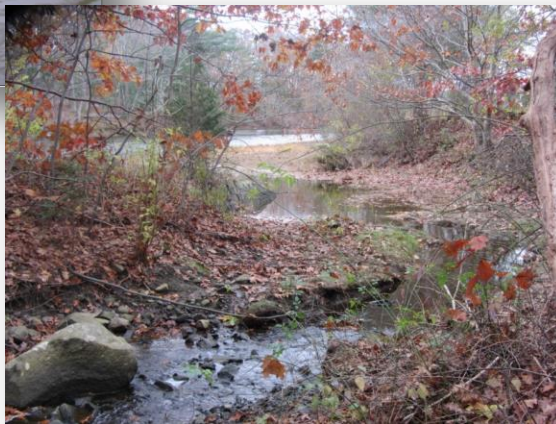
*Trafton Downstream*

- Trafton Downstream: This site is located at the outlet to Spruce Creek. The yard for the house at 11 Trafton Lane is located adjacent to this site.
