## 2013 SPRUCE CREEK TRIBUTARY SAMPLING AND CANINE DETECTION

*FORT FOSTER BEACH &  
THE SPRUCE CREEK WATERSHED*

**KITTERY, MAINE**

**JANUARY 2014**

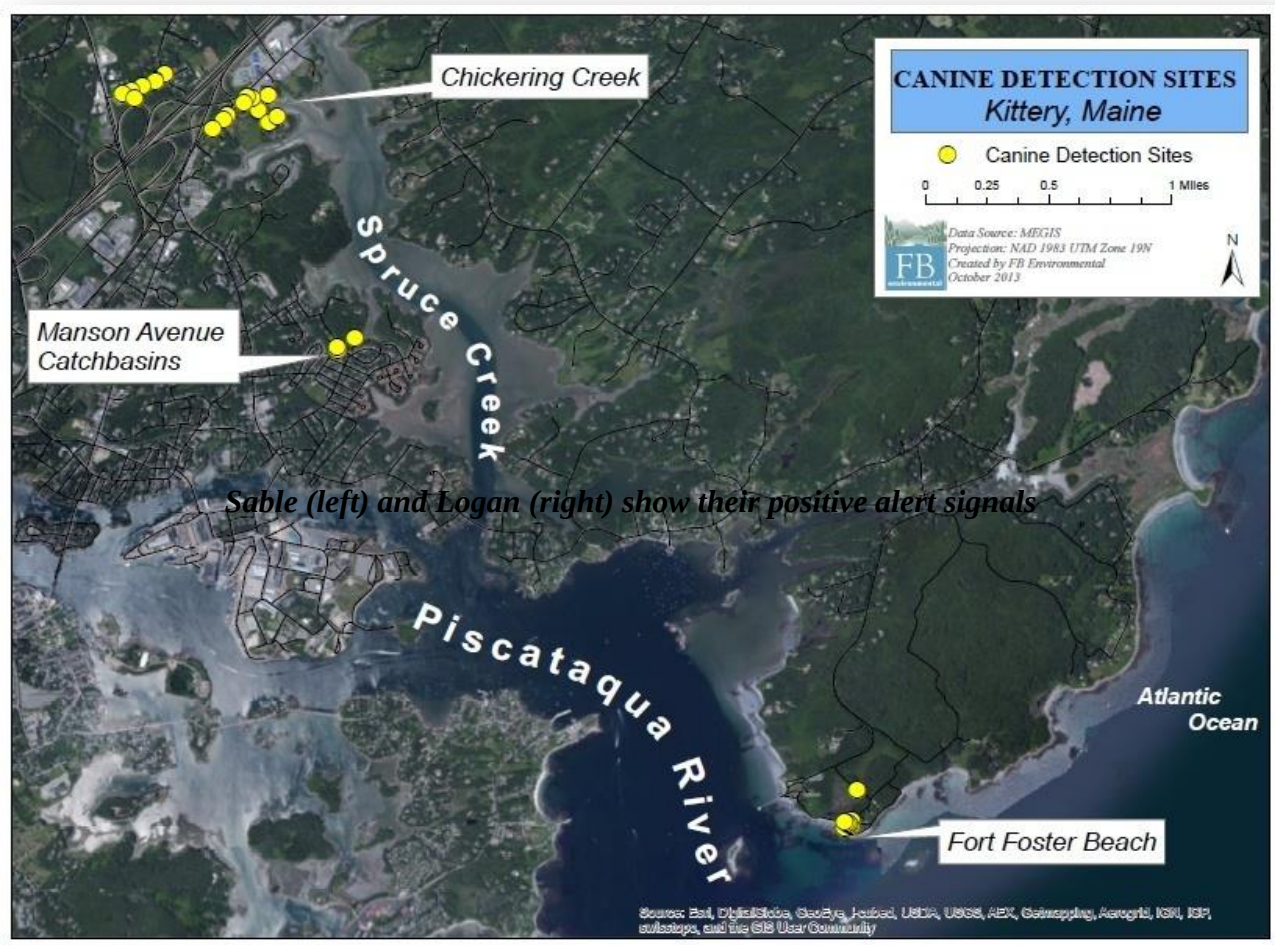
**Figure 2: Canine Detection Locations in Kittery, ME**

On July 31, 2013, Emily DiFranco and Whitney Baker from FB Environmental Associates (FBE), Scott and Karen Reynolds from Environmental Canine Services (ECS), and Fred Dixon from the Kittery Department of Public Works investigated and sampled tributaries and outfalls discharging to Spruce Creek and areas along Fort Foster Beach (Figure 2).

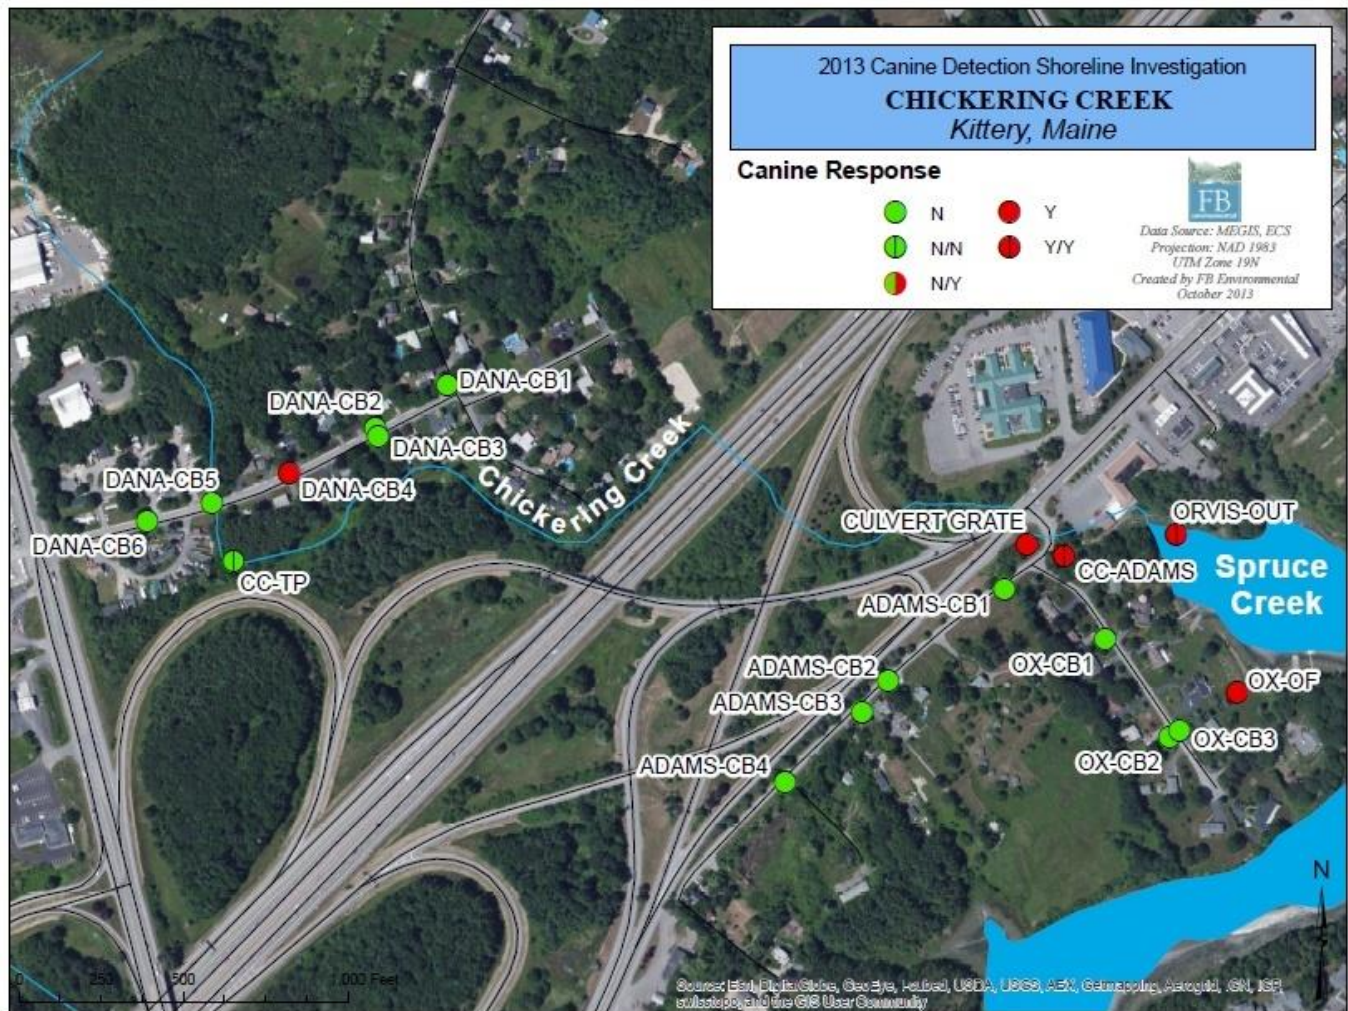
**Figure 4: Sampling locations on Chickering Creek in Kittery, ME (July 31, 2013). Colored dots indicate canine response.**

bacteria. These sites include a catch basin on Dana Road, a culvert grate near the intersection of Adams and Oxpoint Drive, an outfall in the Oxpoint Drive neighborhood, and the two downstream sampling locations along Chickering Creek (CC-Adams and Orvis Out).

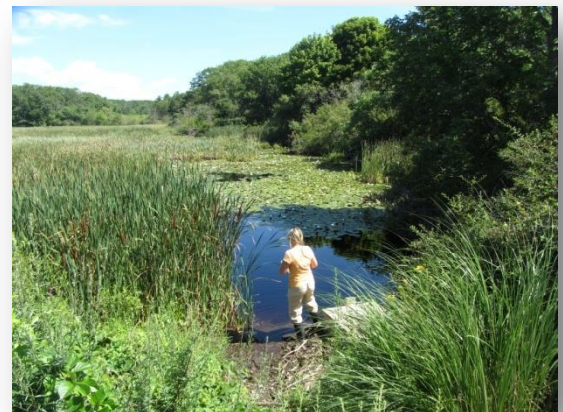
At one location (Wet Seep 1), enterococci concentrations were over 20 times the water quality standard (Table 3). However, the dogs indicated that there were no human sources of bacteria present at this location. This may be a result of wildlife activity or other non-human sources inland and northeast of the beach. ‘Wet Seep 3’ also had bacteria concentration of over six times the state bacteria standard for enterococci. A white substance was present in this seep. Though Sable did not indicate the presence of human wastewater at this site, high bacteria results, and a positive response from Logan indicate that human sources may be

contributing to the contamination at this location. Both dogs gave positive responses at the ‘Wet Seep 2’ location on Fort Foster Beach. However, bacteria concentrations were below the water quality standard indicating that the extent of contamination at this site may be low.

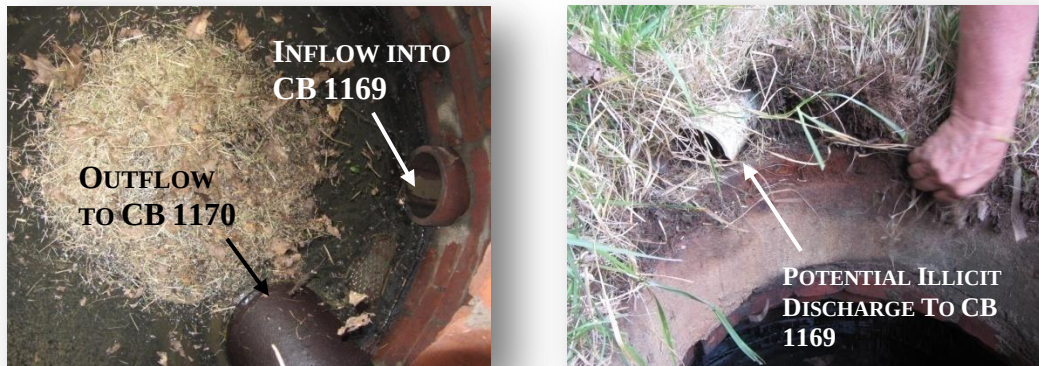
1. Inside catch basin (CB) 1169 a source of flow was documented. An 8-inch clay pipe was observed with an unknown origin. This pipe may potentially be from a perimeter drain discharging from the adjacent residence. A potential illicit discharge was also discovered at this location. A small PVC pipe was observed just above the storm drain cover. This may be used as a laundry drain or basement sump pump. The origins of both pipes should be investigated.

*Catch Basin 1169 in the Upper portion of the Cromwell Street Drainage area.*

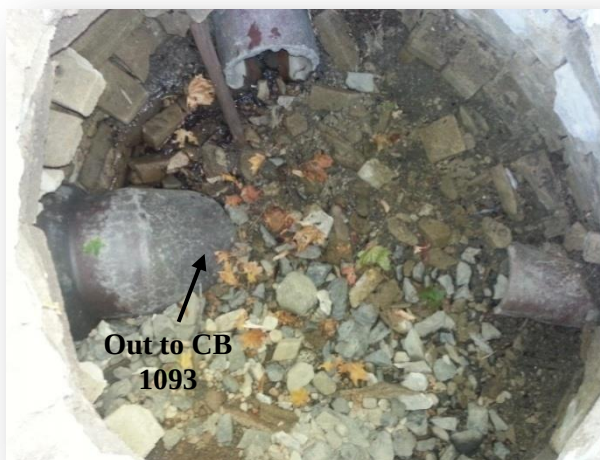
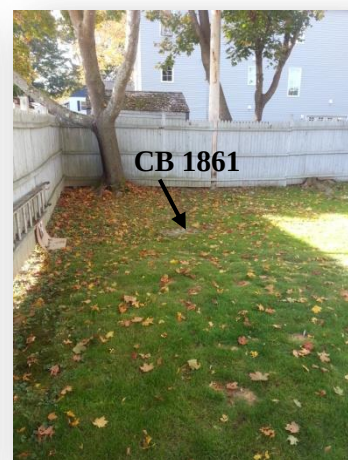
2. Catch basin 1861 is located in the backyard of parcel 16-75 and has three inflow pipes of unknown origin. According to homeowners, this catch basin receives a large amount of stormwater during rain events and often floods. Though the basin was dry during the investigation, the origins of these three pipes should be further investigated.

*CB 1861 located on parcel 16-75 on Goodrich Street.*

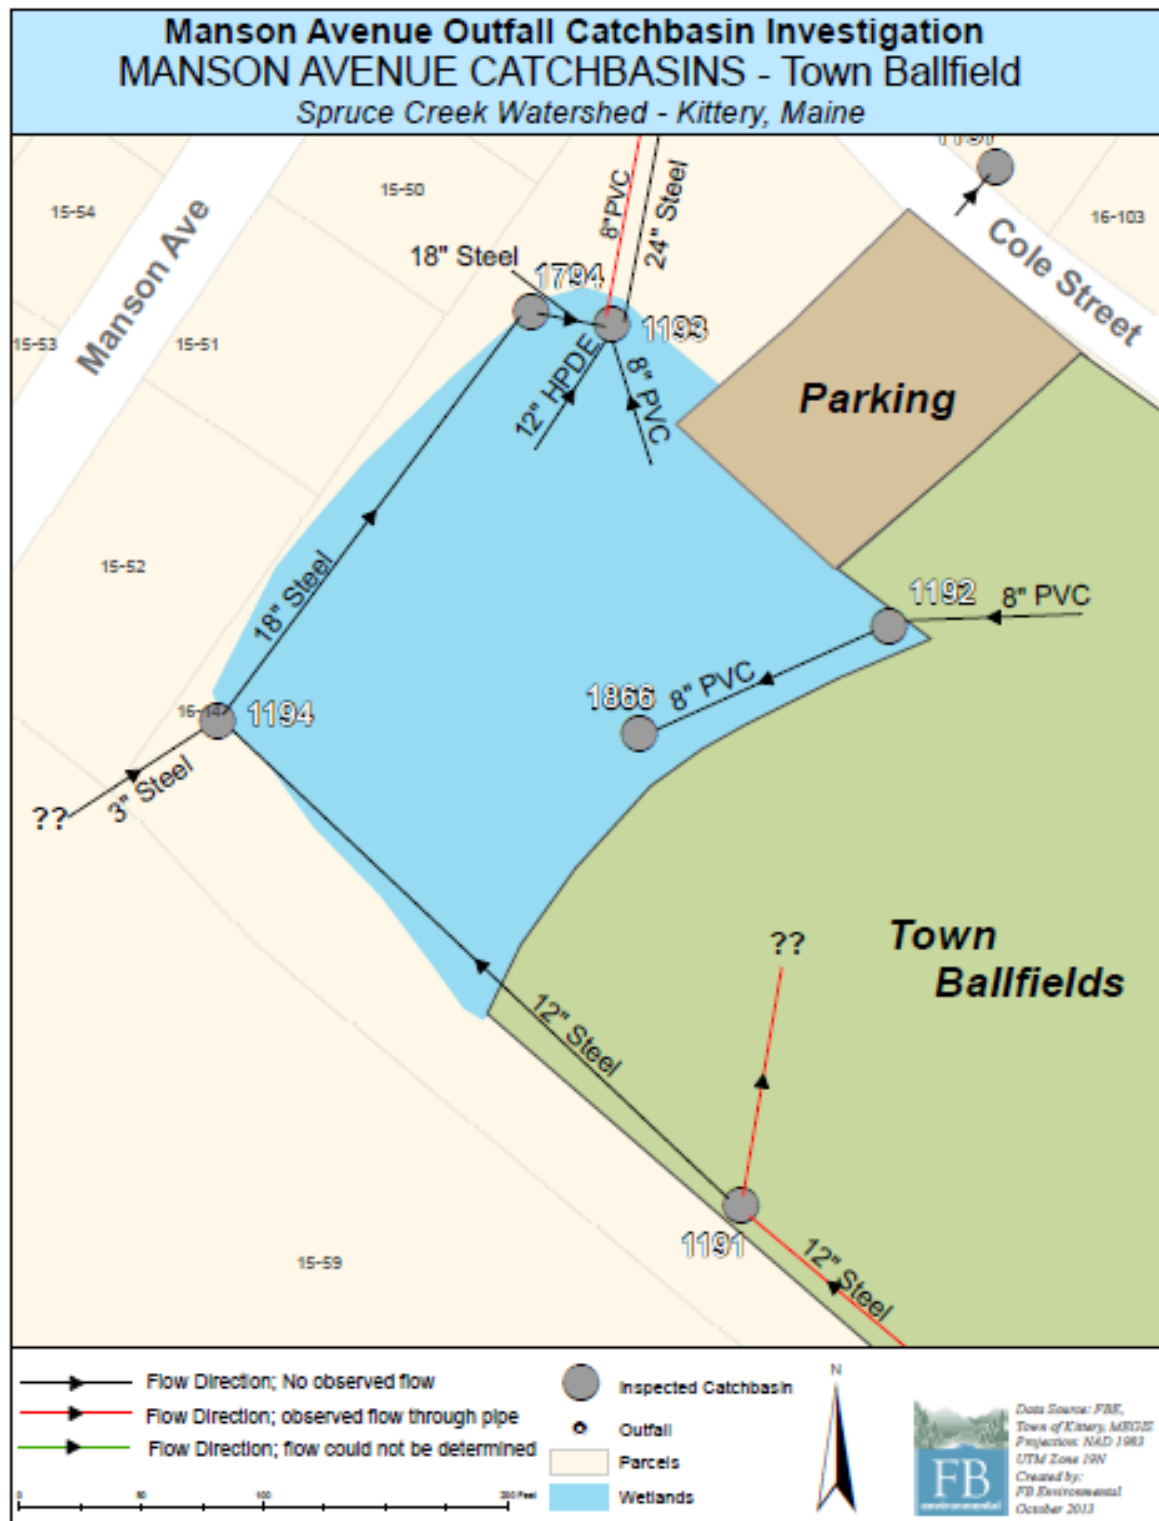
Figure 14: Manson Avenue Outfall Catch Basin Investigation - Ball field Catch basins

The next area included catch basins located around the town's ball park. Though there was flow into the catch basins, in many cases the outflow pipe was located high up in the basin. The catch basin would have to fill almost completely before water would drain out to the next downstream catch basin. Figure 14 summarizes the flow conditions in the ball field area and parking lot off of Cole Street in Kittery.

**Findings from the investigation of the town ball field drainage area are as follows (Figure 14):**

1. No signs of illicit discharges were discovered in the ball park area. Flow through CB 1193 is suggested to be solely stormwater driven. CB 1866 and CB 1192 receive water from perforated pipes that run underground along the perimeter to the ball fields. These collect water draining into the ditches along the field and drain into these two catch basins. The town installed these pipes to help prevent standing water on the fields.
