SPRUCE CREEK WATERSHED

KITTERY, MAINE

2015 WATER QUALITY MONITORING REPORT

FB Environmental Associates
170 West Road, Suite 6
Portsmouth, NH 03801

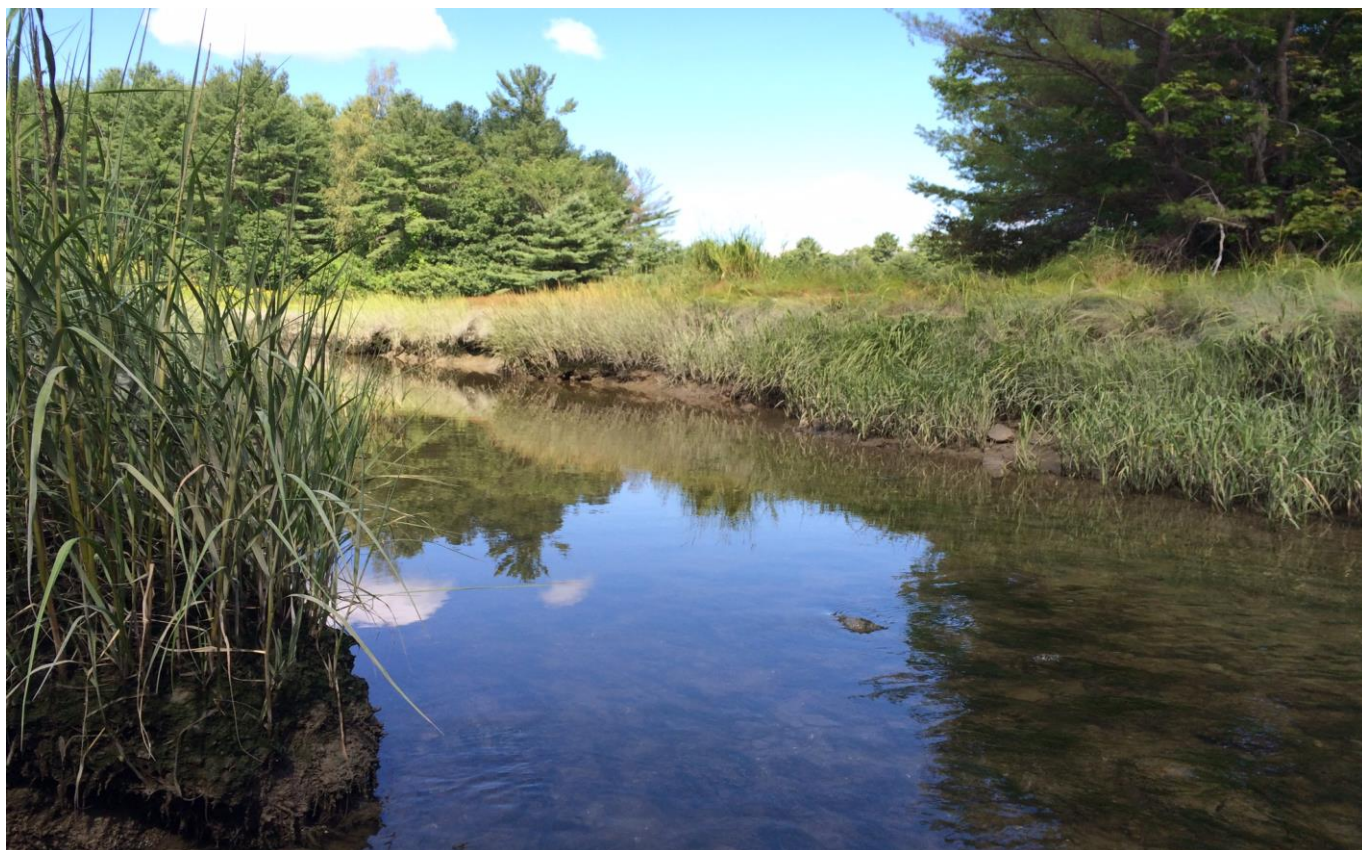
Upper estuary monitoring site at the Picott Road crossing.

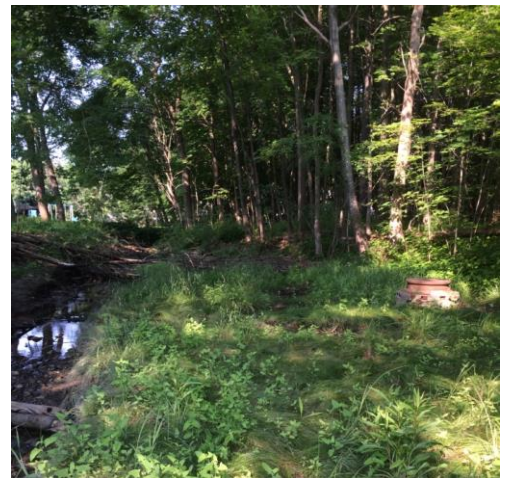
MC1 had the highest overall geometric mean in 2015, with alarmingly-high bacteria counts in both wet and dry weather. Other outfalls in this area (along Manson Avenue) have had high bacteria counts (see Figure 3). DNA analysis indicated human sources of bacteria in 2015, and canine detection in previous years indicated human fecal contamination as well. An aboveground sewer manhole is located on the north side of this creek, and a force main runs underneath the creek through this manhole. Kittery Sewer Department staff investigated the manhole in January 2016. A water sample from the manhole contained only 5 mpn/100mL of fecal coliform, and the force main showed no visual evidence of a leak (J. Kellogg, Kittery Shoreland Resource Office, pers. comm.). However, smoke tests from 2014 indicated that there may be a leaky sewer connection upstream of this site as smoke was observed coming out of stormwater catch basins during a test of the sewer system (CB 1795). Additionally, nearby properties may still have private septic systems that have not been connected to the sewer line. The area around this site should be investigated further.

Sewer manhole visible to the right of MC1 sampling site. The Kittery Sewer Department found no evidence of malfunction during an investigation in January 2016.

- c. Monitor any further investigative work related to the elevated manhole (connected to the force main) immediately upstream of MC1; investigations by the Kittery Sewer Department in January 2016 found no evidence of fecal contamination or leaks from this infrastructure, but additional follow-up work may be forthcoming.

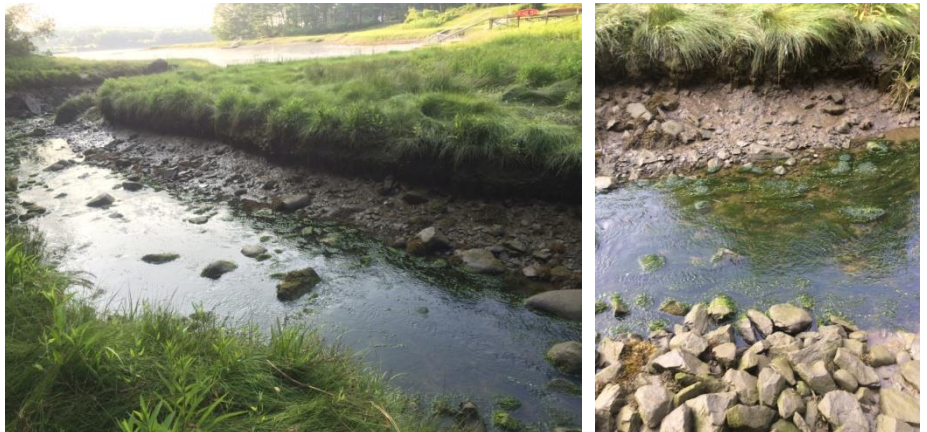
Chickering Creek had the third highest overall geometric mean in 2015; historical annual geometric means also exceeded the State criterion for *E. coli*, but to a lesser degree than in 2015. The creek showed high bacteria counts in both wet and dry weather, suggesting inputs from both stormwater (including outfalls near the intersection with Interstate 95) and potentially malfunctioning septic/sewer. Canine detection in 2013 also indicated human fecal contamination at scattered locations throughout the Chickering Creek drainage area, and DNA analysis in

Chickering Creek behind the Orvis Outlet. LEFT: Chickering Creek, looking towards the confluence with Spruce Creek. RIGHT: Close-up of green algae covering the creek bottom.

2015 showed human-sourced bacteria in both wet and dry weather. An additional concern for this area is the large amount of filamentous green algae growing on the streambed. Though dissolved oxygen was only measured during the day, nighttime respiration by these algae may cause dissolved oxygen levels to drop at night, potentially affecting other aquatic organisms living in the creek. Most properties in the Chickering Creek drainage have private septic systems, which could be a source of both nutrients (stimulating algae growth) and fecal contamination. In 2016, most of this area will be connected to a new extension of the Town sewer line, eliminating many of the private septic systems and one of the few remaining overboard discharge sites in Kittery (B. Marchi, Kittery Code Enforcement Officer, pers. comm.).
