2020 WATER QUALITY MONITORING REPORT FOR

# SPRUCE CREEK

FOR THE TOWN OF KITTERY, ME

[December 2020]

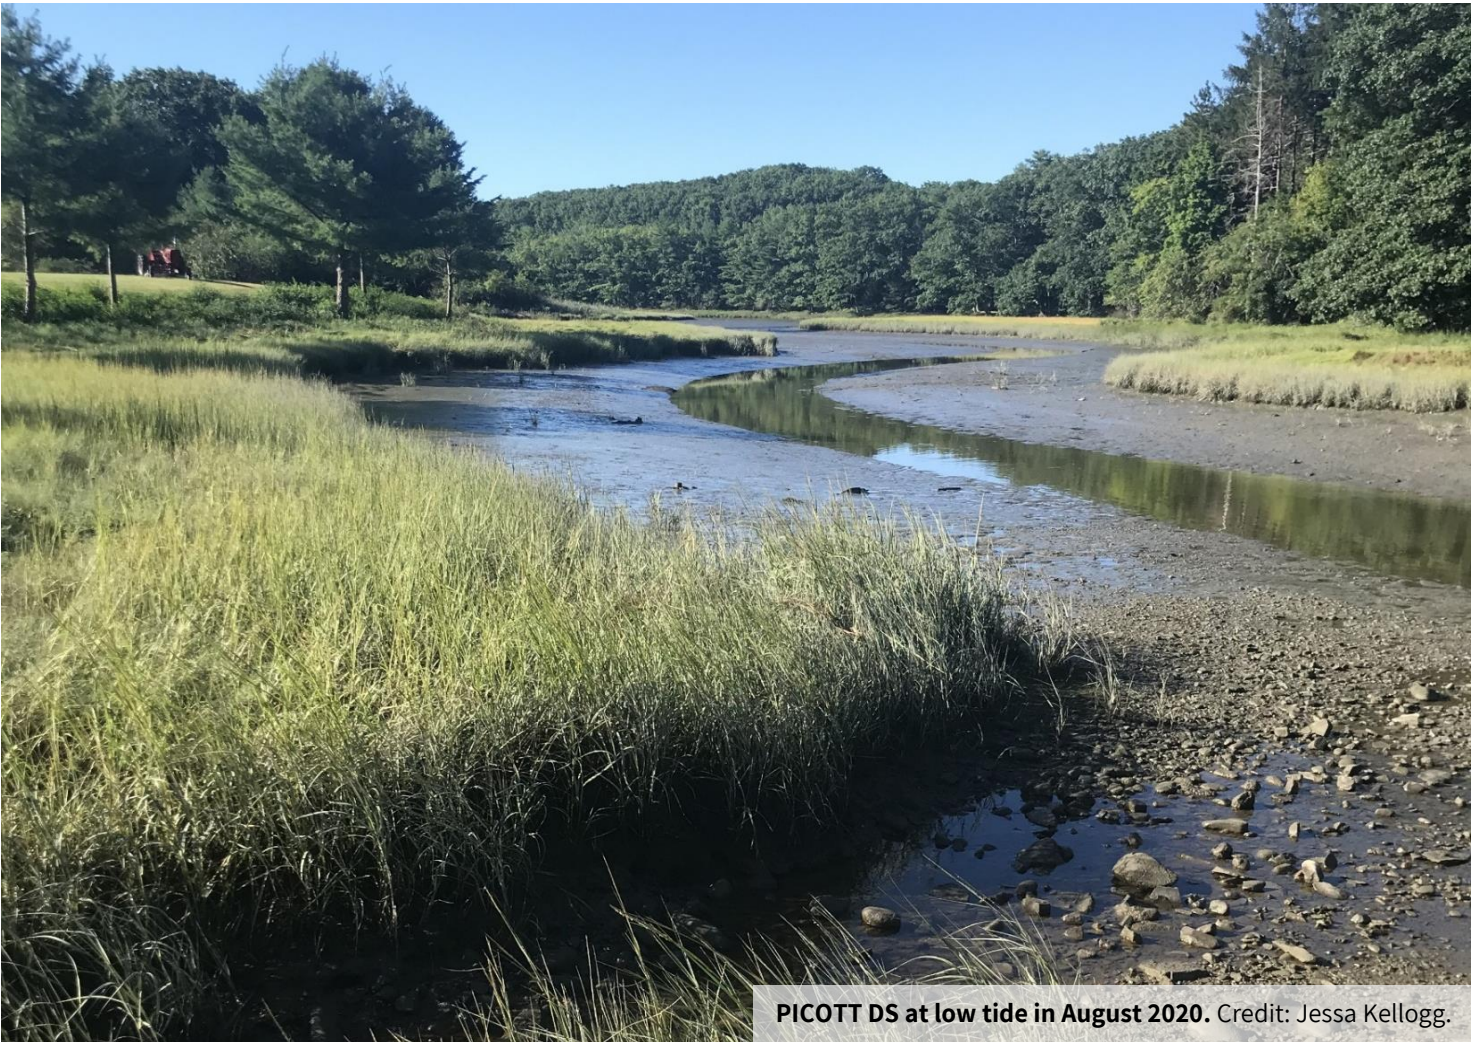
PICOTT DS at low tide in August 2020. Credit: Jessa Kellogg.

- **PICOTT DS** met the state criteria for Enterococci for the annual geometric mean and for all single samples except for one (389 mpn/100mL on 8/11/20). PICOTT DS was also found to have elevated total Kjeldahl nitrogen concentrations on two sample days (1.0-1.2 mg/L) and elevated total phosphorus concentrations ranging from 0.06-0.24 mg/L on all sample days. Dissolved oxygen did not meet state criteria on any of the sample days. pH was generally low but reflected brackish waters mixing with marine and freshwater.

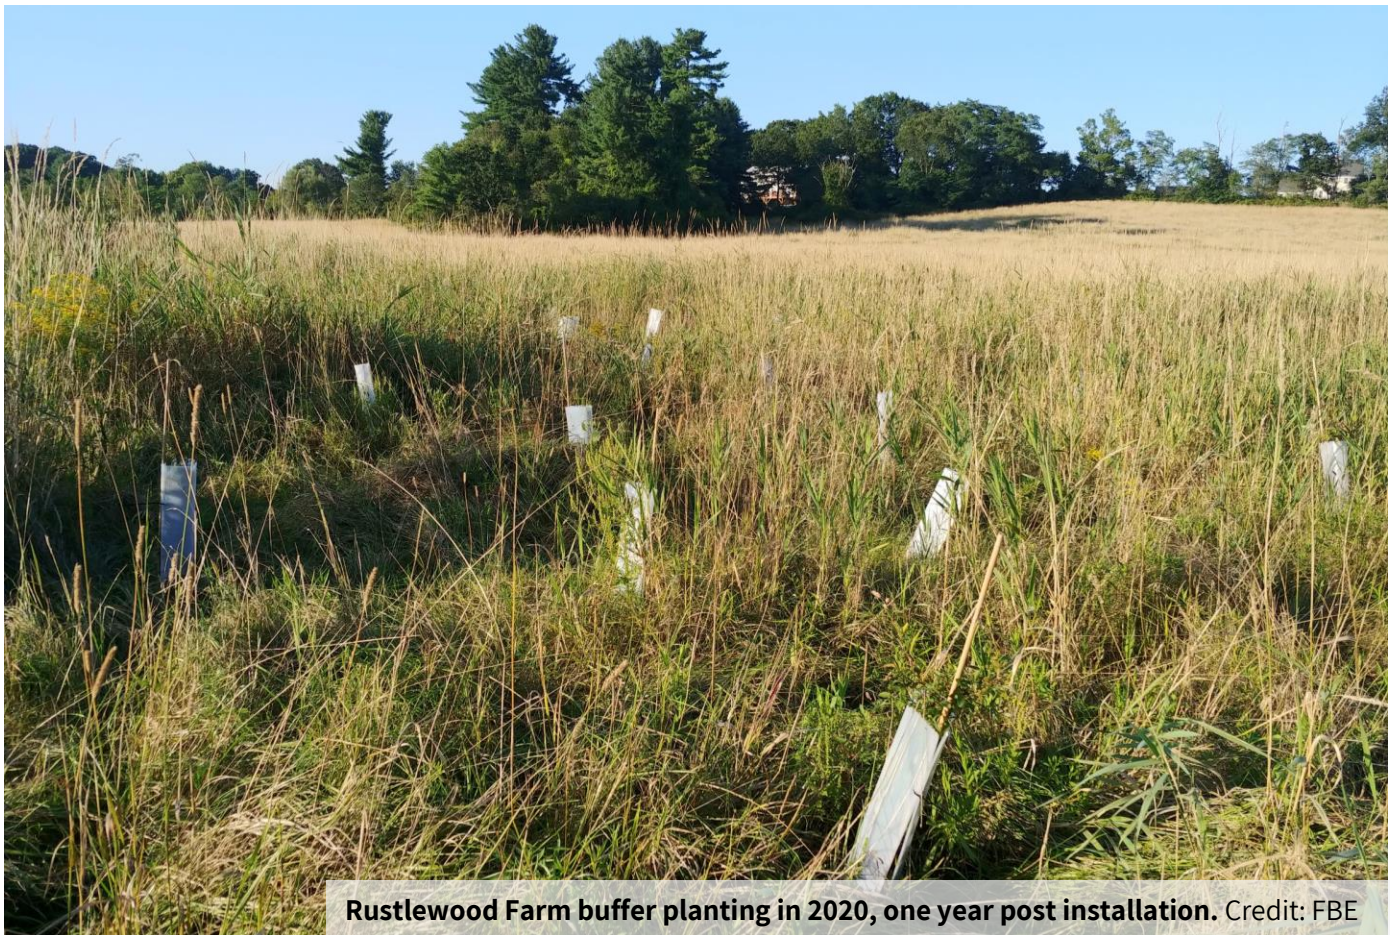
Rustlewood Farm buffer planting in 2020, one year post installation. Credit: FBE

Funded by a Maine DEP-administered 319 Watershed Assistance Grant in May 2019, the Town of Kittery, FBE, and 40 local volunteers gathered at Rustlewood Farm to plant 600 native trees along 400-foot stretch of Spruce Creek’s headwaters between two established sampling sites (RUSWOODFARM-2, upstream, and RUSWOODFARM-1, downstream; Map 2). A riparian buffer is a vegetated area along a stream that reduces erosion and flooding, provides shade, and minimizes the amount of pollutants entering the stream by absorbing and filtering animal waste, sediments, nutrients, and pesticides from nearby lands. The owners of Rustlewood Farm apply manure on adjacent hayfields according to a USDA-approved Comprehensive Nutrient Management Plan, which sets the timing and rate of manure application to reduce nutrient runoff to nearby surface waters. The goal of the buffer planting was to further reduce any possible untreated surface runoff from the manured hayfields to the Creek.
