ITEM 2—5 Whipple Road—Major Site Plan — Final Review

Action: Hold public hearing. Approve plan or continue review Mike Sudak, on behalf of owner/applicants PB Real Estate Holdings LLC, requests approval to construct a 3,400 square foot commercial facility containing a butcher’s shop and restaurant, along with associated parking and utilities, on the property of 5 Whipple Road, Tax Map 9, Lot 134, in the Business Local (B-L) Zone.

OVERALL SITE PLAN
 MAINE MEAT BUTCHER & RESTAURANT
 5 WHIPPLE ROAD, KITTEERY, MAINE

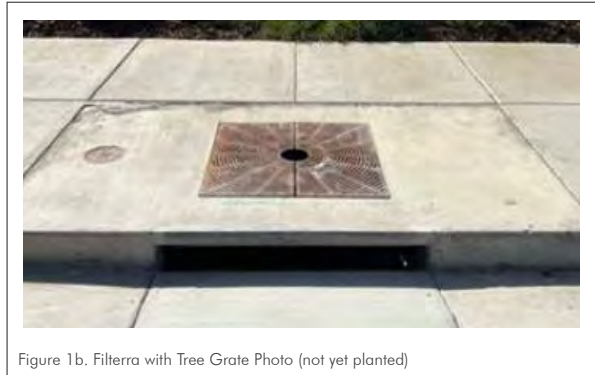
Figure 1b. Filterra with Tree Grate Photo (not yet planted)
