SOIL GAS INVESTIGATION REPORT

We Care Cleaners
17 Wentworth Street
Kittery, ME 03904

April 4, 2017
StoneHill Project No. 26045

RE: Soil Gas Investigation Report
We Care Dry Cleaners
17 Wentworth Street, Kittery, ME

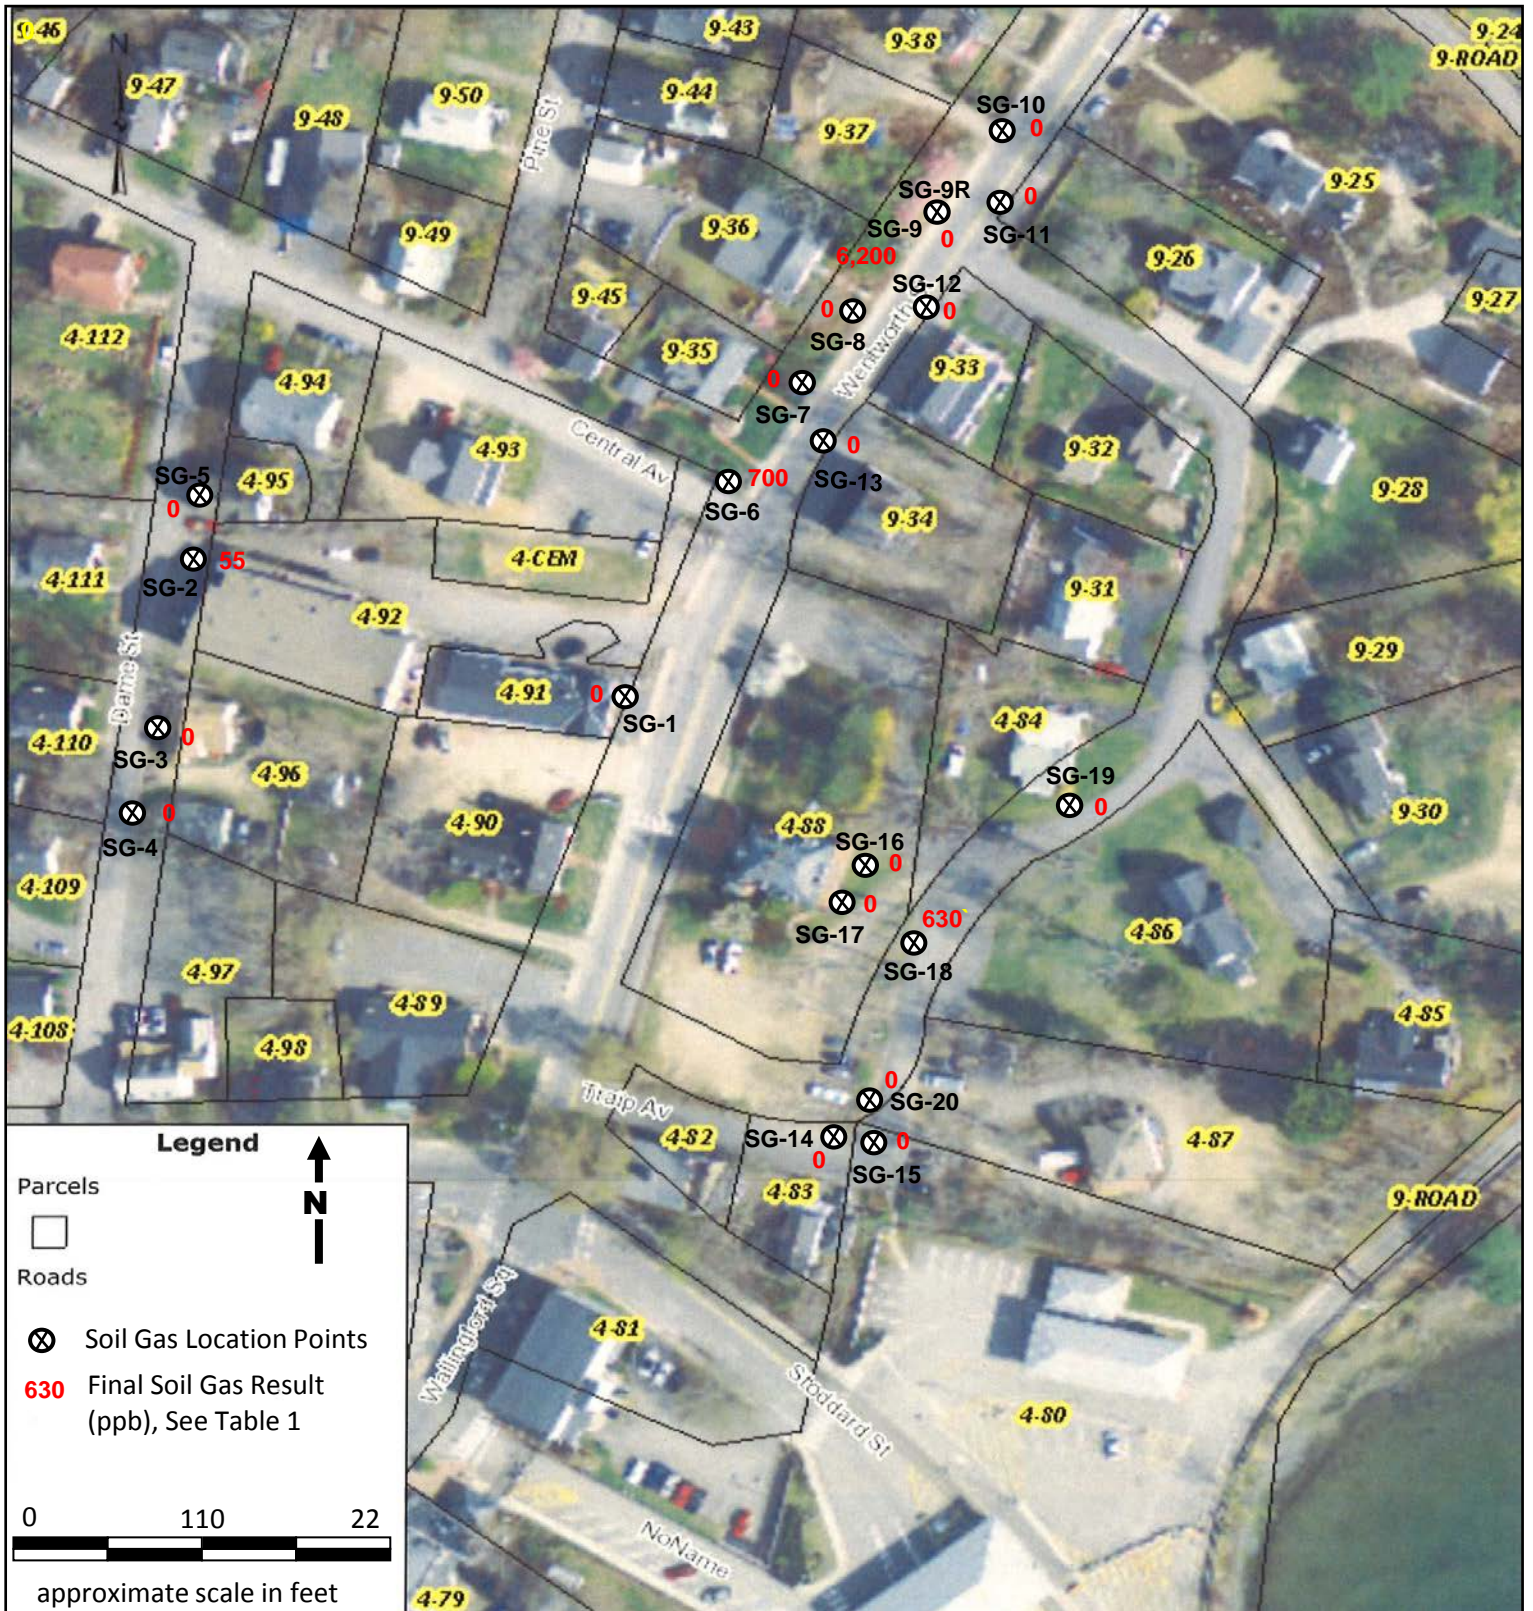
FIGURE 2
WE CARE
SOIL GAS SAMPLE LOCATIONS

- StoneHill collected soil gas field screening measurements at twenty locations primarily where residential sewer and/or water utility lines were estimated to connect with the main utility lines at several locations along the streets identified above (Figure 2).

During the summer of 2016, StoneHill worked with the Town of Kittery to identify and map the sewer and water line connections beneath four roadways in the vicinity of the We Care property; Dame Avenue, Central Avenue, Wentworth Street, and Traip Avenue. Sanitary sewer, storm sewer and municipal water line maps provided by the town are provided in Appendix A. On August 29, 2016, StoneHill was joined by Troy Smith of the MEDEP to collect soil gas measurements adjacent the sewer and water connections at several locations beneath these roadways. To obtain a soil gas sample, a ½-inch diameter by two foot long hole was drilled through the concrete walk or street paving at each location. A 3/8-inch diameter stainless steel probe was advanced into the hole and a clay seal placed around the probe at the ground surface to prevent ambient air from entering into the probe hole and thus diluting the sample. Prior to collecting each soil gas sample, oxygen and carbon dioxide levels were collected as a measure of the adequacy of the surface seal. Each sample was collected using the vacuum produced by the measuring instrument to draw soil gas through the metal probe and into the instrument. A RKI Eagle IR 5K was used to measure oxygen and carbon dioxide and a ppbRAE3000 was used to measure volatile organic compounds. The soil gas sample locations and results are shown on Figure 2 and results are summarized in Table 1. While it is assumed the PID is measuring primarily PCE and other chlorinated volatile organic compound (cVOC) degradation products, it must be recognized that other sources of VOCs may be measured that are not associated with the historic We Care operations.

The sample locations were chosen based upon the possibility of soil gas migrating from the We Care property (Map 4-Lot 92) outward along the utility lines beneath the roadways and into surrounding structures via individual utility service lines. As such, soil gas measurements were collected from the back of the We Care property, along Dame Street as well as from the front of the We Care property, along Wentworth Street. The soil gas sample (SG-2) collected along Dame Street, adjacent the sewer utility line service connection to the back of the new We Care

Cleaners building, revealed a sustained measurement of 55 parts per billion by volume (ppbv). However, the soil gas measurements to the north along the sewer line beneath Dame Street (SG-5) and south (SG-3), revealed sustained measurements of 0 ppbv. This indicates that PCE impacted soil gas is not migrating via the utility lines beyond these two soil gas locations and thus is not likely migrating to structures along Dame Street. Further, given the sustained reading of 55 ppbv at SG-2, well below the action level of 500 ppbv (as agreed upon with Troy Smith), no further investigation relative to the migration of soil gas crossing or along Dame Street was deemed necessary.

Of additional note is the measurement of 6,200 ppbv measured within the soil gas probe at SG-9, located further north on Wentworth Avenue. The probe was advanced immediately adjacent to, and likely encountered, creosote covered landscaping railroad ties and thus was not considered representative of the soil gas in the sewer line at that location. As such, an additional soil gas probe and measurement (SG-9R) was collected approximately three feet away from the landscape ties, immediately adjacent Wentworth Avenue. This measurement revealed a sustained measurement of 0 ppbv and is believe to be representative of the soil gas within the sewer line path at this location. No additional soil gas exceedances related to the Site were noted along Wentworth Avenue, thus the continuing investigation was focused on the possible impacts of soil gas along the sewer lines servicing the Rice Library and the parts of Traip Avenue south and east of the Rice Library.

To assess whether soil gas containing VOCs was impacting the sewer main beneath Traip Avenue, soil gas was collected adjacent a manhole southeast of the Rice Library (SG-18). This revealed a sustained measurement of 630 ppbv, raising the concern of soil gas contamination

migrating north and south along Traip Avenue as well as along the service line into the eastern foundation of the Rice Library. However, soil gas measurements collected along the eastern foundation of the Rice Library (SG-16 and SG-17) were 0 ppbv. Further, additional soil gas measurements to the north (SG-19) and south (SG-14, SG-15 and SG-20) of SG-18, along the sewer line under Traip Avenue and service line to 4 Traip Avenue (Lot 4-83) were also 0 ppbv. As such, PCE impacted soil gas is not migrating toward residences north, south, and east of Traip Avenue, via the main sewer line beneath Traip Avenue, or via the service line into the Rice Library.

While soil gas results along the sewer service lines leading into the Rice Library and the residence at 4 Traip Avenue were 0 ppbv, the additional collection of soil gas measurements from beneath these two structures was deemed appropriate to assess the possible presence of VOCs in soil gas resulting from the shallow bedrock groundwater contaminant plume identified in the 2008 StoneHill investigation.

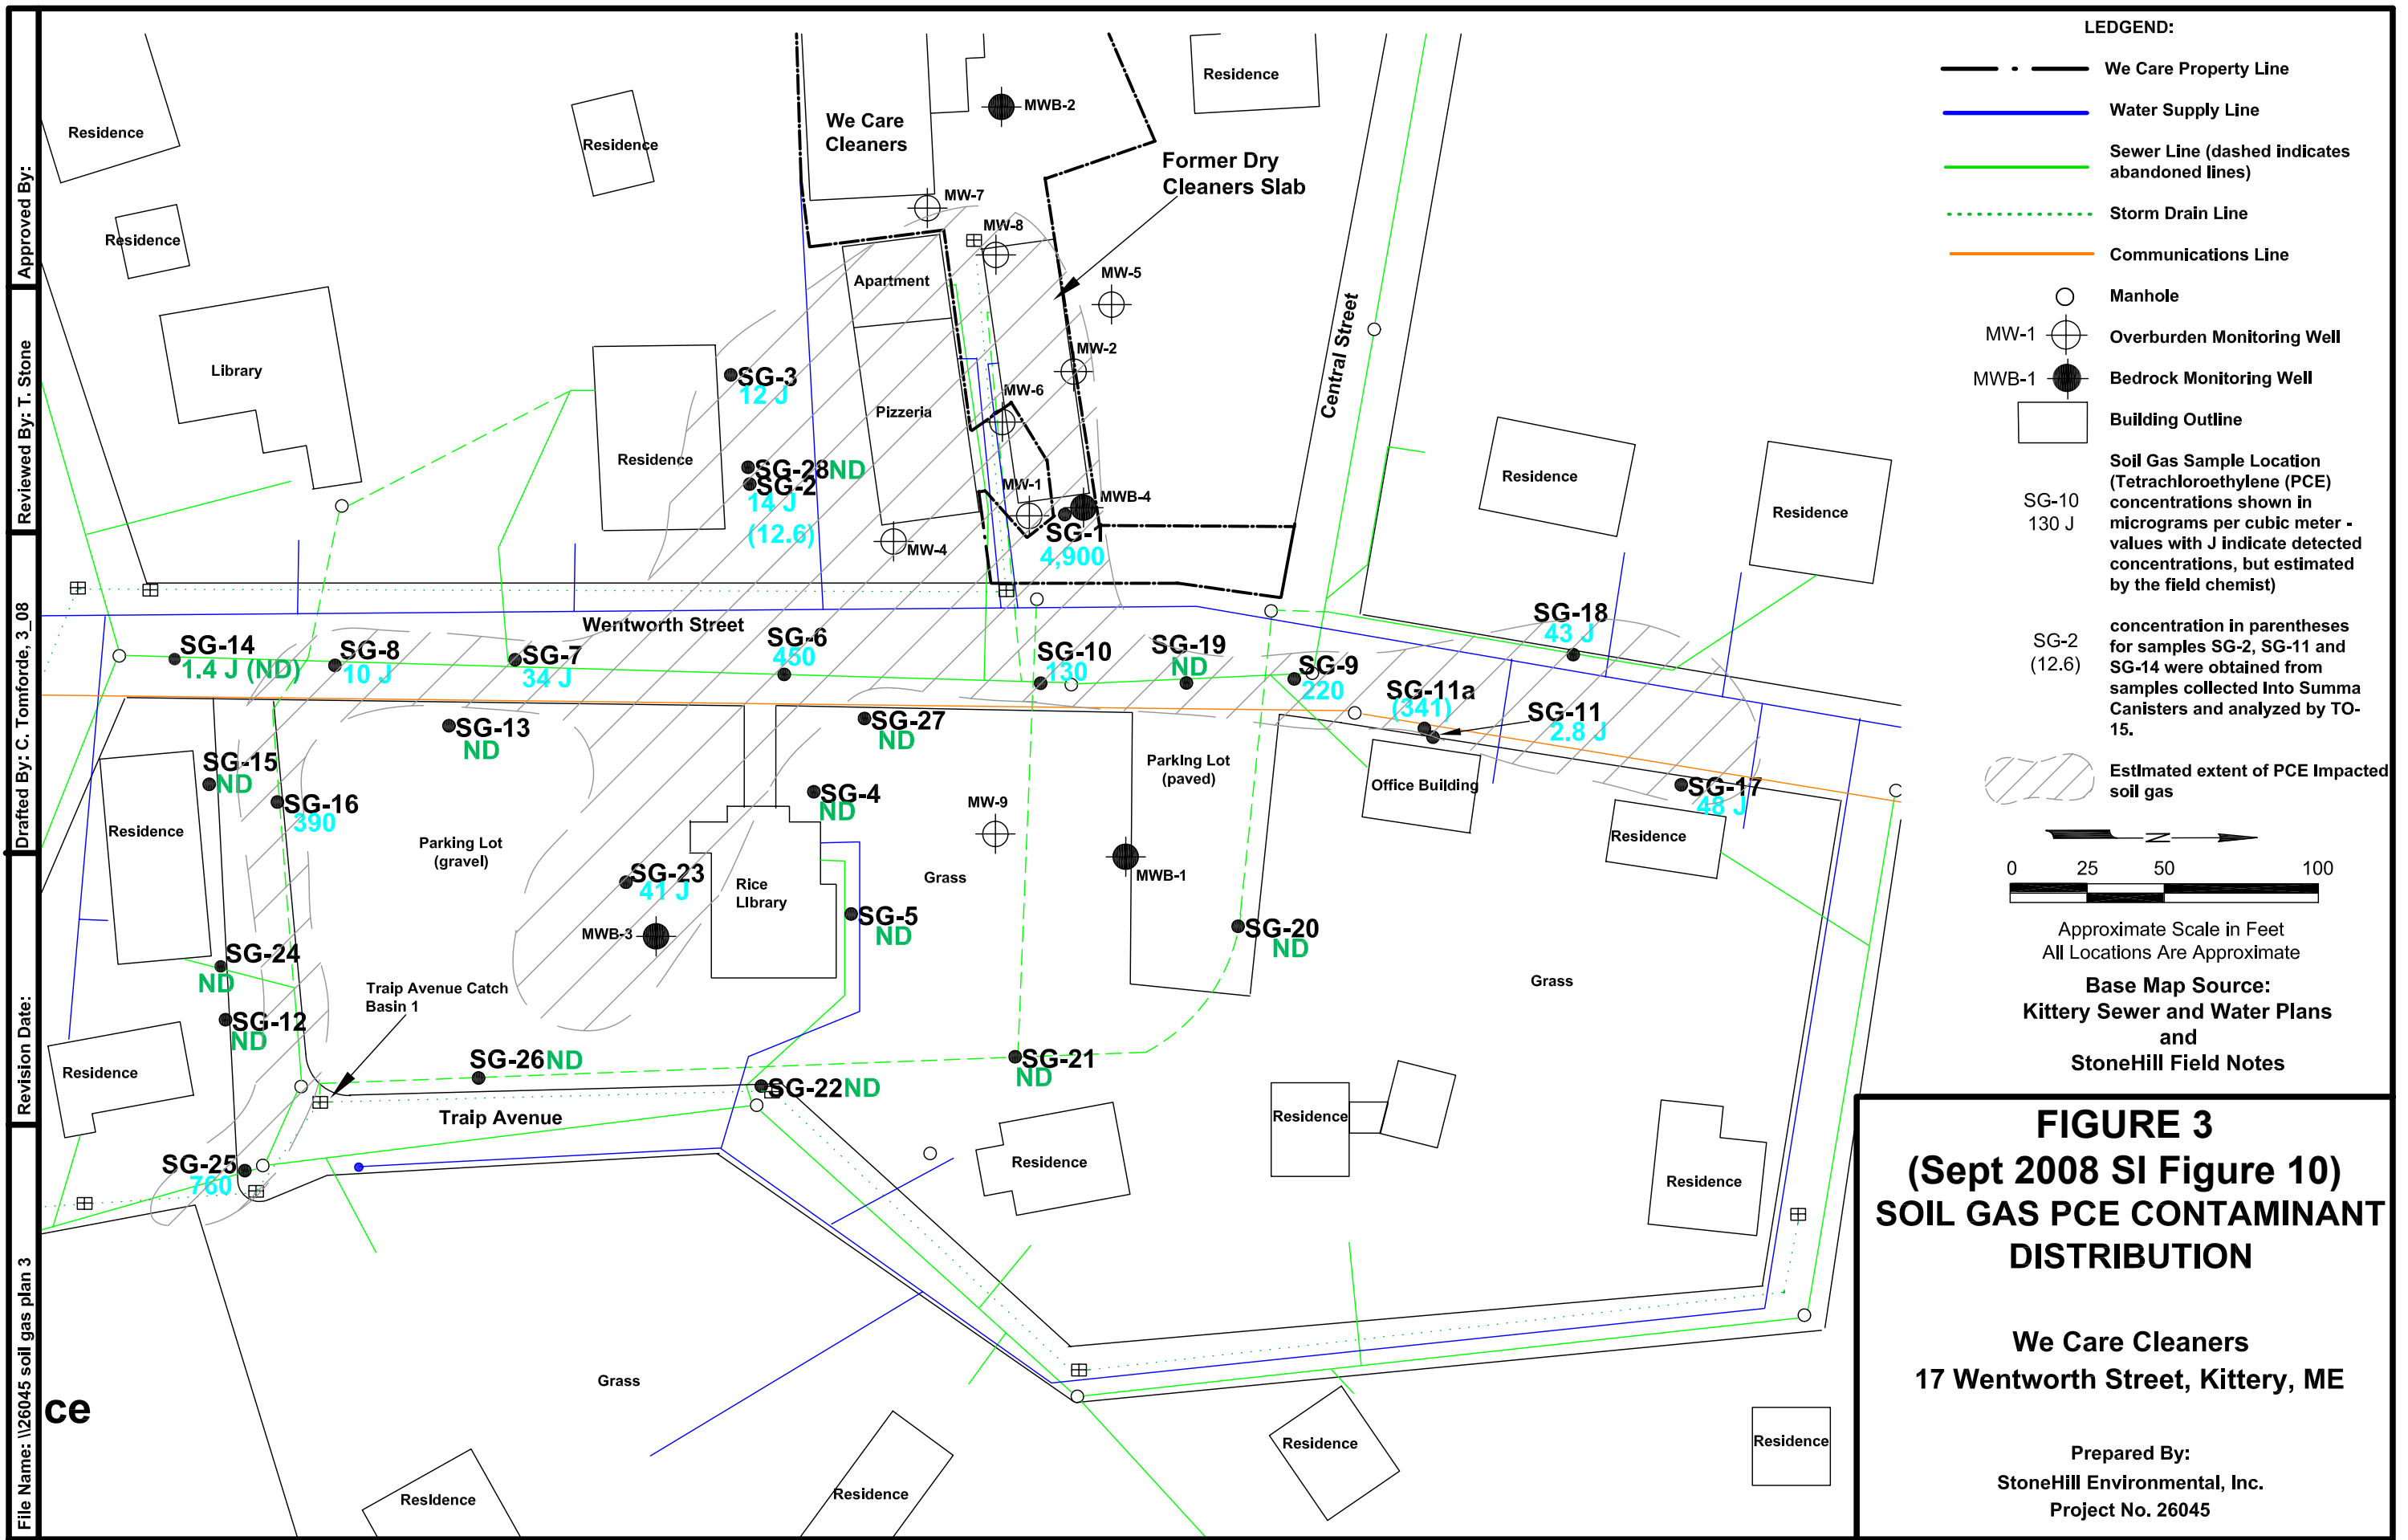
FIGURE 3
(Sept 2008 SI Figure 10)
SOIL GAS PCE CONTAMINANT
DISTRIBUTION

- Overburden soil and groundwater impacted with chlorinated solvents are mostly confined to the Site property.
- A shallow bedrock chlorinated solvent groundwater contaminant plume extends to the southeast beneath the Rice Library property located southeast of the Site.
- PCE impacted soil gas was measured along the sewer utility main under Wentworth Street and southern portion of Traip Avenue (See attached Figure 3, Copy of Figure 10 from the SI Report, StoneHill Environmental, Inc., September 3, 2008). As was documented at the time, a soil gas concentration of 4,900 ug/m³ PCE was noted at the

eastern end of the former We Care Cleaners building location (closest Wentworth Street), as high as 450 ug/m³ along Wentworth Street in front of the Rice Library, and 760 ug/m³ approximately 350 feet to the south at the corner of Traip Avenue, near the residence at 4 Traip Avenue.

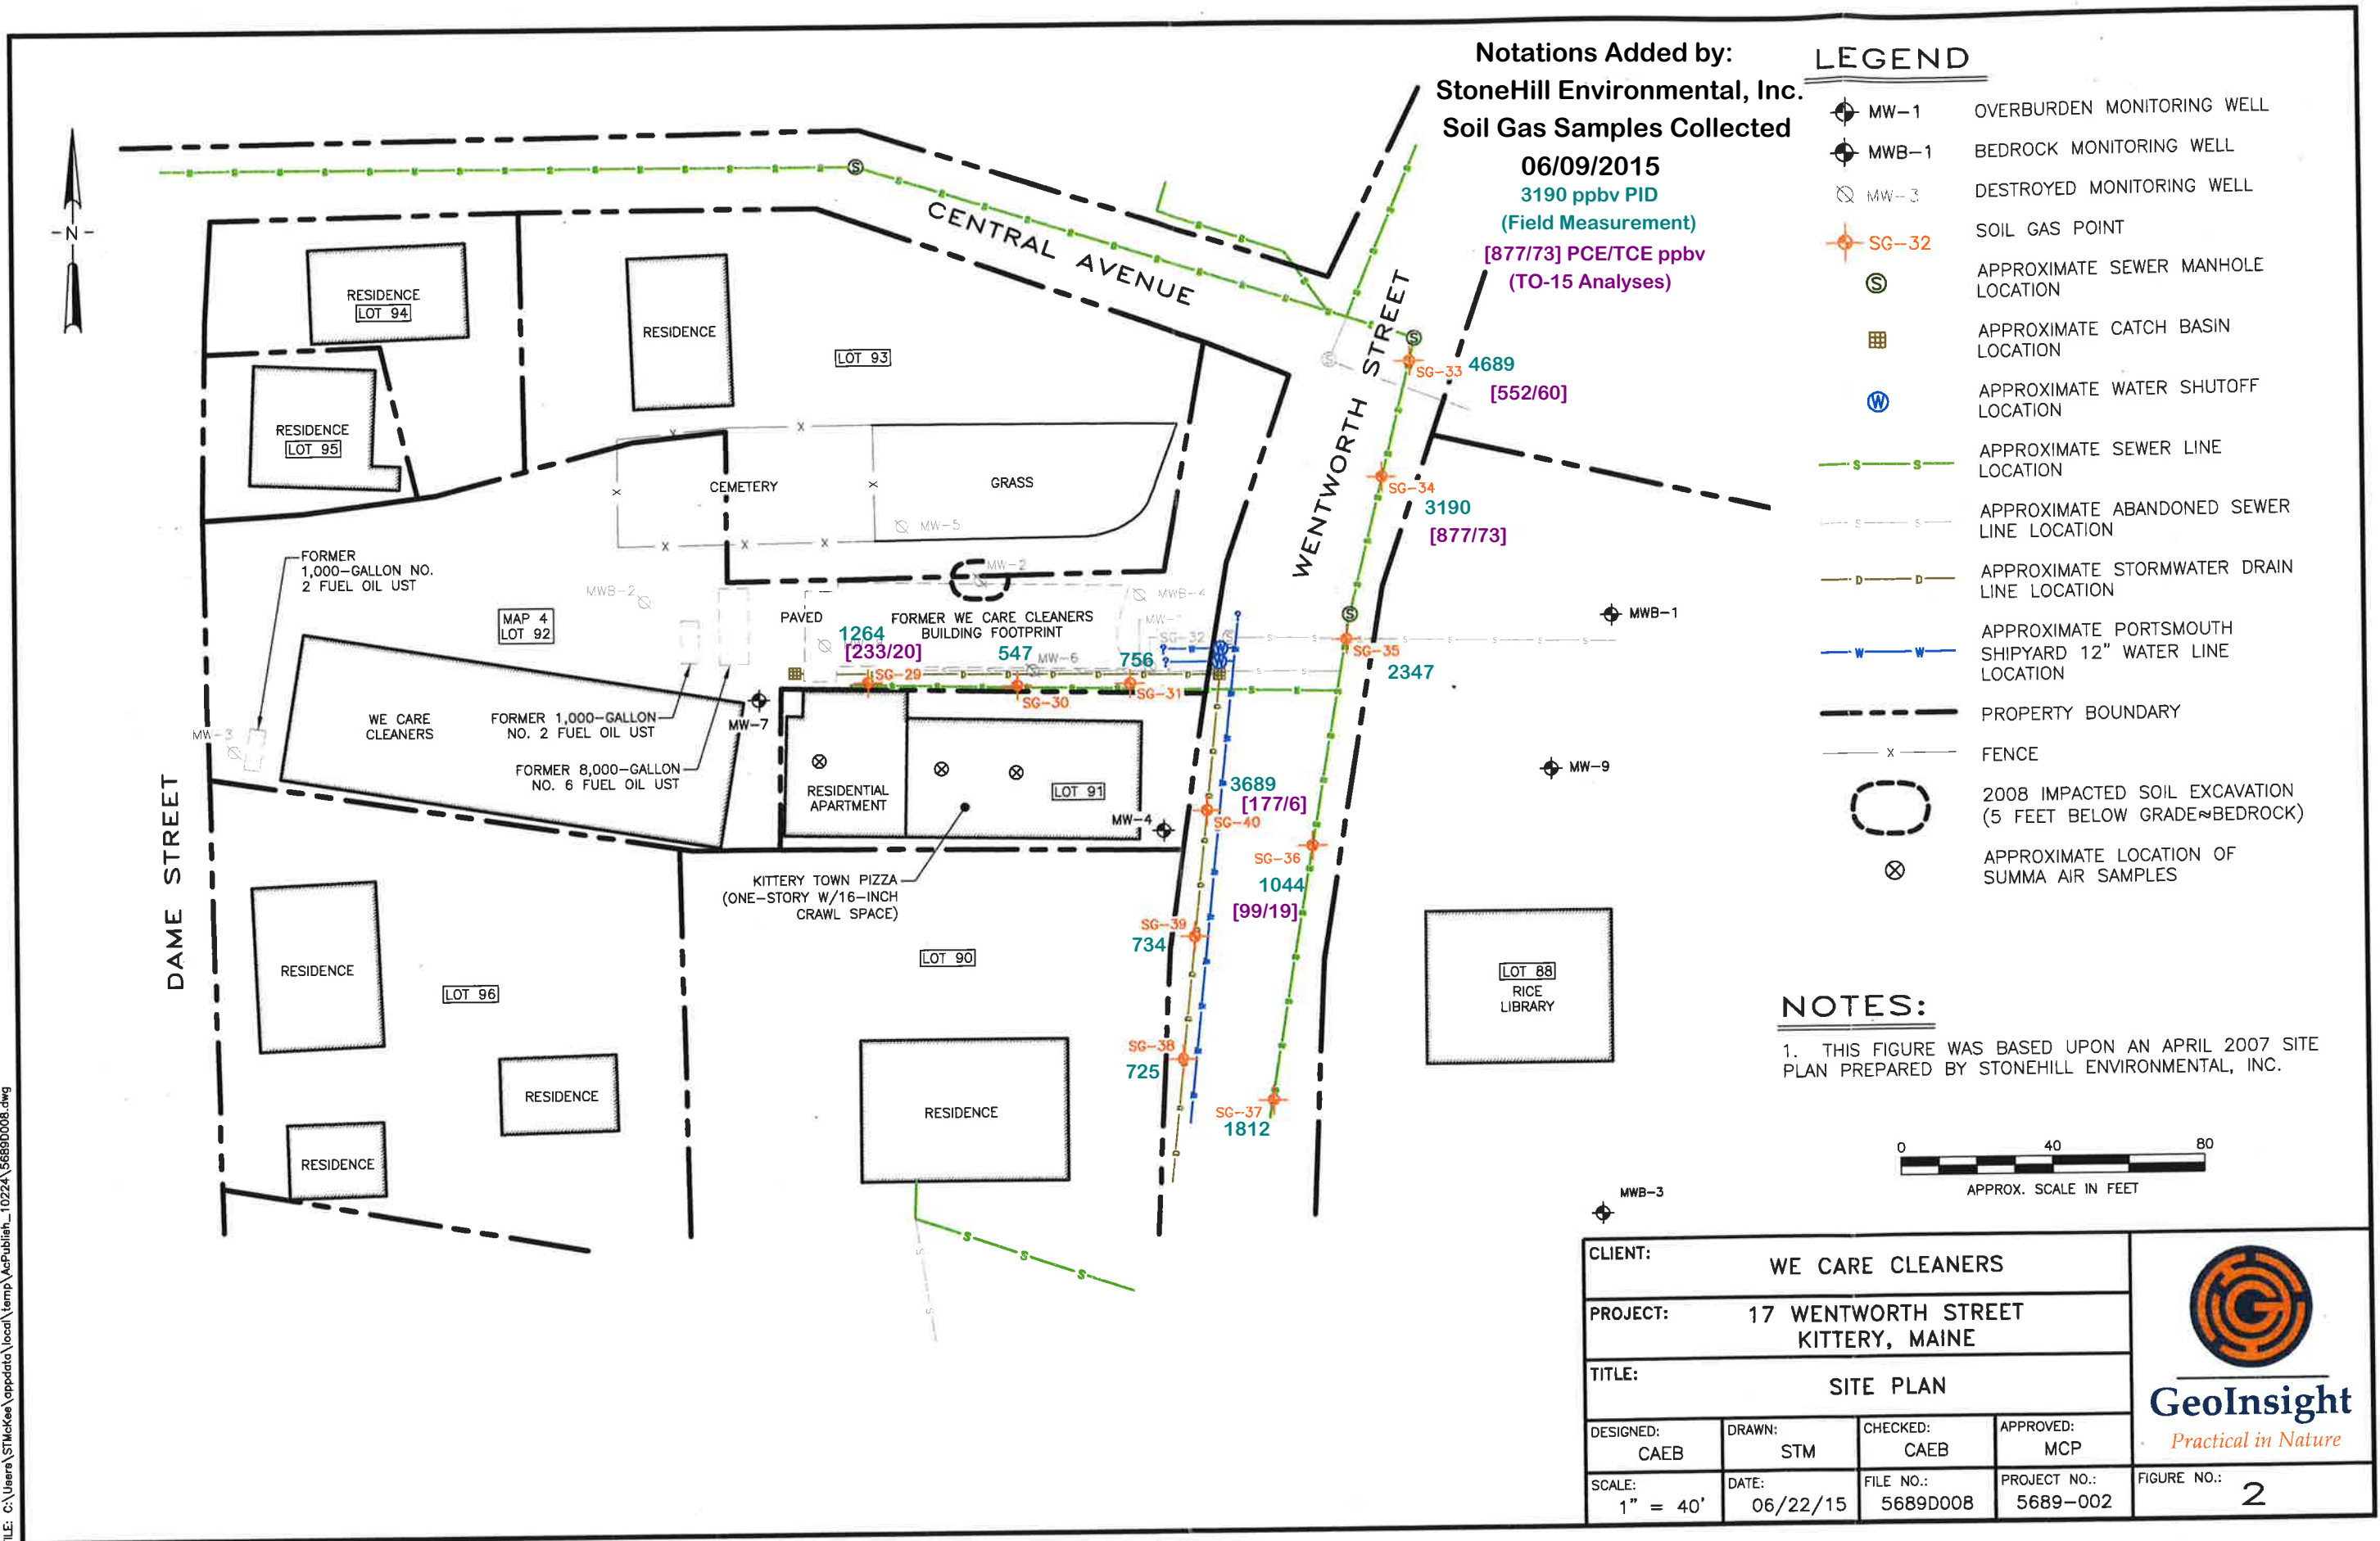
StoneHill Figure 4

Subsequently, GeoInsight of Manchester, NH was retained by We Care to assess whether the sewer and/or utility lines beneath the We Care property were acting as a preferential pathway for the PCE detected beneath Wentworth Street. In 2015 GeoInsight completed another soil gas survey confirming StoneHill's previous findings that the sewer line running along the north end of Kittery Town Pizza (along the southeastern property boundary of the We Care property) was facilitating the migration of PCE contaminated groundwater and soil gas into the utilities along Wentworth Avenue and possibly toward the newly constructed We Care Cleaners building on the western portion of the property (See attached Figure 4 – Copy of GeoInsight Figure 2, June 22, 2015). Given this finding, the MEDEP requested additional assessment into the extent of soil gas migration within the sewer lines beyond the We Care property to the west along Dame Street, to the east along Wentworth Street, and beneath Traip Avenue to the southeast.

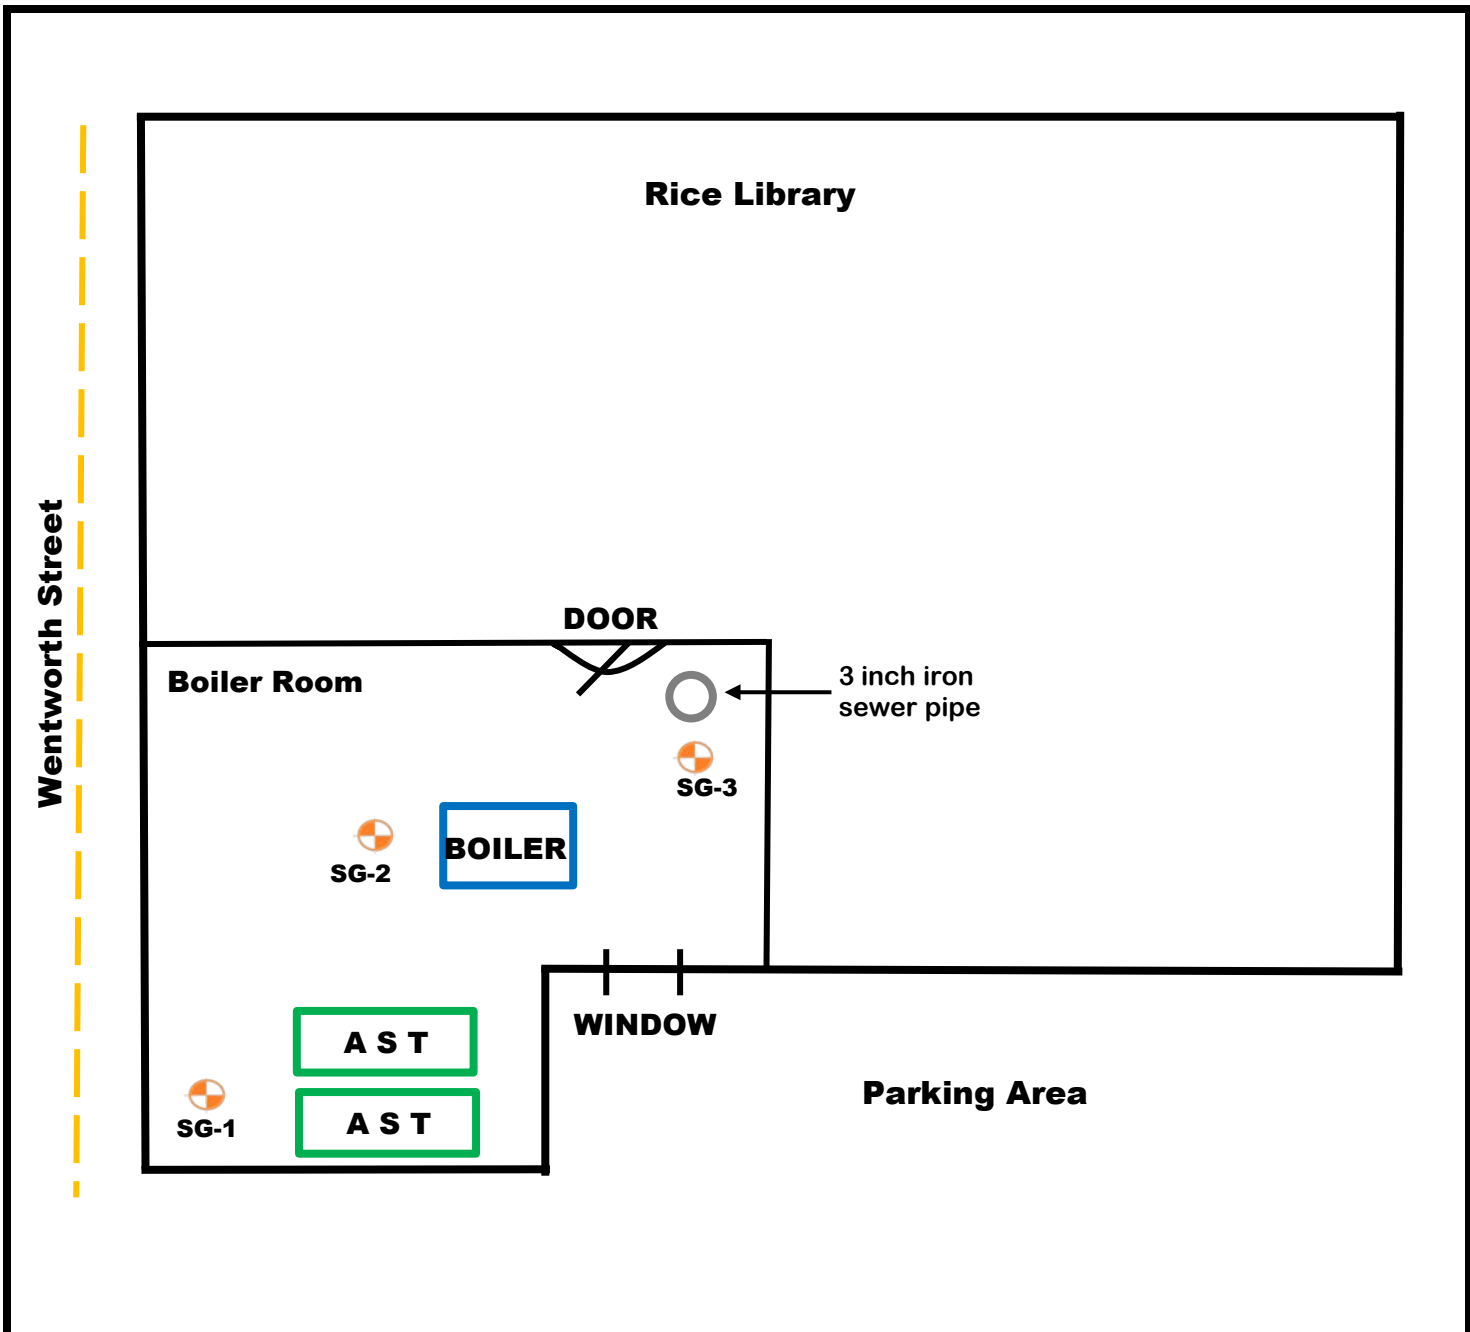
FIGURE 6

On January 11, 2017, StoneHill conducted a subslab investigation beneath the Rice Library and the residence at 4 Traip Avenue (Figure 5). To obtain soil gas from beneath the basement slab at the Rice Library, three ½-inch diameter holes were drilled through the concrete floor in the boiler room (Figure 6). One of the holes (SG-3) was advanced adjacent a 3-inch diameter iron sewer pipe coming up through the southeast corner of the boiler room floor, another in the middle of the room (SG-2), and the third in the western corner of the boiler room (SG-1), closest Wentworth Avenue. As with the soil gas probes completed along the sewer lines in the street, soil gas samples were collected via a stainless steel probe placed into the hole and sealed with clay at the floor surface. A ppbRAE3000 was used to draw and measure VOCs in soil gas drawn from these holes.

Soil gas samples SG-1 and SG-2 equilibrated between 0 ppbv and 416 ppbv, respectively. Soil gas sample S-3 peaked at 10,410 ppbv, slowly decreasing to approximately 6,800 ppbv after several minutes. Based on this result, a decision was made to return at a later date to repeat the soil gas PID sampling, measure CO₂ and O₂, and collect a summa canister sample from SG-3 for laboratory analysis.

On January 18, 2017, StoneHill returned to the Rice library to repeat the sub-slab soil gas sampling and measure the CO₂ and O₂ levels within SG-1, SG-2, and SG-3. After several

minutes of equilibration, the CO₂ measurements from each of the three soil gas holes were noted as being greater than 5,000, 980 and 1,880 ppm in SG-1, SG-2, and SG-3, respectively. Ambient CO₂ within the basement was 420 ppmv. The oxygen levels measured in the three soil gas holes were 20.9%, identical to ambient measurements within the boiler room. Upon equilibration of CO₂ levels, a soil gas measurement was collected from within each probe hole using the ppbRAE3000 PID. The soil gas results were 0 ppbv within both SG-1 and SG-2 and 1,176 ppbv within SG-3.

Based upon the soil gas results a Summa canister soil gas sample, drawn over a period of approximately 50 minutes, was collected from SG-3. The Summa canister laboratory data sheets are attached. In accordance with “Maine Remedial Action Guidelines (RAGs) for Sites Contaminated with Hazardous Substances,” Table 2 February 5, 2016, the soil gas analytical results were adjusted by an attenuation factor of 0.03 and compared with the RAGs. The adjusted results for tetrachloroethene, trichloroethene, and cis-1,2-dichloroethene were 5.61 ug/m³, 0.64 ug/m³, and 0.12 ug/m³, respectively. These are below the residential RAGs of 42 ug/m³, 2.1 ug/m³, and 63 ug/m³, respectively.

StoneHill recommends, as required by the MEDEP for consideration of liability relief via the Voluntary Response Action Program (VRAP), We Care complete a Site Investigation Report summarizing all site related data and events occurring since the prior 2008 StoneHill Site Investigation Report. In addition, based upon StoneHill's discussions with Troy Smith, the significance of the sub-slab contaminant concentrations measured in soil gas beneath the Rice Library requires either confirmation and/or mitigation. Two methods of confirmation include one year of seasonal sampling of the indoor air within the boiler room or high vacuum sub-slab sampling and analysis of soil gas across a wider area of the basement. In lieu of these confirmation options, a radon-type sub-slab depressurization system can be installed in the Rice Library furnace room to mitigate the potential migration of cVOCs into the building.

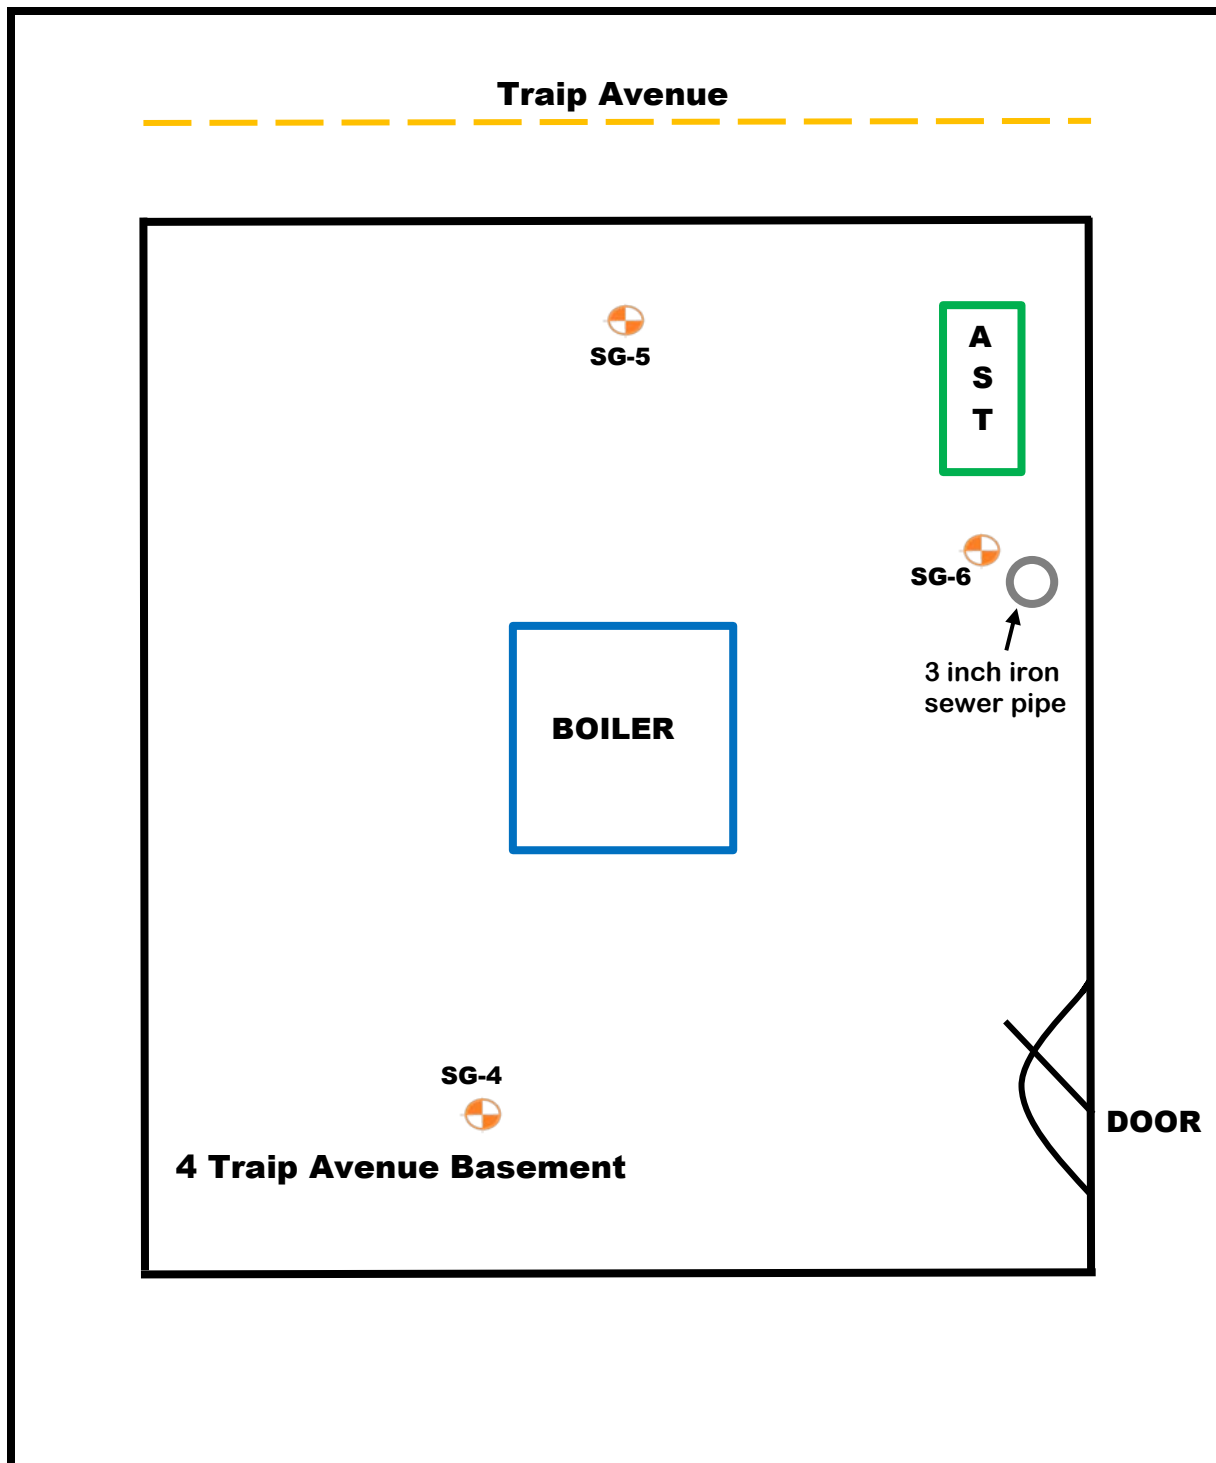
FIGURE 7

Also on January 11, 2017, StoneHill drilled three ½-inch diameter holes (SG-4, 5, and 6) into the basement cement floor at 4 Traip Avenue (Figure 7). One of the holes was advanced adjacent a 3-inch diameter iron sewer pipe coming up through the floor and the other two were advanced at either end of the basement. None of the PID measurements at the three locations were above 0 ppbv. A decision was made to return at a later date to confirm the results while measuring CO₂ and O₂ at each location. However, because the sub-slab soil gas PID field results were below the 500 ppbv action level, a summa canister sample would not be collected from beneath the basement.

Also on January 18, 2017, StoneHill returned to 4 Traip Avenue to confirm the sub-slab soil gas results from January 11, 2017 and to measure CO₂ and O₂ within SG-4, 5, and 6. The oxygen level in each was 20.9 percent, identical to the ambient oxygen level within the basement. The CO₂ results were 380, 1,280, and 3,020 ppm for SG-4, SG-5 and SG-6, respectively. The ambient CO₂ measured within the basement was 380 ppm. The ppbRAE results at each of the three holes were 0 ppbv.

Soil gas samples collected adjacent to the residence at 4 Traip Ave and beneath the residence basement floor revealed no indication of VOC contamination impacting the soil gas adjacent to or beneath the residence.
