Wood Island Feasibility Study

Part One: Study of Site History and Initial Site Assessment

Part Two: Site Assessment and Recommendations

Completed for the Town of Kittery, Maine in cooperation with the University of New Hampshire and Appledore Engineering, Inc.

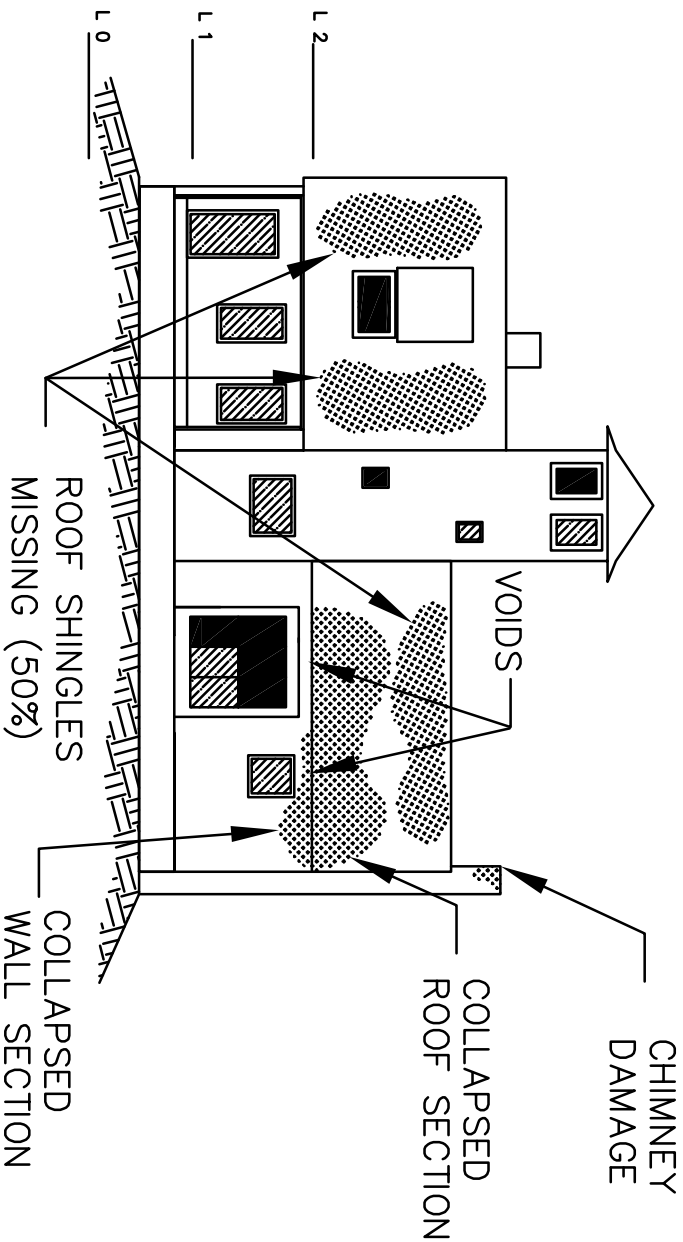
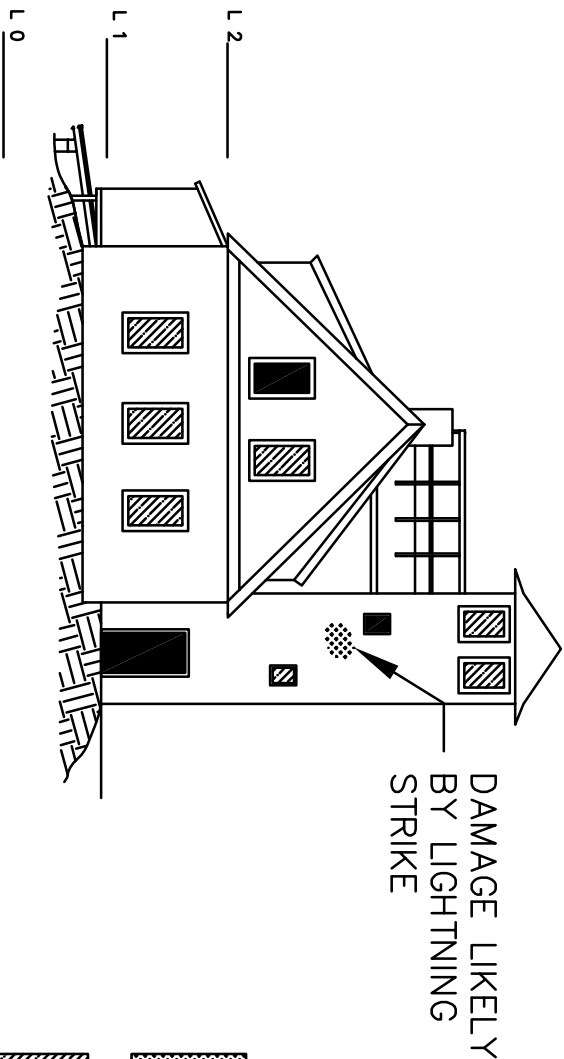
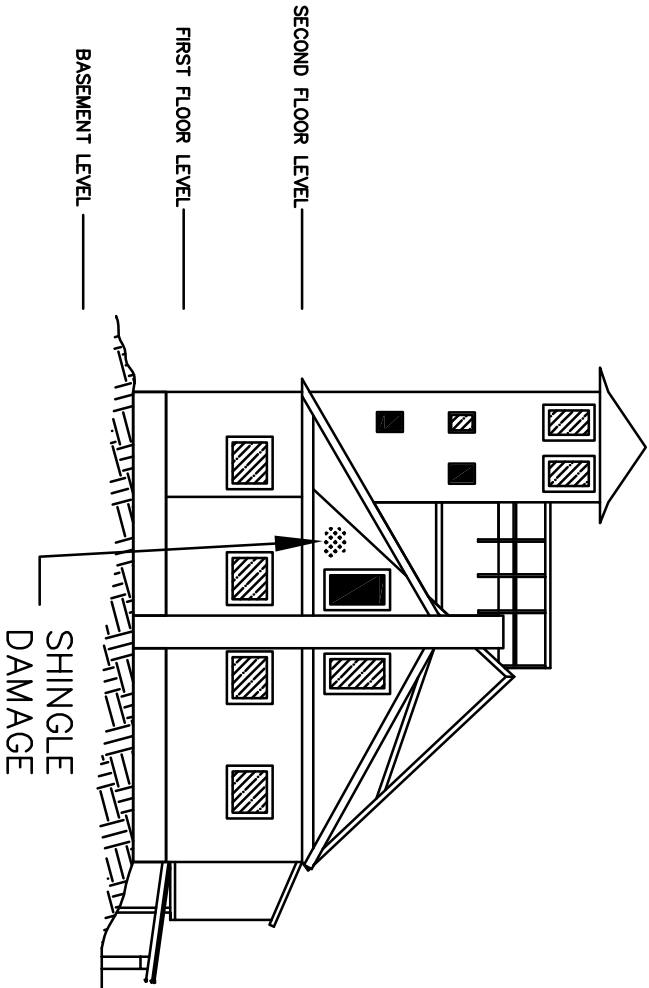
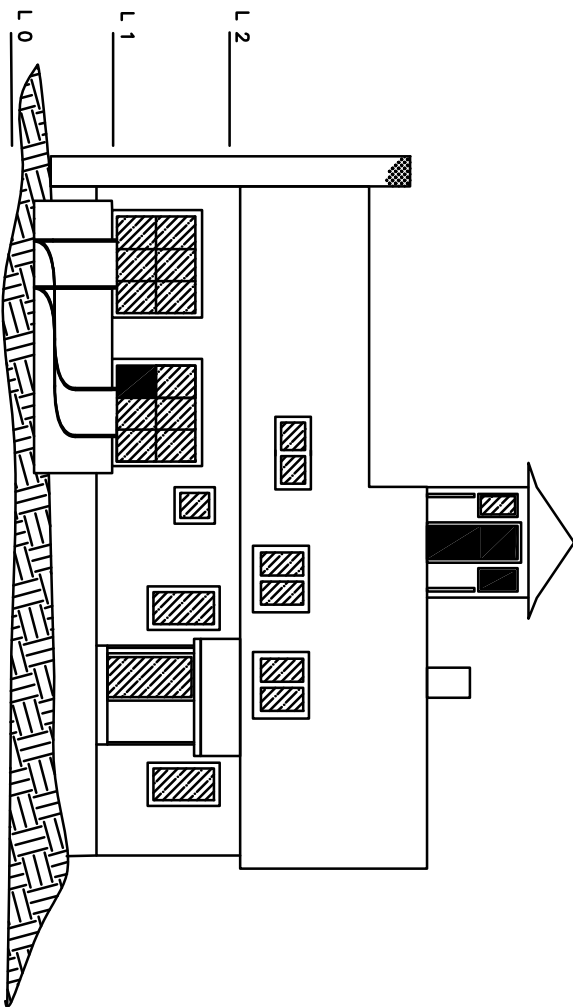
Generally the roof appears to be in good condition; however, a section over the boathouse has partially collapsed. The roof on the southern elevation has approximately fifty-percent of roofing shingles missing. This damage contributes to further deterioration of interior timber frame elements by rainwater.

The siding on the building has aged well and continues to protect the building. Siding shingles are missing in some small areas on the exterior walls.

No original windows remain in the building. Many of the window frames are unblocked and continue to allow seagulls to enter and inhabit the building. Some windows and exterior door frames remain blocked by previous attempts to seal the building. Evidence of damage and break-in attempts by vandals exists along the perimeter of the building.

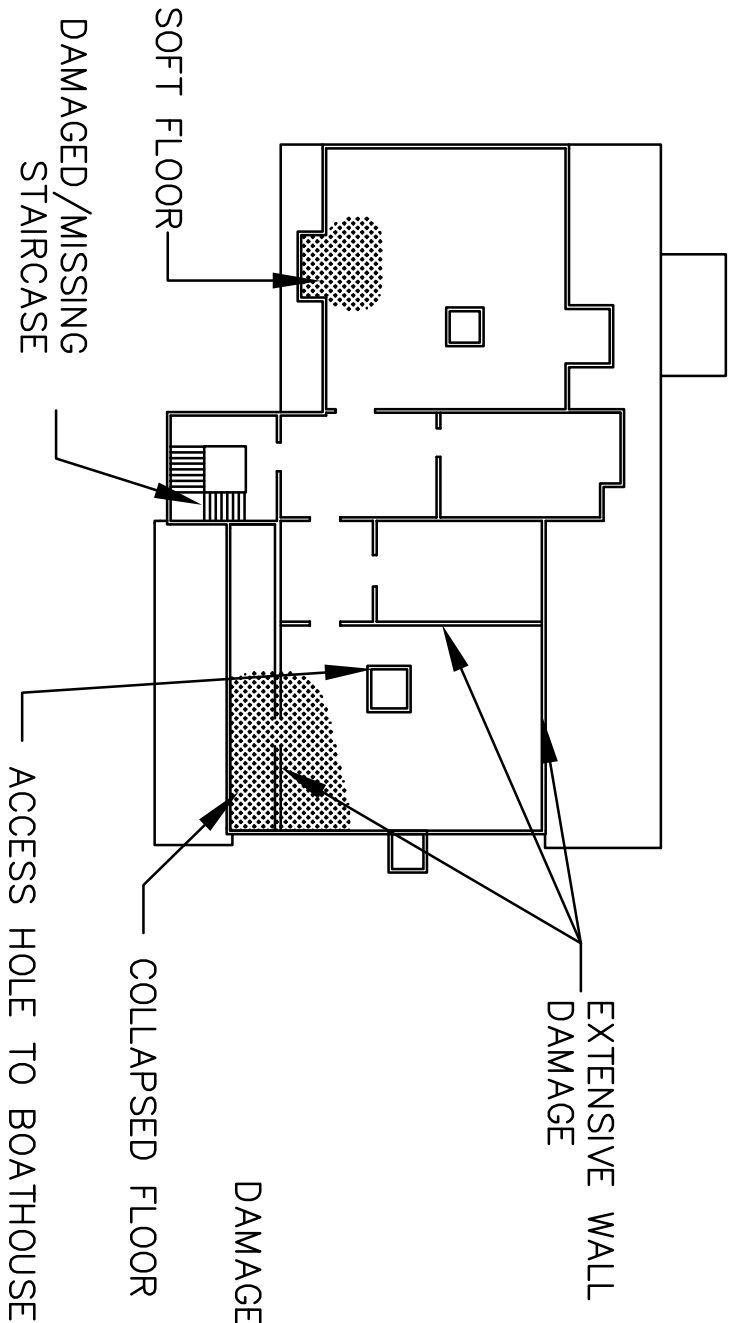
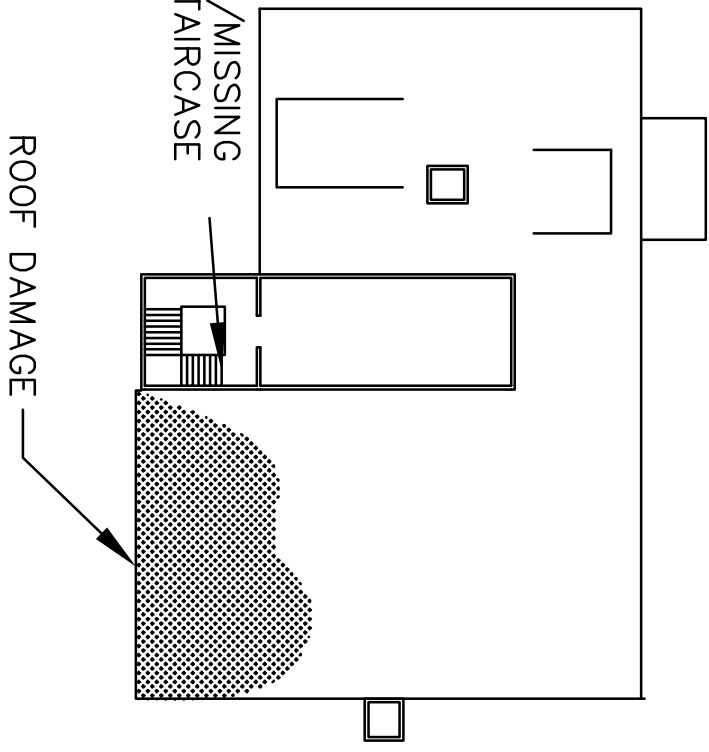
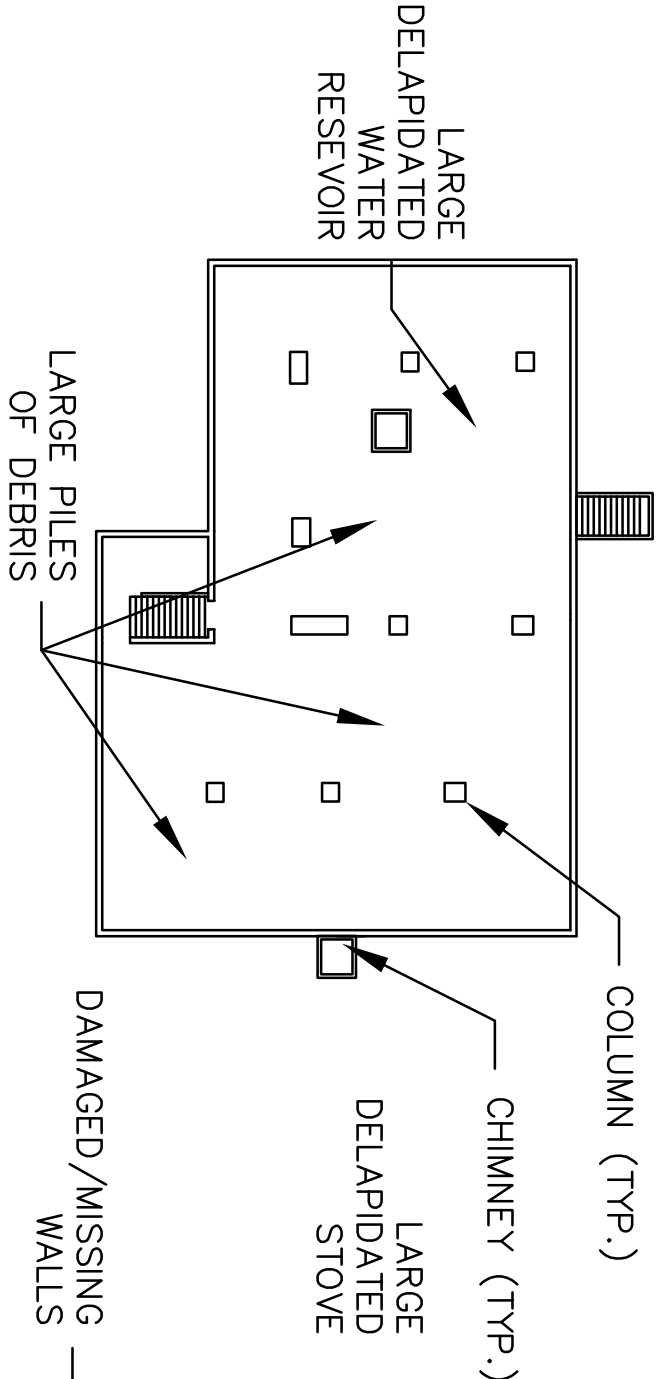
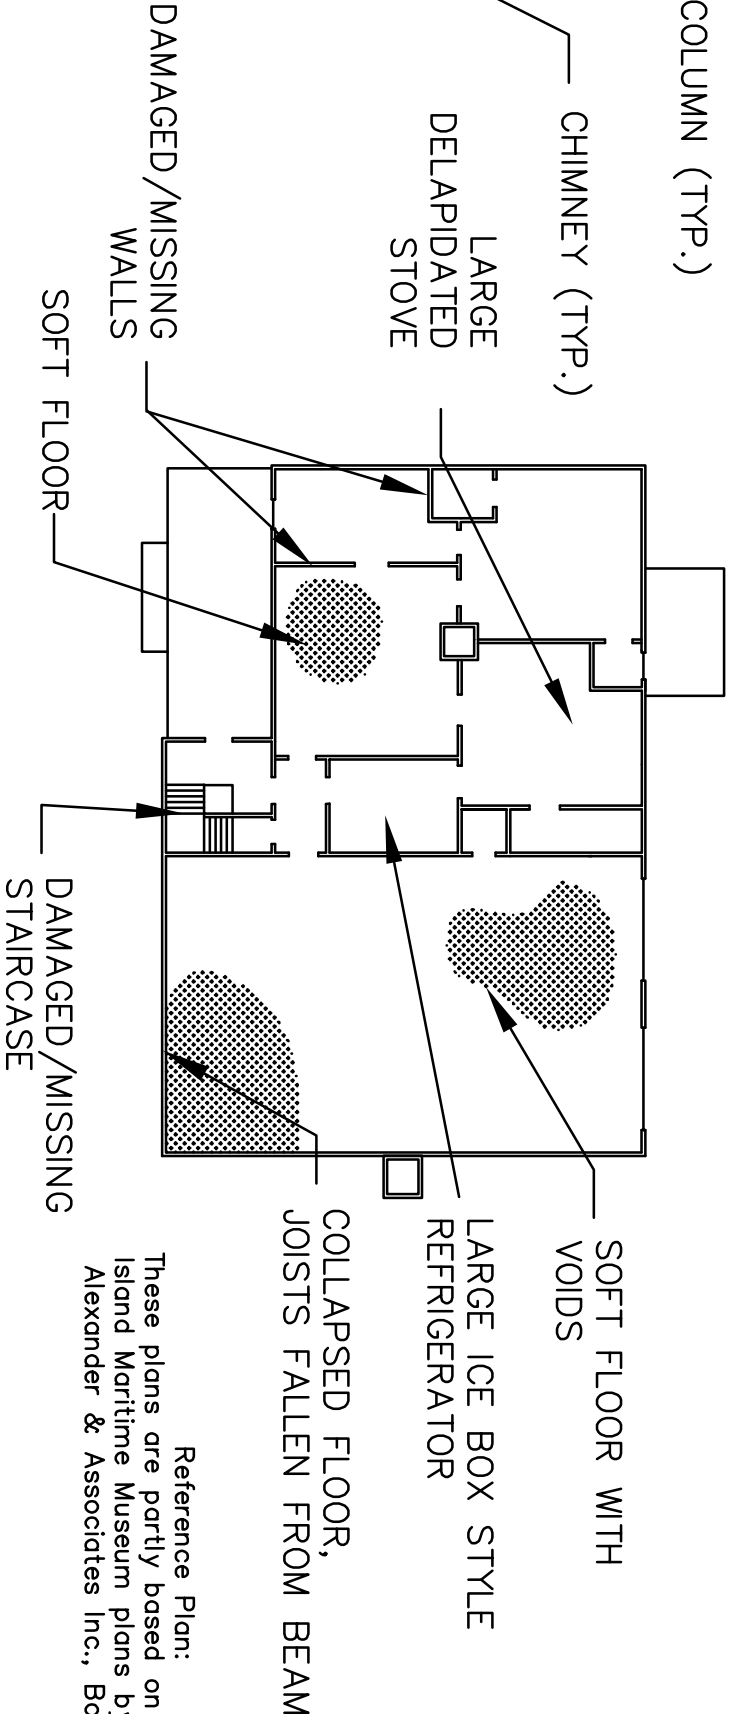
INITIAL ASSESSMENT: INTERIOR DAMAGE

- 1) Seagull droppings form large piles in all rooms in the building. Most piles are several inches deep.
- 2) No doors or original windows remain.
- 3) Asbestos insulation covers pipes in the basement.

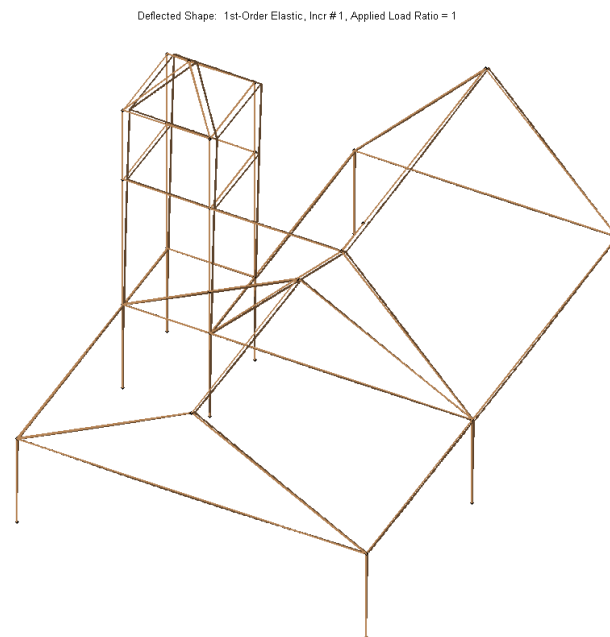
Figure 15: Deflections under Maximum Design Loading

According to the American Institute of Steel Construction Manual, $H/100$ is the maximum permissible interstory drift for a building of height H . Therefore the maximum allowable drift is 5.4 inches for the top of the tower. The maximum 8.1 inch deflection estimated by the matrix analysis exceeds this design criterion. If these deflections are in fact the case, they could result in fatigue stresses in the moment connections at each joint. Over time, loading cycles could result in cracking and damage to these connections. Minimizing interstory drift reduces the effects of fatigue. If these movements are undesired or if further analysis relieves unsafe fatigue, the structure could be braced.

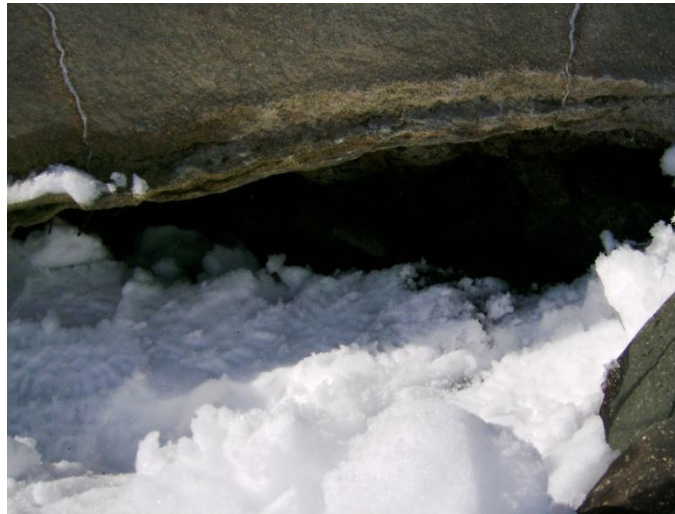
Figure 19: Undercutting of South Seawall

One of the initial observations made of the south seawall was the signs of undercutting by wave action.

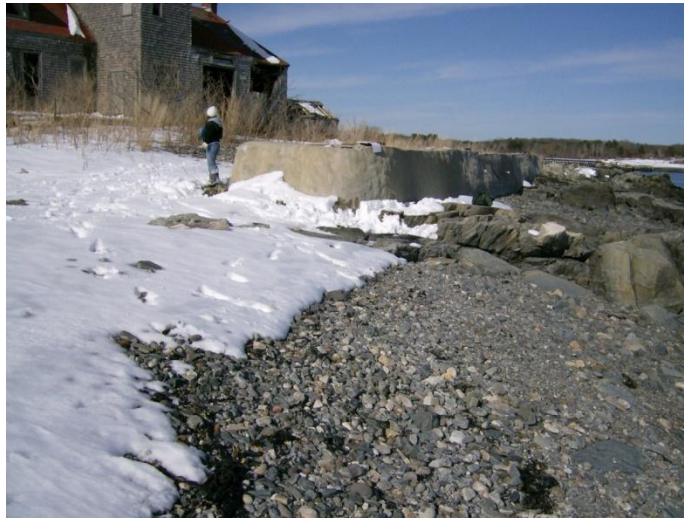
From collected tide data it suggested that high tide would not come within 5 feet of the toe of the existing structure. Upon the March 5, 2009 site visit, shortly after a recent snowfall, marks of the high tide could be seen in the melting of the snowfall. Seen in the figures below is that high tide does come into contact with the bottom of the wall and that this would warrant concern of continuing undercutting of the structure and weathering.

Figure 29: High Tide Marks on South Seawall (1)

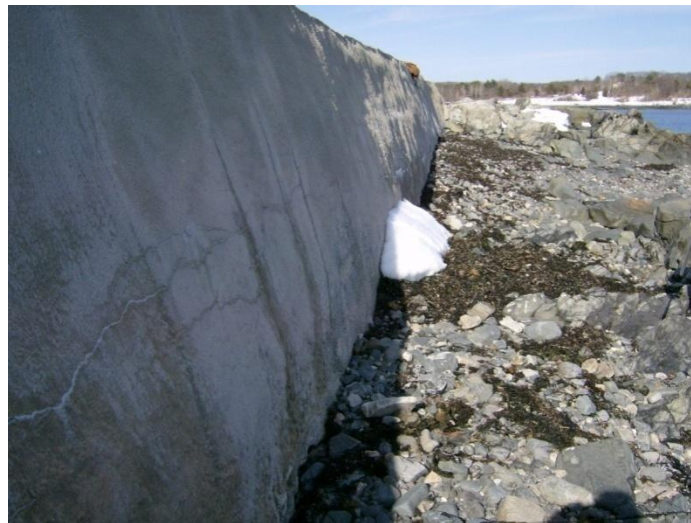
Figure 30: High Tide Marks on South Seawall (2)

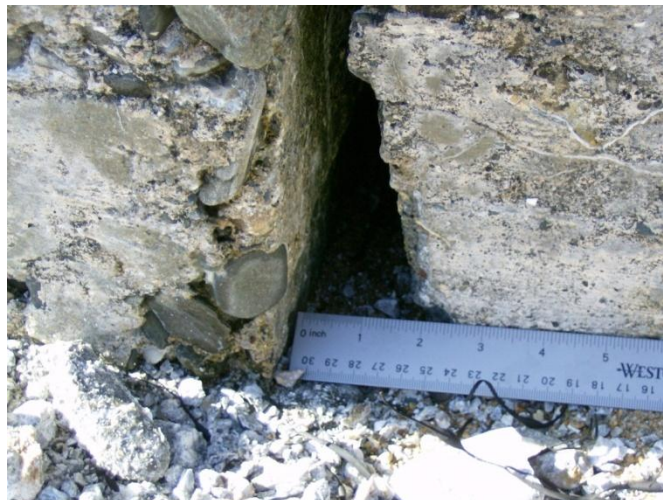
Figure 37: Horizontal Displacement and Overturning of North Seawall (2)

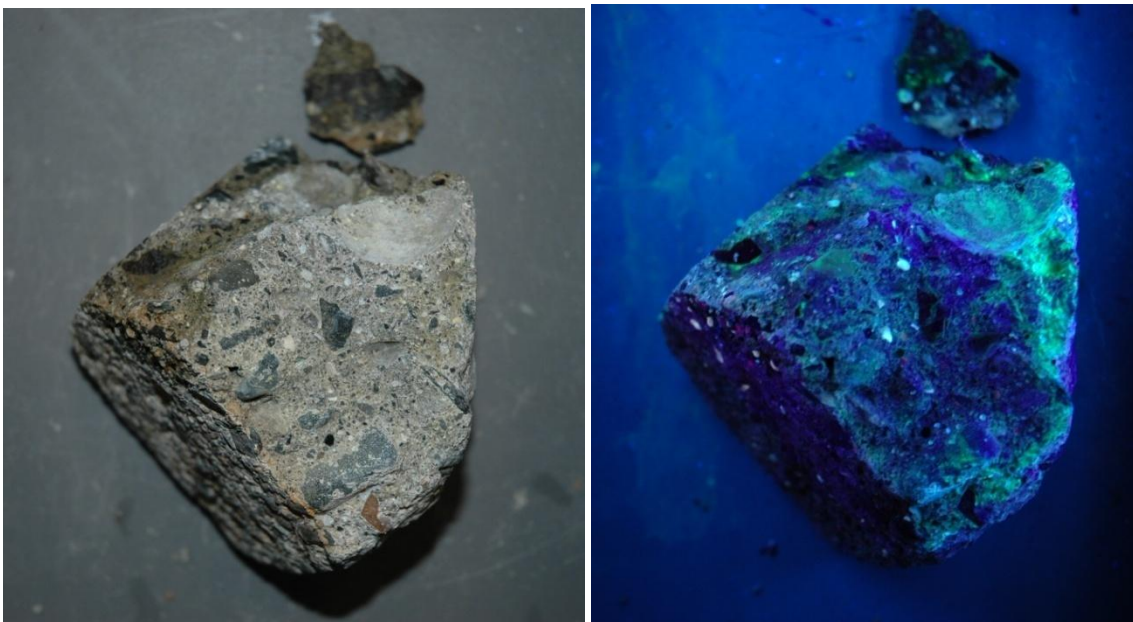
From observations, ASR was present in the sample, yet to a degree which seemingly was of minimal concern to the integrity of the structure. ASR was also observed in a cut and polished section of the sample and was seen as dark rings which surround some aggregate faces showing the damage due to portland cement expansion.

Figure 49: Sample Showing before and after with ASR Fluorescence under Black Lights

Since a sample was used, in considerably small volume compared to the entire structure, it is hard to correlate to the entire structure. More samples would be needed to determine the exact extent of the acceleration of ASR within the entire system, though observations suggest minimal threat.

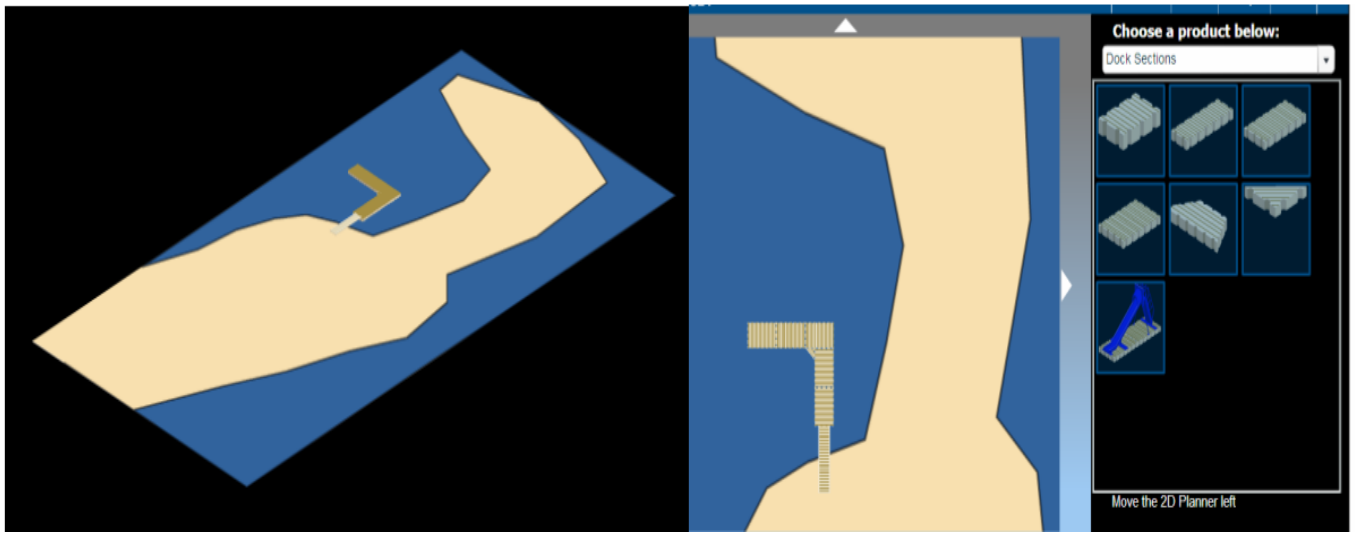
Figure 67: EzDock design

The EzDock design is flawed, it cannot withstand rough seas (greater the two foot waves) without breaking. Therefore this product cannot be considered as a solution.
