I. Description of Site

A. Wood Island

1. Wood Island Station

Conditions Assessment

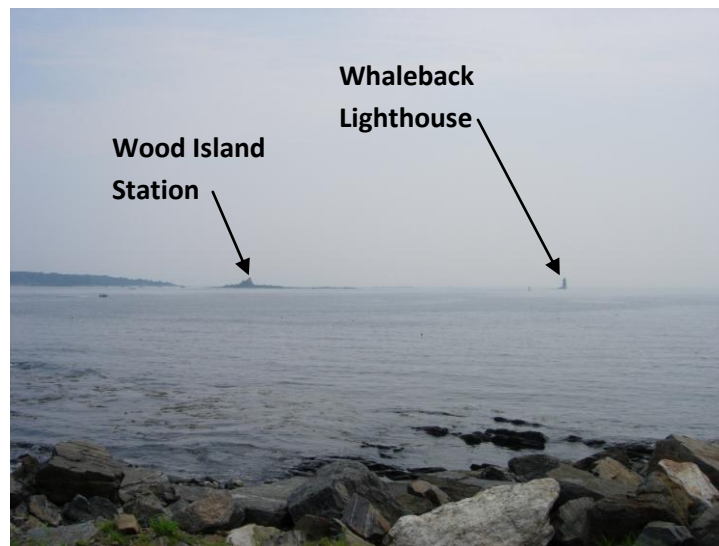
Figure 5 View of Whaleback Lighthouse (right) and Wood Island Station (left) from Newcastle Commons, NH

Wood Island Station lies 1,500 feet from Whaleback Light and complements an iconic seascape depicting the maritime history of Maine and New Hampshire. Although the building has deteriorated significantly, from a distance it portrays an enduring symbol of its former duty to the Piscataqua River region.

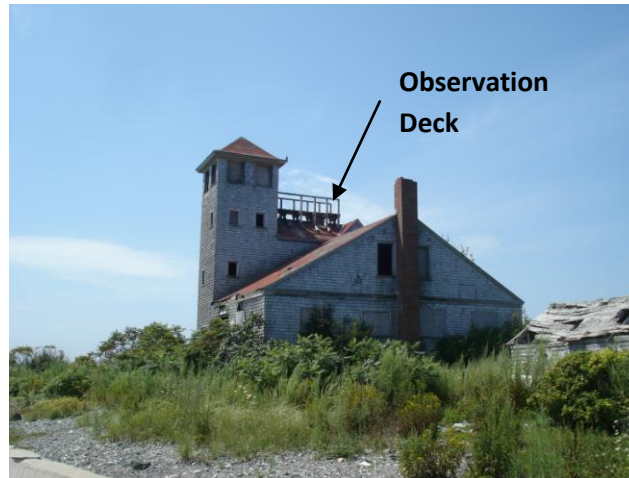
Figure 7 Wood Island Station

The observation deck on the fourth level was not closely inspected due to lack of access. The deck appears in good condition. The deck is not believed to be part of the original 1907 structure; it was probably constructed during the 1940s by the U.S. Navy.

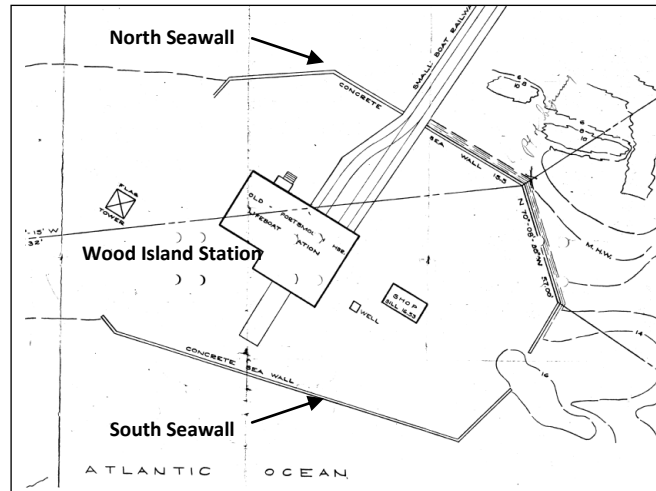
Figure 17 Seawall (Taken from a topographic map dated 1955)

The south wall measures approximately two hundred and fifteen feet in length. It stands six feet tall at the highest point. The front seawall has been damaged repeatedly by tidal surge and wave action. A town document reported that in 1993, a one hundred foot by two foot by six foot section of the wall was repaired by Shotcrete Systems International, Inc. at the cost of approximately \$40,000.00 using FEMA Federal and State disaster assistance. The photos in Figures 24 and 25 are of the front concrete wall that was repaired by Shotcrete Systems. The contractor installed a steel wire mesh over the damaged wall and shot pressurized concrete over the mesh.

The wall north of the building is approximately two hundred and fifty feet long with sections of wall over eight feet tall. By visual inspection, the wall has not been modified or repaired since it was originally constructed. The wall is un-reinforced concrete with small and large stone aggregate. The wall was presumably built of natural materials found on the premises. Large iron pins are located in the rock face near the base of the wall. Duncan Mellor, P.E. suggests the pins may provide a shear brace to prevent the wall from sliding toward the water.

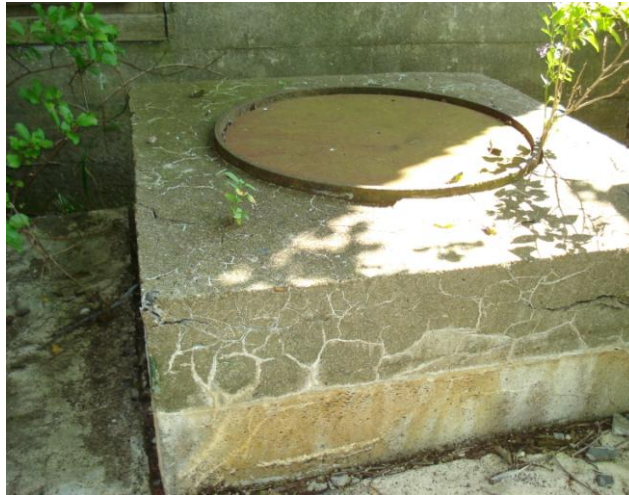
Figure 25 Manhole

A manhole structure was found to the north of the station building. The interior was not inspected.

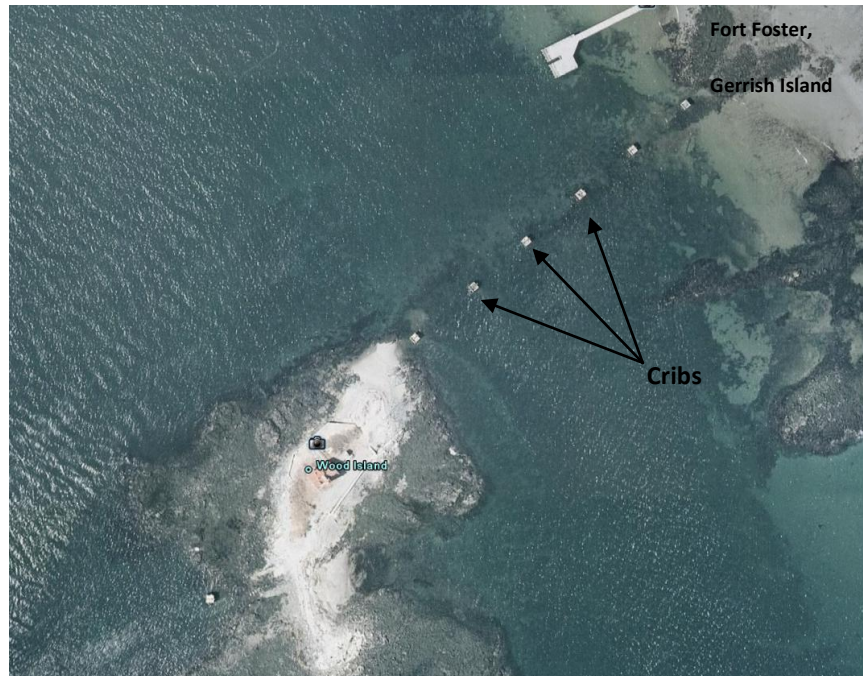
Five of the seven cribs appear to be stable. Two of the cribs appear to have collapsed. The structural integrity of each crib may be comprised by wood degradation by marine-borers. A full dive inspection would be required to determine the extent of possible degradation.

Figure 28 Cribs near Wood Island (Courtesy of Google Earth)
