April 2009

## **II. Seawall Assessment**

Katherine Andruchuk, Seth Lizotte

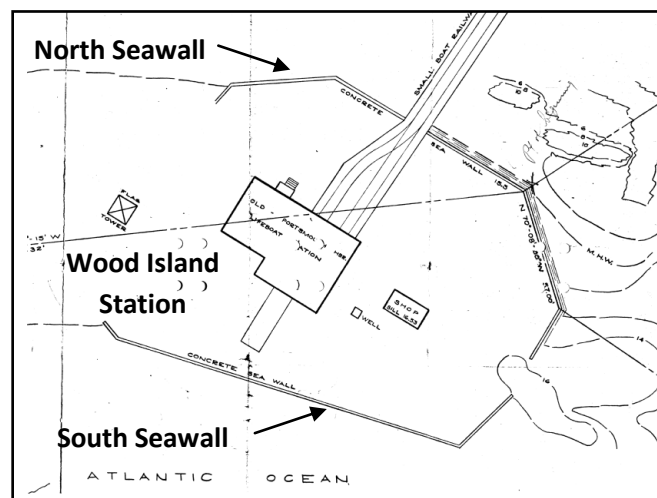
**Figure 18 Seawall (Taken from a topographic map dated 1955)**

The Wood Island Life Saving Station is protected by two concrete seawalls located on the north and south faces of the building. Over the past century the seawalls have been damaged repeatedly by tidal surge and wave action. The damage done to the seawalls has made it less of a protective barrier for the building and more of a potential hazard for those who visit the island. If the seawalls continue to be left alone, it's only a matter of time until full deterioration occurs. The south face seawall has previously been repaired by Shotcrete Systems International, Inc. as a temporary fix but continues to deteriorate. This report is meant to outline some of the feasible options to remediate these problems.

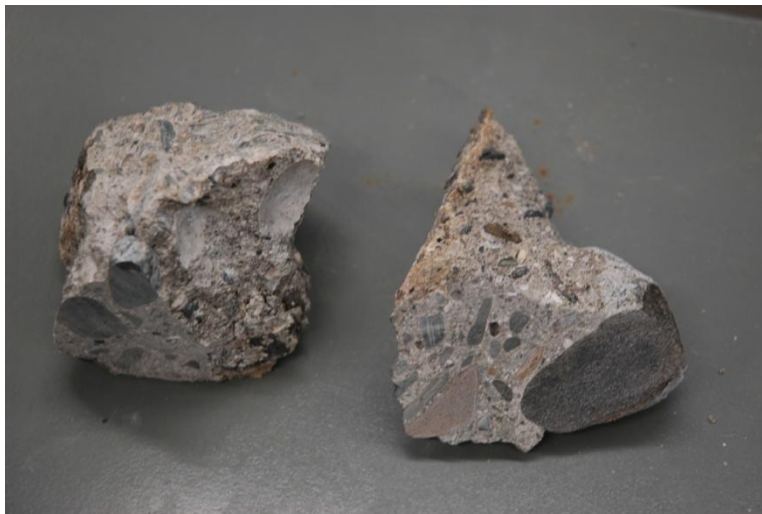
**Figure 47: Core Sample after Fracture**

From observations, ASR was present in the sample, yet to a degree which seemingly was of minimal concern to the integrity of the structure. ASR was also observed in a cut and polished section of the sample and was seen as dark rings which surround some aggregate faces showing the damage due to portland cement expansion.
