# Wood Island Feasibility Study

## Part Two: Site Assessment and Recommendations

**April 2009**

Completed for the Town of Kittery, Maine in cooperation with the University of New Hampshire and  
Appledore Engineering, Inc.

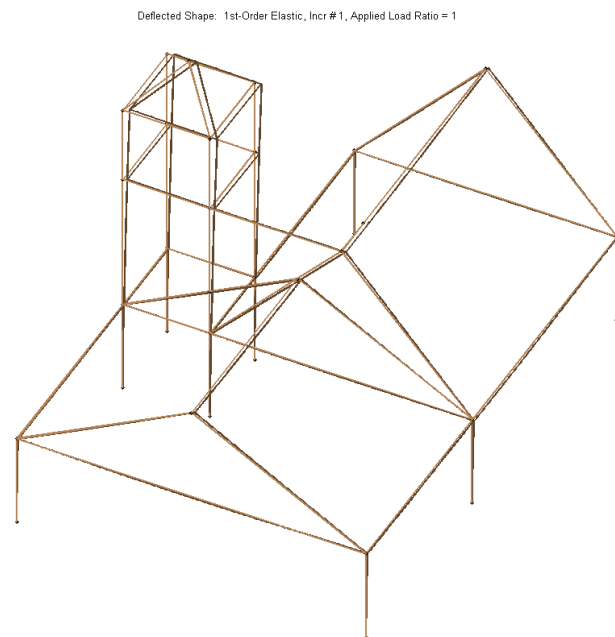
**Figure 15: Deflections under Maximum Design Loading**

According to the American Institute of Steel Construction Manual,  $H/100$  is the maximum permissible interstory drift for a building of height  $H$ . Therefore the maximum allowable drift is 5.4 inches for the top of the tower. The maximum 8.1 inch deflection estimated by the matrix analysis exceeds this design criterion. If these deflections are in fact the case, they could result in fatigue stresses in the moment connections at each joint. Over time, loading cycles could result in cracking and damage to these connections. Minimizing interstory drift reduces the effects of fatigue. If these movements are undesired or if further analysis relieves unsafe fatigue, the structure could be braced.
