WOOD ISLAND LIFE SAFETY STATION WOOD ISLAND – KITTERY POINT, MAINE STRUCTURAL OBSERVATIONS

Town of Kittery, Maine
200 Rogers Road Ext.
Kittery, Maine 03904
Attn.: Jonathan Carter, Town Manager

December 6, 2010
Project No.: C129-10

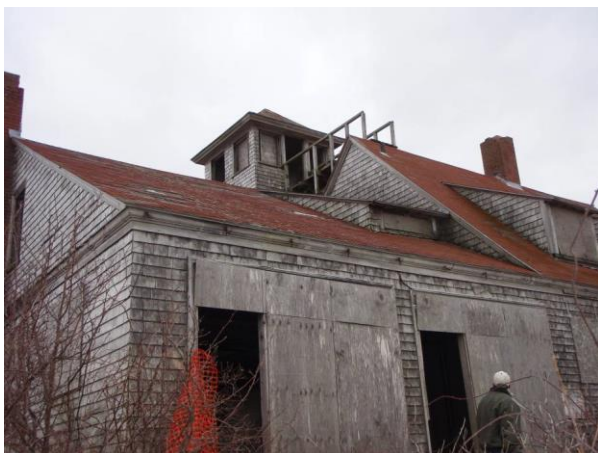
NORTH SIDE OF LIFE BOAT AREA

First floor sill members have deteriorated in several locations. The northern portion of the boat storage area contains some deteriorated sill members, floor joists and laid-up board flooring. Timber column and beam members supporting the second level floor, which are visible within this area, appear to be in good condition. Flooring and support members located in the kitchen and living area in the westerly portion of the first floor appear to be in fair to good condition. A majority of the area is covered with seabird guano and remnants of the original lath-plaster applied to the ceiling and walls. Water intrusion appears to be minimal. A few of the original window and door openings are open to the weather.

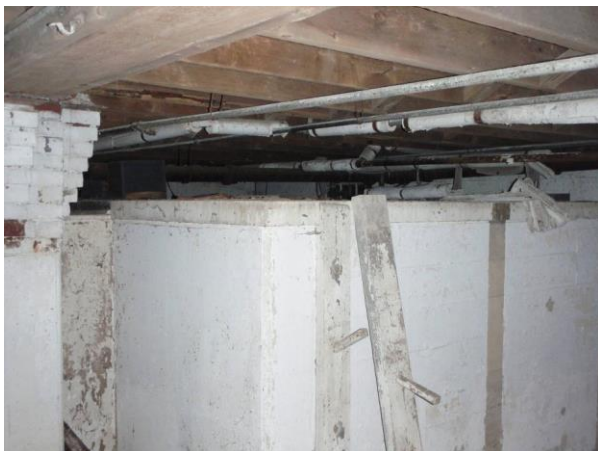
BASEMENT AREA – CISTERN

The concrete basement walls appear to be cracked in several locations, although no wall sections appear to have separated from adjacent sections. The basement contains a large concrete cistern, located in the northwest corner and a hot water boiler and tanks, located in the easterly portion; heat and water supply pipes have been lagged with asbestos.

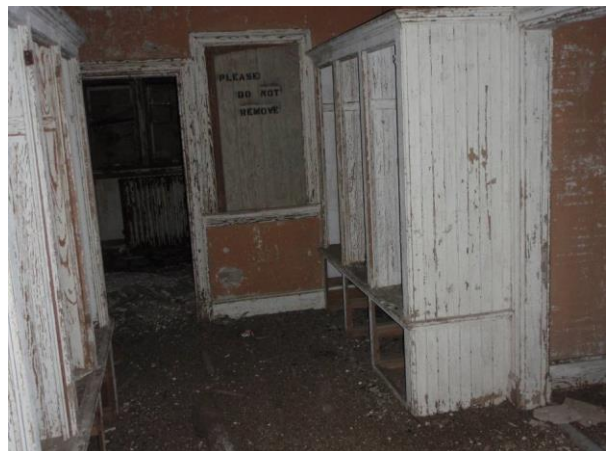
SECOND FLOOR LOCKER AREA

Second level floor joists and flooring are in fair condition, the westerly portion of the building is in better condition than the east sleeping quarters. Access to the cupola/lookout is limited, although portions of the stair stringers are in-place, the treads and risers have been removed; we were only able to access the first level landing of the lookout; access to the top level was not possible.
