Wood Island Feasibility Study

Part One: Study of Site History and Initial Site Assessment

Part Two: Site Assessment and Recommendations

University of New Hampshire, Department of Civil Engineering

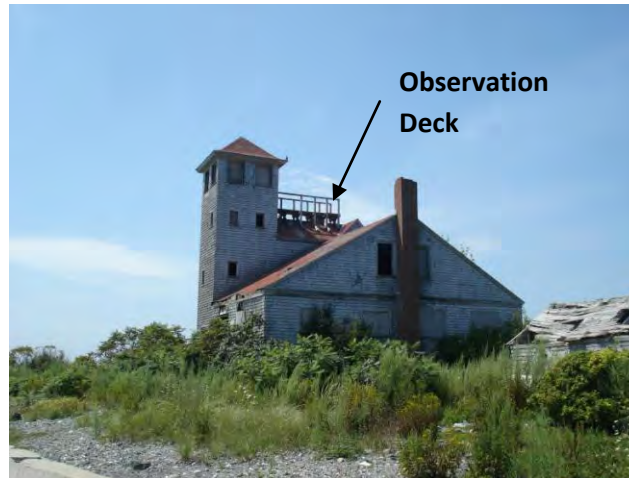
Figure 7 Wood Island Station

Generally the roof appears to be in good condition; however, a section over the boathouse has partially collapsed. The roof on the southern elevation has approximately fifty-percent of roofing shingles missing. This damage contributes to further deterioration of interior timber frame elements by rainwater.

The siding on the building has aged well and continues to protect the building. Siding shingles are missing in some small areas on the exterior walls.

No original windows remain in the building. Many of the window frames are unblocked and continue to allow seagulls to enter and inhabit the building. Some windows and exterior door frames remain blocked by previous attempts to seal the building. Evidence of damage and break-in attempts by vandals exists along the perimeter of the building.

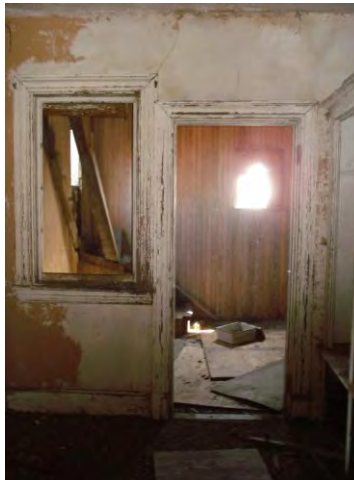
The paint used on the interior walls and moldings appears to be lead based due to its flaky appearance and the time period the building was constructed and maintained.

Figure 13 Stairs and peeling paint

The stairs throughout the interior are damaged or missing. On many levels, make-shift boards with footings were installed previously. The stairs to the basement from the first floor and from the outside are in good condition.

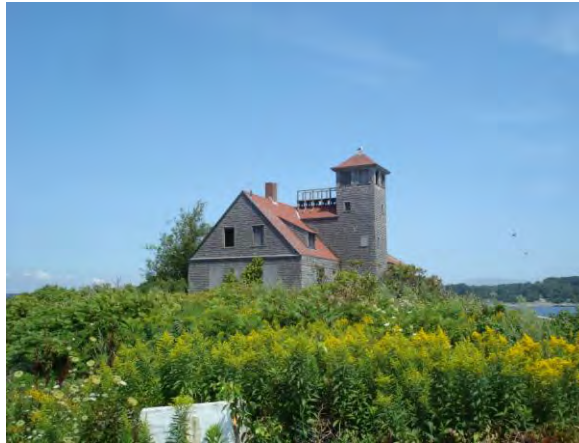
As seen in Figure 33, any existing pathways on the Island are completely overgrown.

Figure 23 Overgrowth

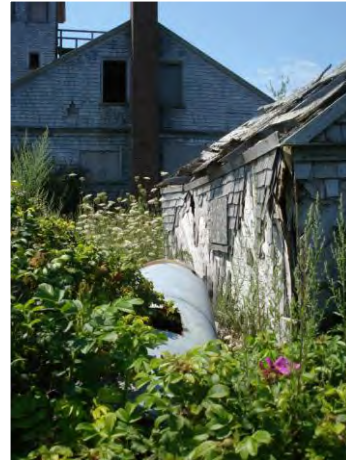
A total of three tanks were found outside near the station and tool house building. A large reservoir (assumed to be for drinking water) was found inside the basement of the station building.

Figure 24 Abandoned tanks

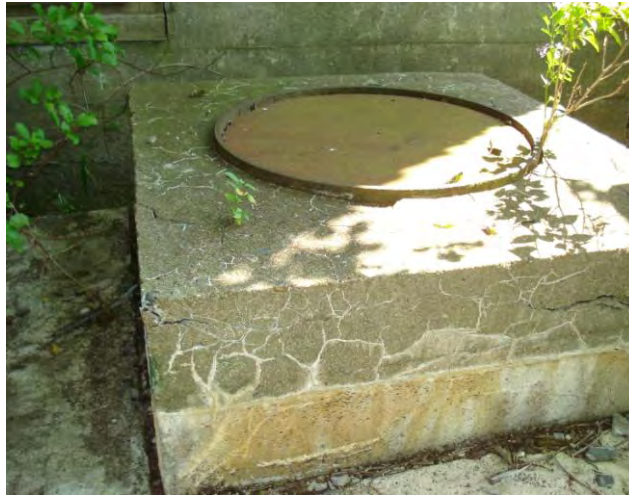
A manhole structure was found to the north of the station building. The interior was not inspected.

Figure 25 Manhole

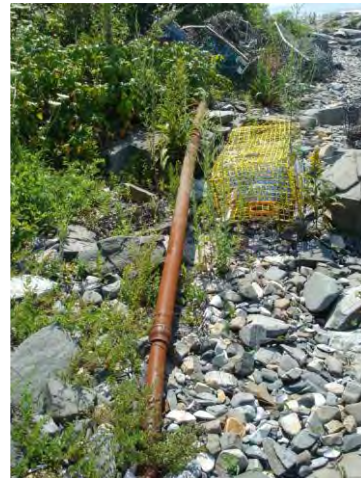
Many large diameter pipes lay scattered on the island. They appear to be damaged and corroded through. There are also several dozen abandoned lobster traps scattered across the island as seen in Figure 38.

Figure 26 Piping

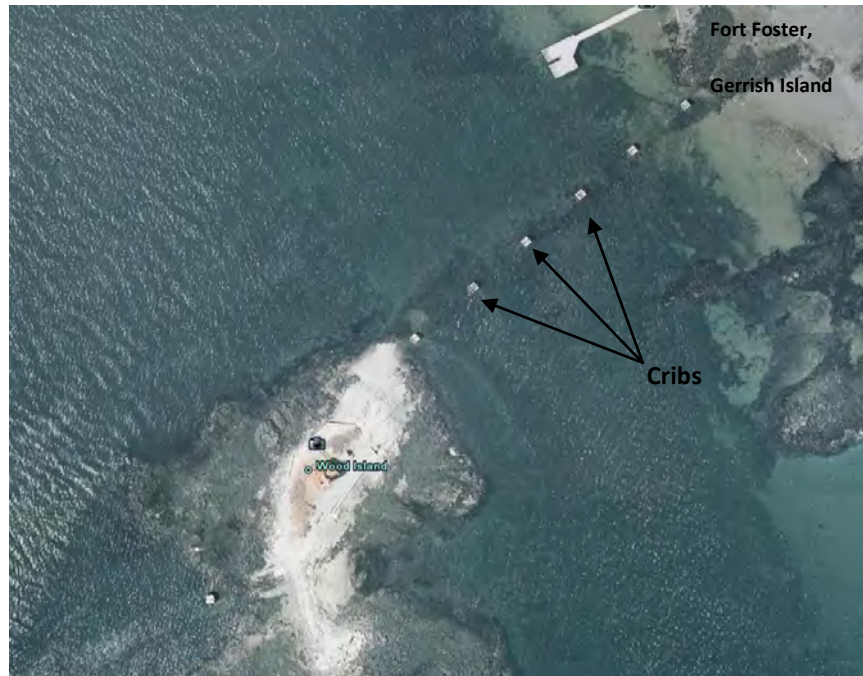
Five of the seven cribs appear to be stable. Two of the cribs appear to have collapsed. The structural integrity of each crib may be comprised by wood degradation by marine-borers. A full dive inspection would be required to determine the extent of possible degradation.

Figure 28 Cribs near Wood Island (Courtesy of Google Earth)

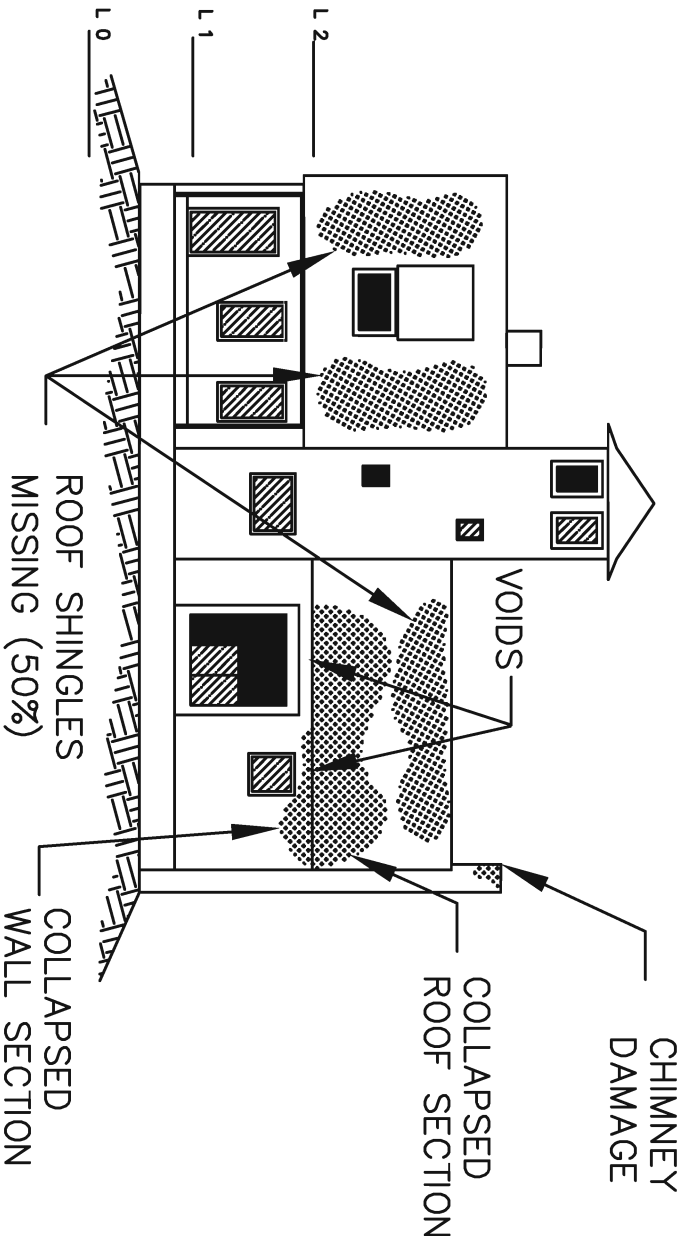
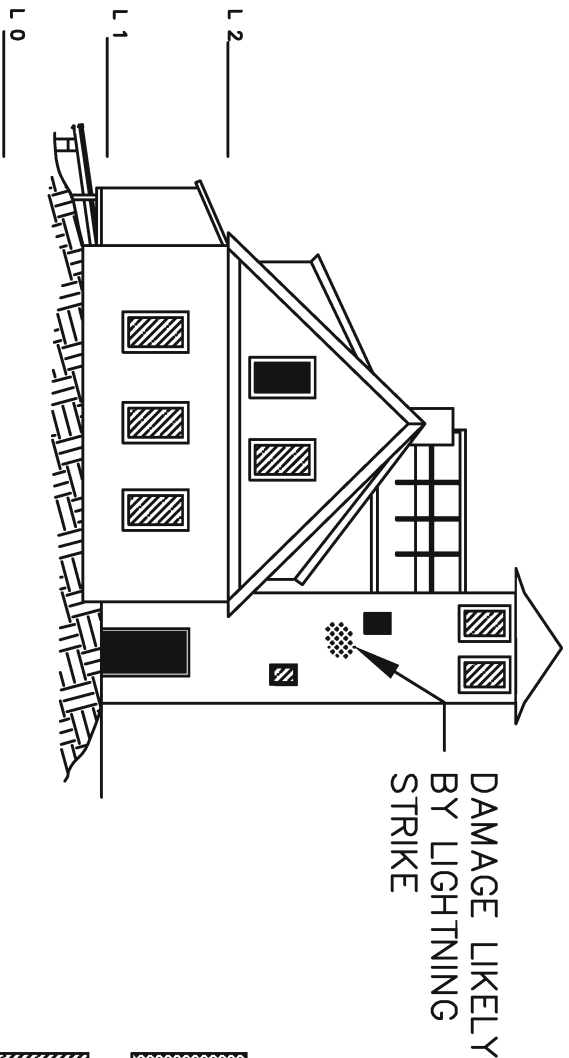
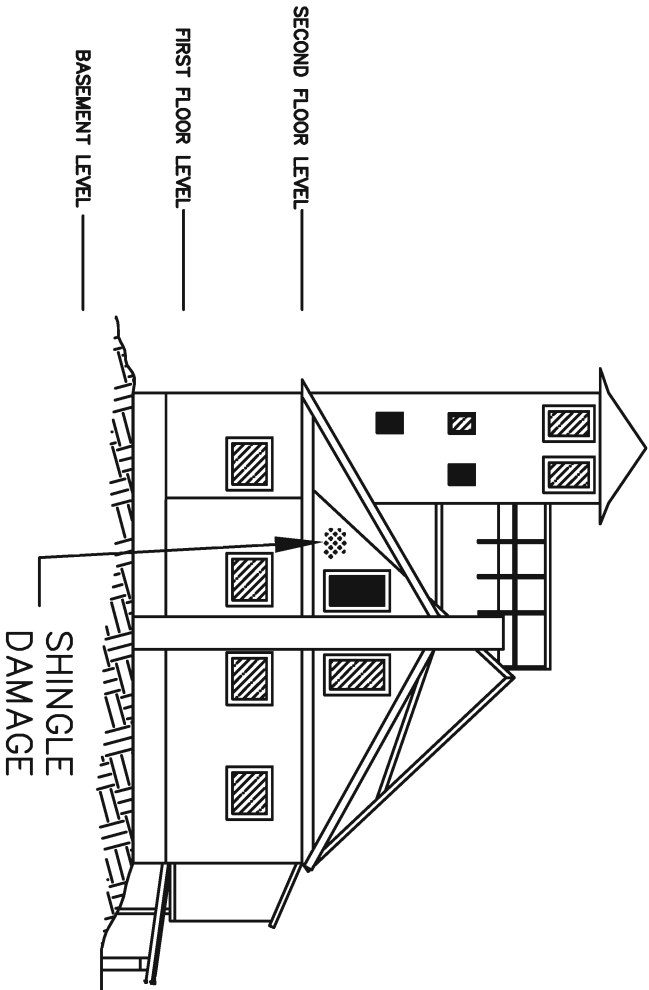
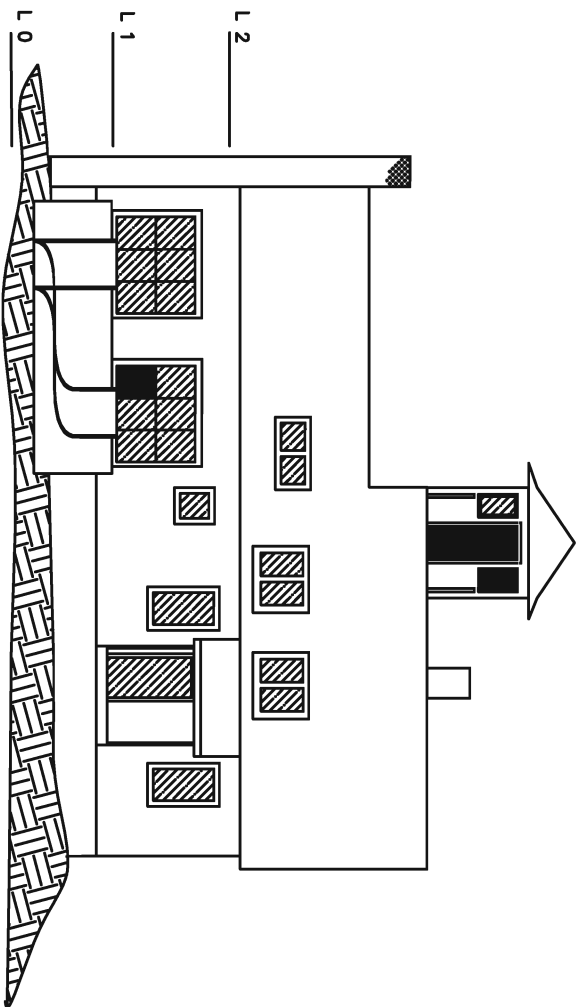
EXTERIOR DAMAGE

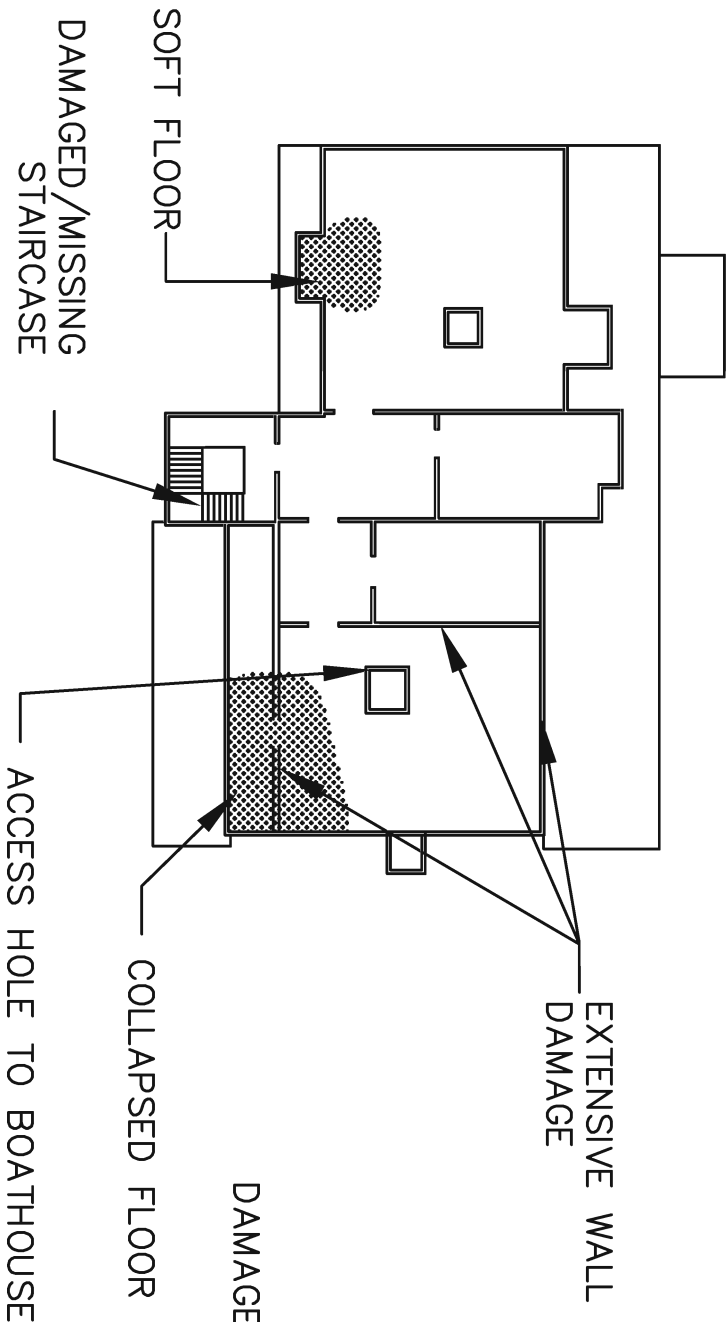
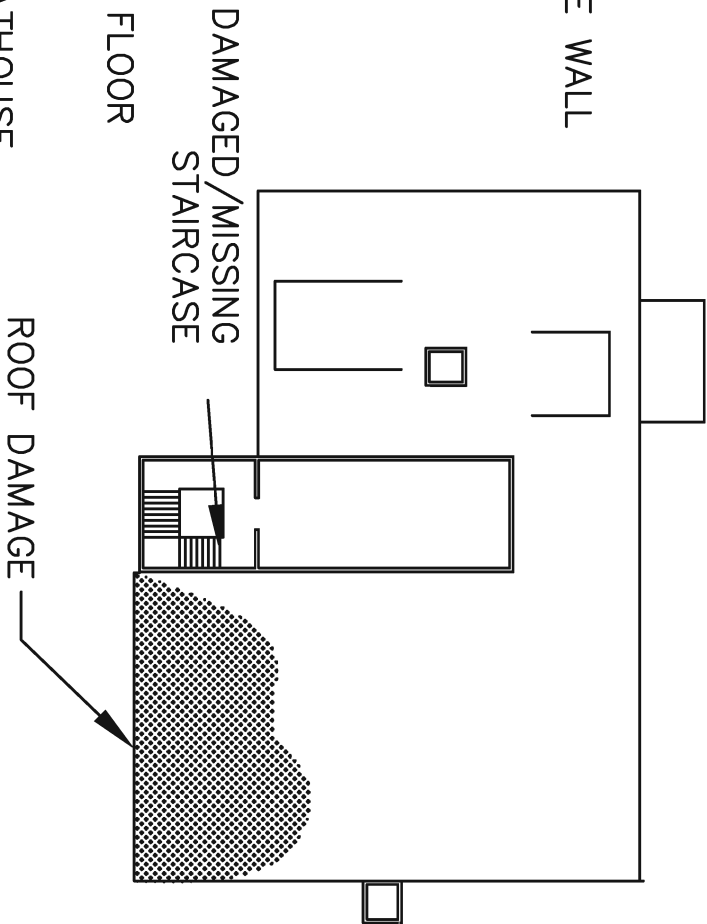
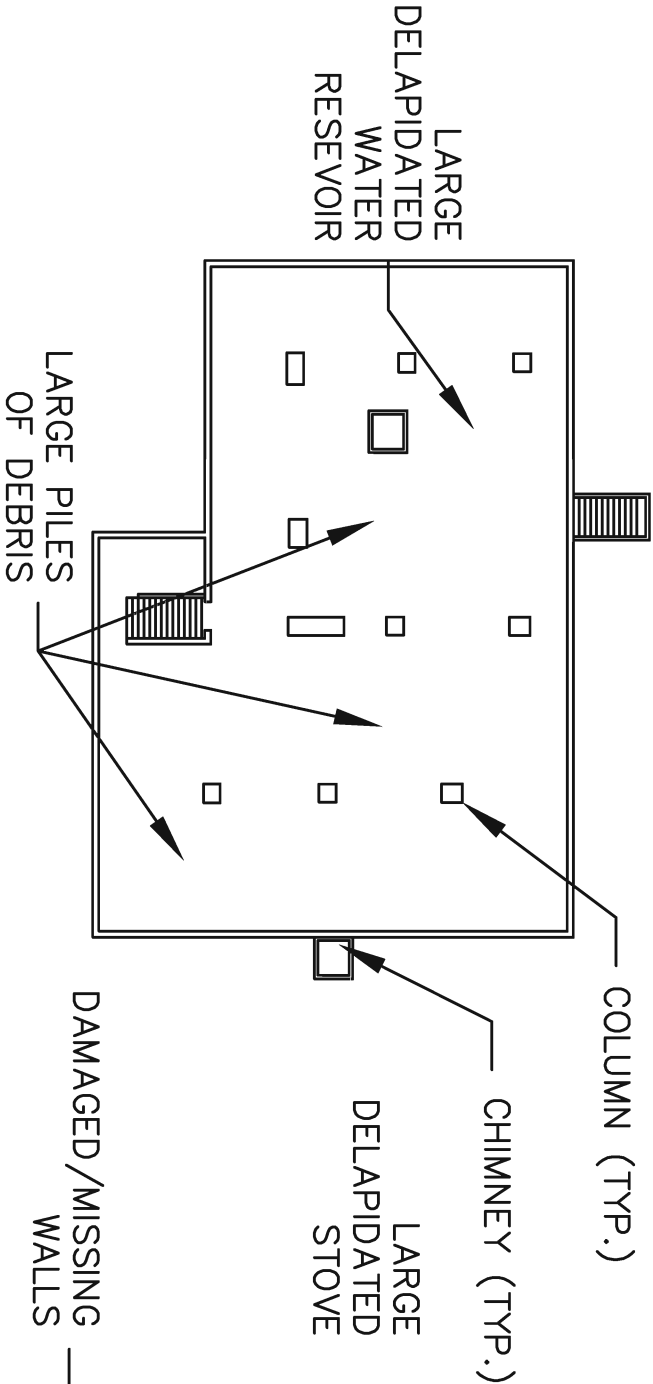
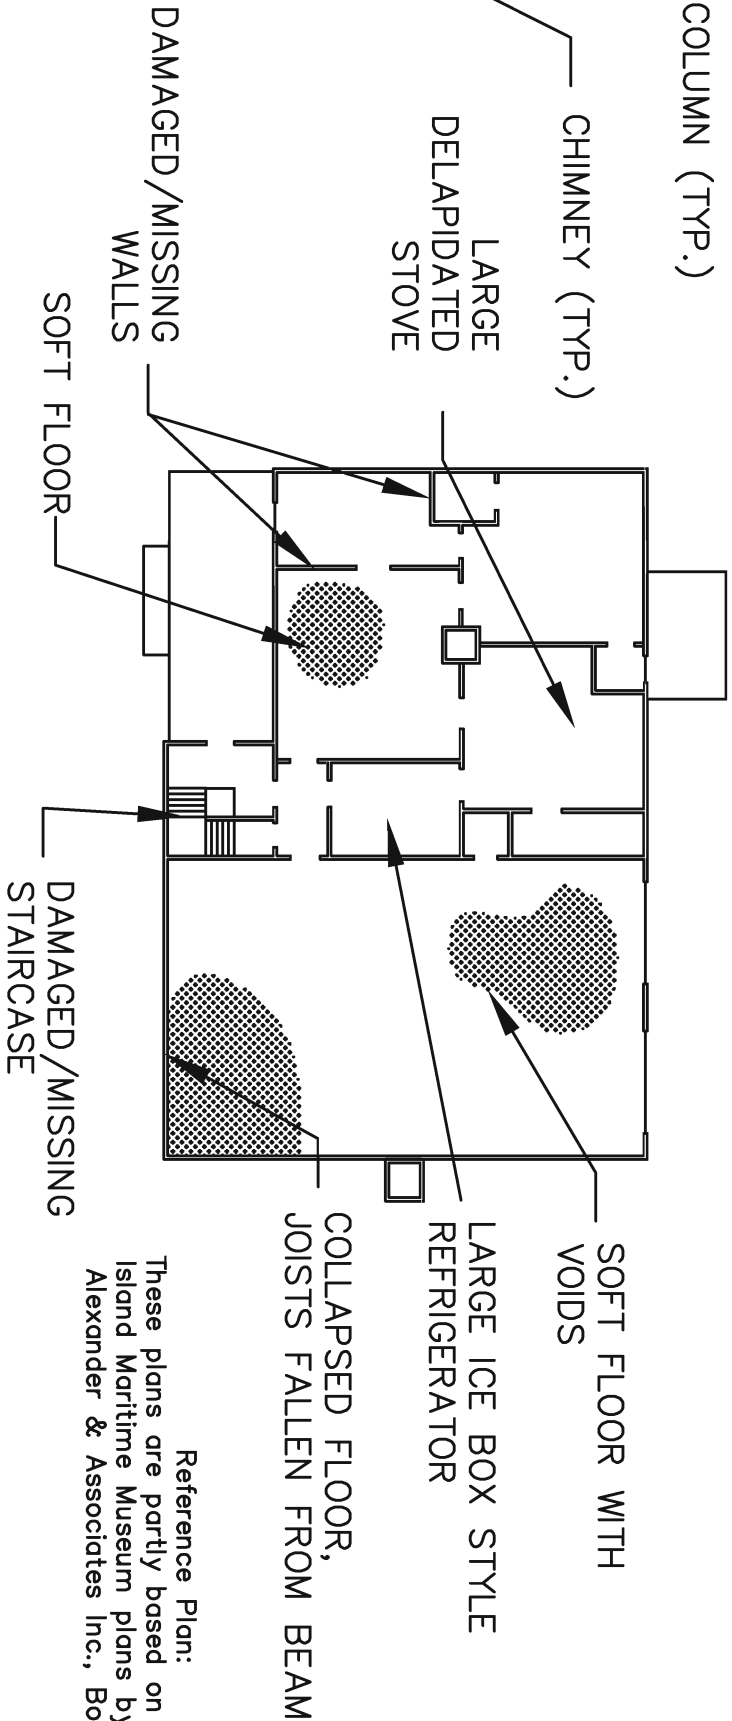
INITIAL ASSESSMENT: INTERIOR DAMAGE

- 1) Seagull droppings form large piles in all rooms in the building. Most piles are several inches deep.
- 2) No doors or original windows remain.
- 3) Asbestos insulation covers pipes in the basement.

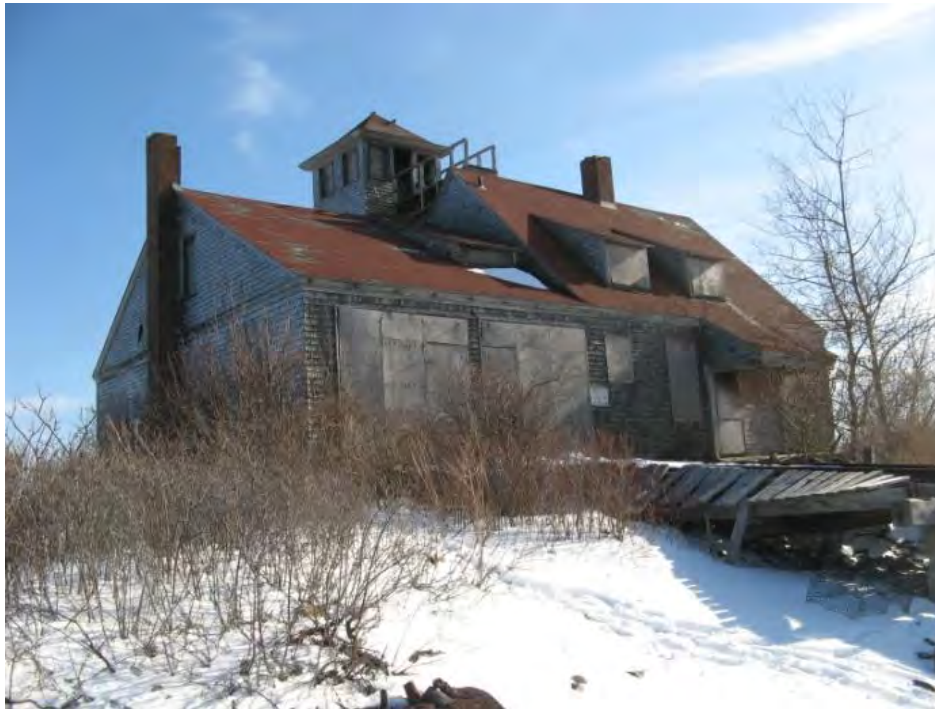
Currently, efforts have been made to close off the structure to visitors. These efforts mainly involved boarding up windows and doors. Unfortunately, these boards have not been able to withstand the harsh wind and rain, as well as visitors, vandals and bird traffic. All of these factors have been able to take down these window and door boards one at a time. Currently, the structure is very much open to the elements and is serving as home for many local birds. These seagulls, as well as other coastal birds, have been further destroying the interior elements.

Figure 1: Boarded side of Lifesaving Station

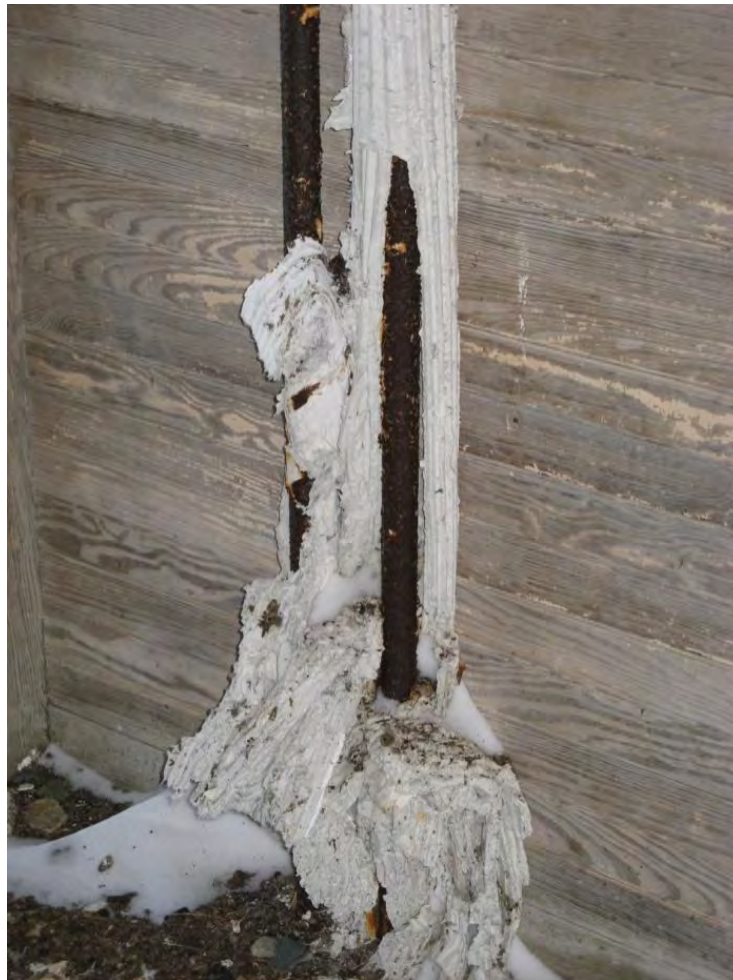
Figure 3: Piping with suspect asbestos containing material used as insulation

One of the most important concerns Mr. Oliver had involved the insulation found on the piping in the boat house (Figure 3). He suspects that this material contains asbestos and would abatement if any type of construction were to occur. Mr. Oliver also stated that it could be dangerous to have out in the open as it is currently. This material would most likely require special removal as well as special landfill disposal procedures and/or costs. Again, this material is deemed suspect only. A laboratory test would need to be conducted to prove it contains asbestos.

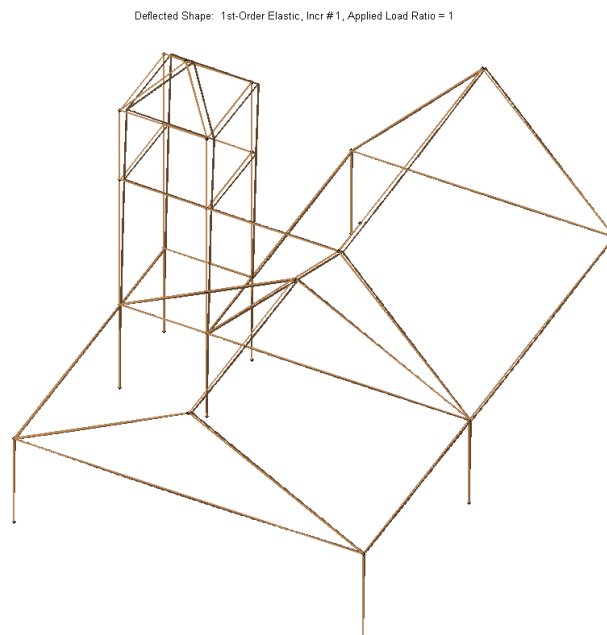
Figure 15: Deflections under Maximum Design Loading

According to the American Institute of Steel Construction Manual, $H/100$ is the maximum permissible interstory drift for a building of height H . Therefore the maximum allowable drift is 5.4 inches for the top of the tower. The maximum 8.1 inch deflection estimated by the matrix analysis exceeds this design criterion. If these deflections are in fact the case, they could result in fatigue stresses in the moment connections at each joint. Over time, loading cycles could result in cracking and damage to these connections. Minimizing interstory drift reduces the effects of fatigue. If these movements are undesired or if further analysis relieves unsafe fatigue, the structure could be braced.

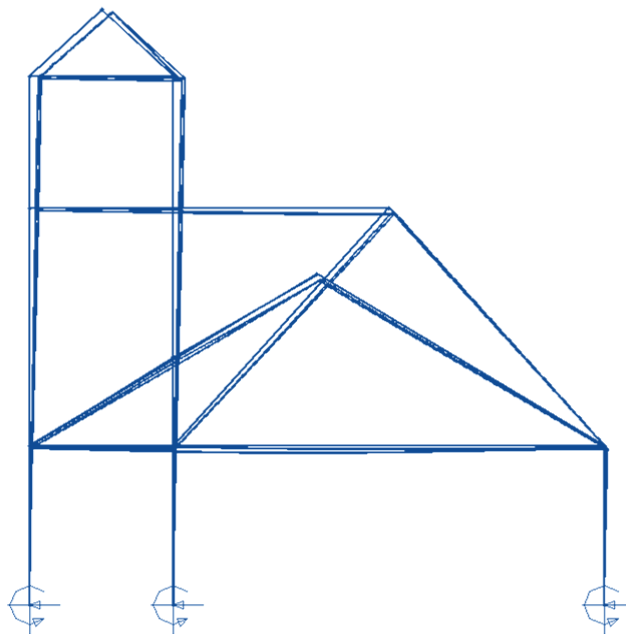
Figure 16: Lateral Deflection under Maximum Design Load

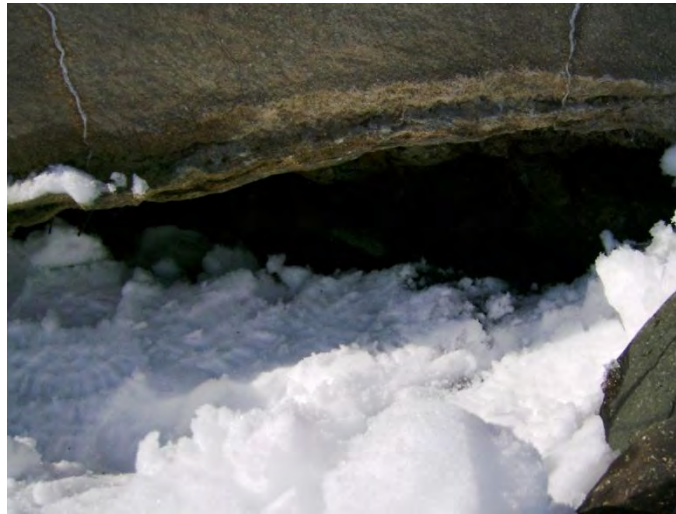
One of the initial observations made of the south seawall was the signs of undercutting by wave action.

Figure 19: Undercutting of South Seawall

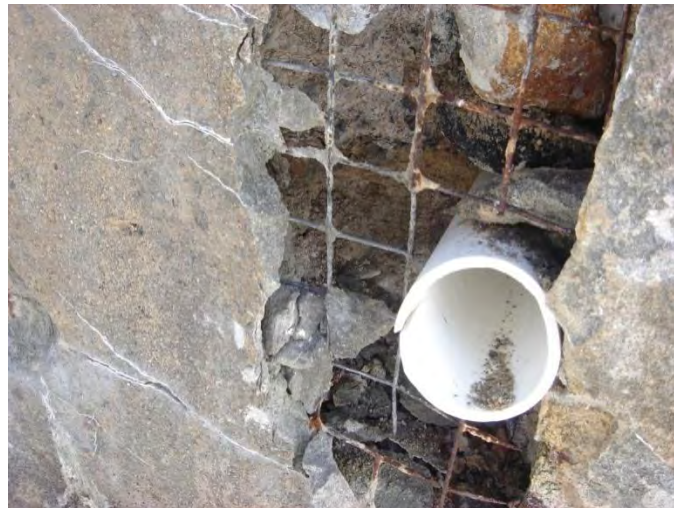
Figure 23: Shotcrete Cap Not Bonded along face near Weepholes

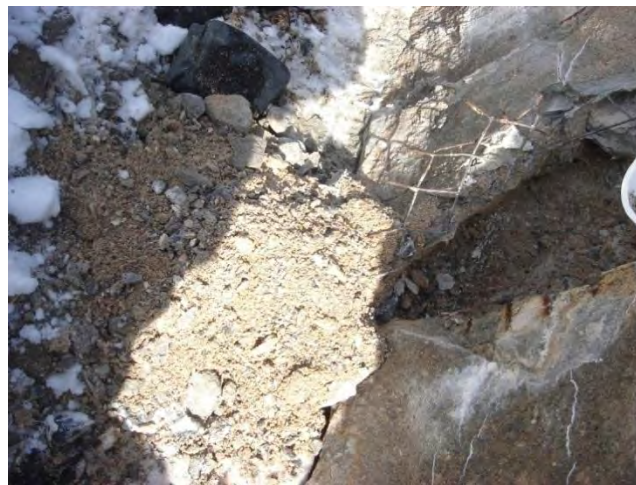
Figure 25: Weathering of Paste as seen through Chiseling

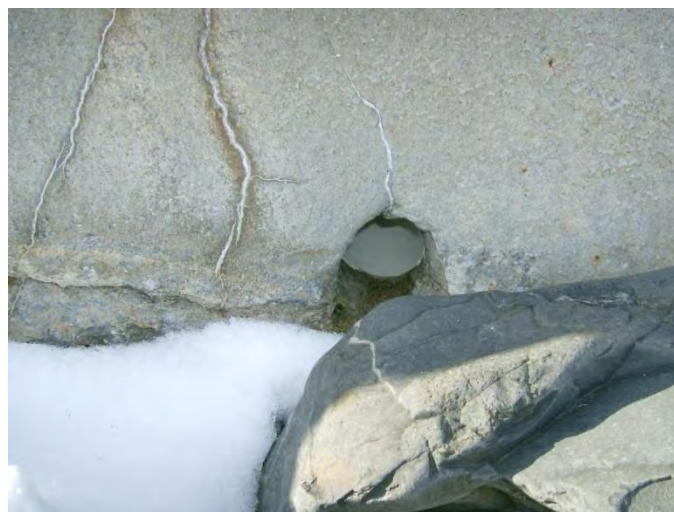
Figure 27: Weephole at toe of South Wall

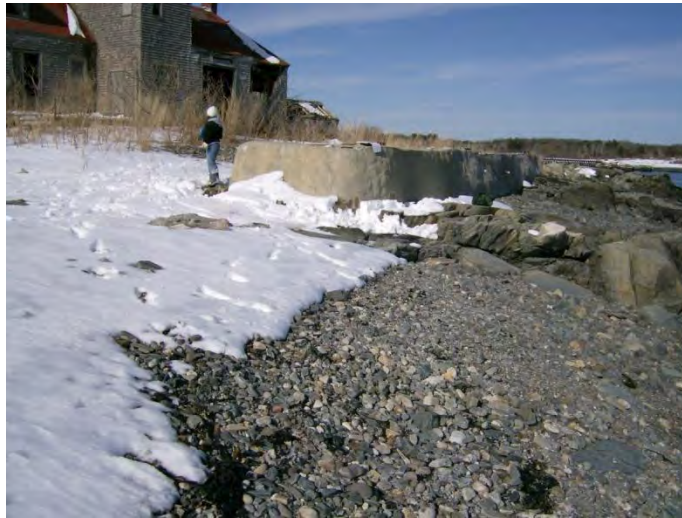
From collected tide data it suggested that high tide would not come within 5 feet of the toe of the existing structure. Upon the March 5, 2009 site visit, shortly after a recent snowfall, marks of the high tide could be seen in the melting of the snowfall. Seen in the figures below is that high tide does come into contact with the bottom of the wall and that this would warrant concern of continuing undercutting of the structure and weathering.

Figure 29: High Tide Marks on South Seawall (1)

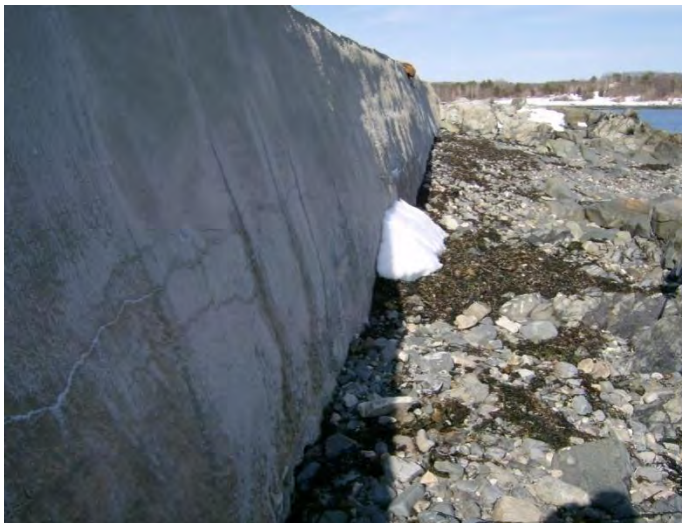
Figure 30: High Tide Marks on South Seawall (2)

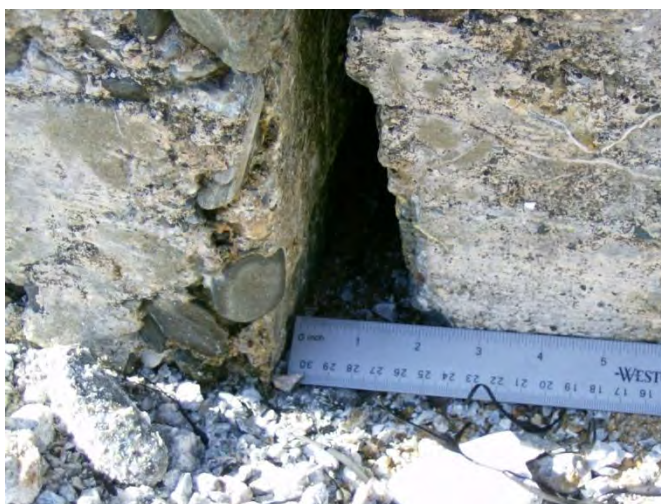
Figure 37: Horizontal Displacement and Overturning of North Seawall (2)

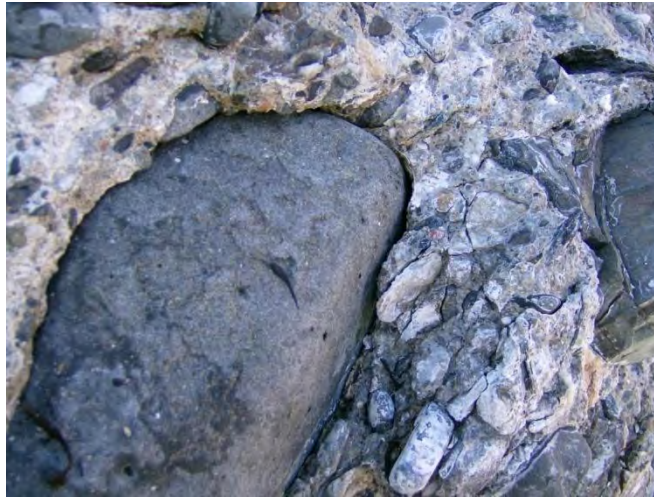
sever decrease in the structures overall strength. The voids present around the aggregates also are typical of Alkali-Silica Reaction present in the structure as internal stresses develop from ASR.

Figure 41: Un-bonding of Aggregate due to Freeze Thaw in North Seawall

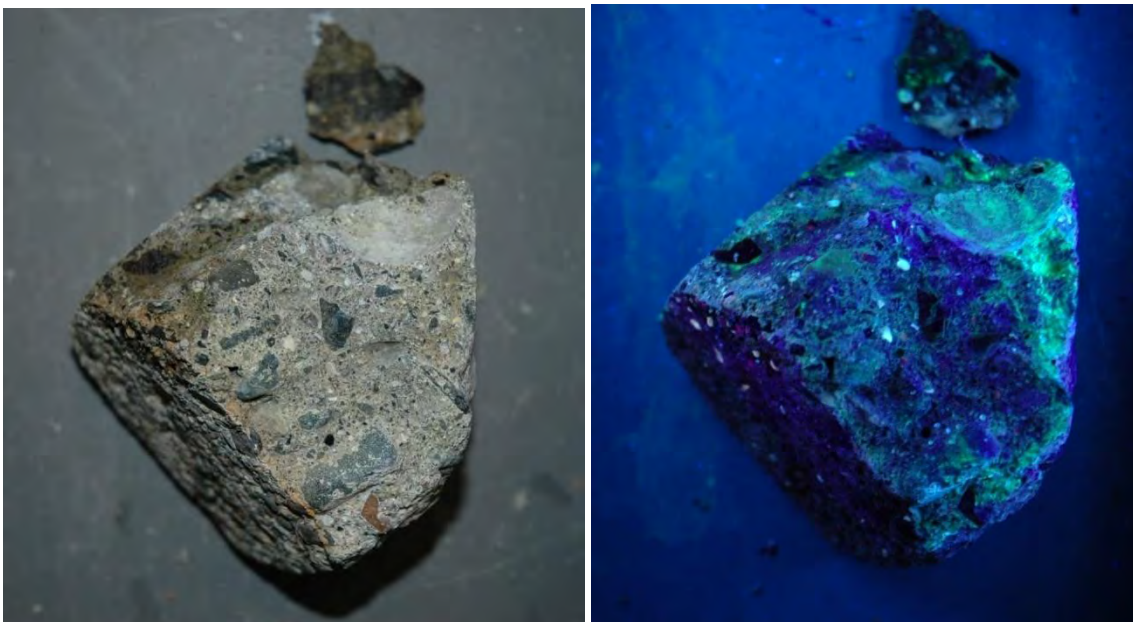
From observations, ASR was present in the sample, yet to a degree which seemingly was of minimal concern to the integrity of the structure. ASR was also observed in a cut and polished section of the sample and was seen as dark rings which surround some aggregate faces showing the damage due to portland cement expansion.

Figure 49: Sample Showing before and after with ASR Fluorescence under Black Lights

Since a sample was used, in considerably small volume compared to the entire structure, it is hard to correlate to the entire structure. More samples would be needed to determine the exact extent of the acceleration of ASR within the entire system, though observations suggest minimal threat.

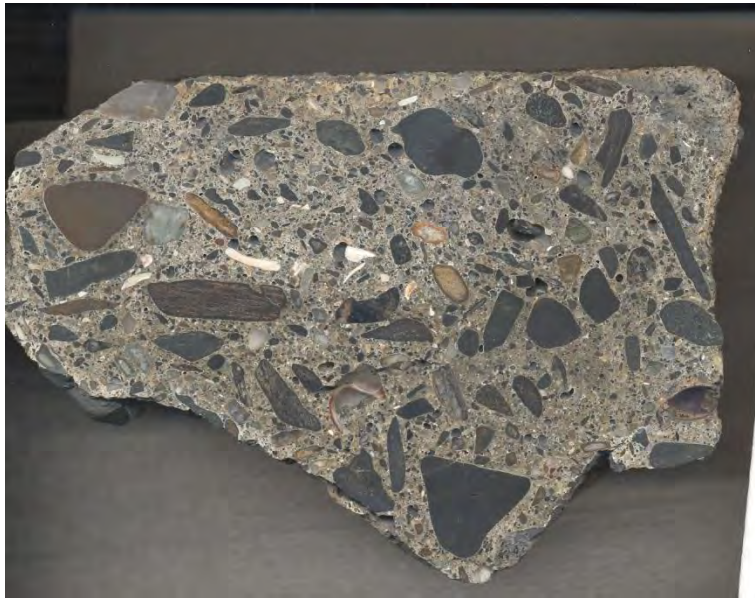
Figure 53: Polished Sample Concrete Face

Evidence of carbonation during observation of the cut and polished sample can be seen with a detectable brownish haze which envelopes the exposed surface of the specimen. Cracking due to carbonation was not observed and it seems that the long term effects would be negligible for rehabilitation. It may actually serve to provide a water barrier if a capping system over the existing structure is chosen.

Evidence of freeze thaw cycling could be seen when a cut and polished section was examined under the microscope. While observing the sample, large cracks were seen extending across the plane parallel and close to the face of the sample. Though it exhibited signs of cycling, the damages seen within the sample seemed minimal with respect to the overall integrity of the structure. Other typical signs the sample exhibited during a site visit were small chunks which had come off of the structure. This could be probable freeze thaw cycling or even impact loads from waves.

To prevent concrete from freeze thaw damages, concrete is air entrained to allow air voids for moisture expansion. Upon observation, it was hard to detect that the sample was air entrained or if small voids were left due to not being fully compacted when placed. To prevent further freeze thaw damages, air entrainment will be examined for the rehabilitation proposal.

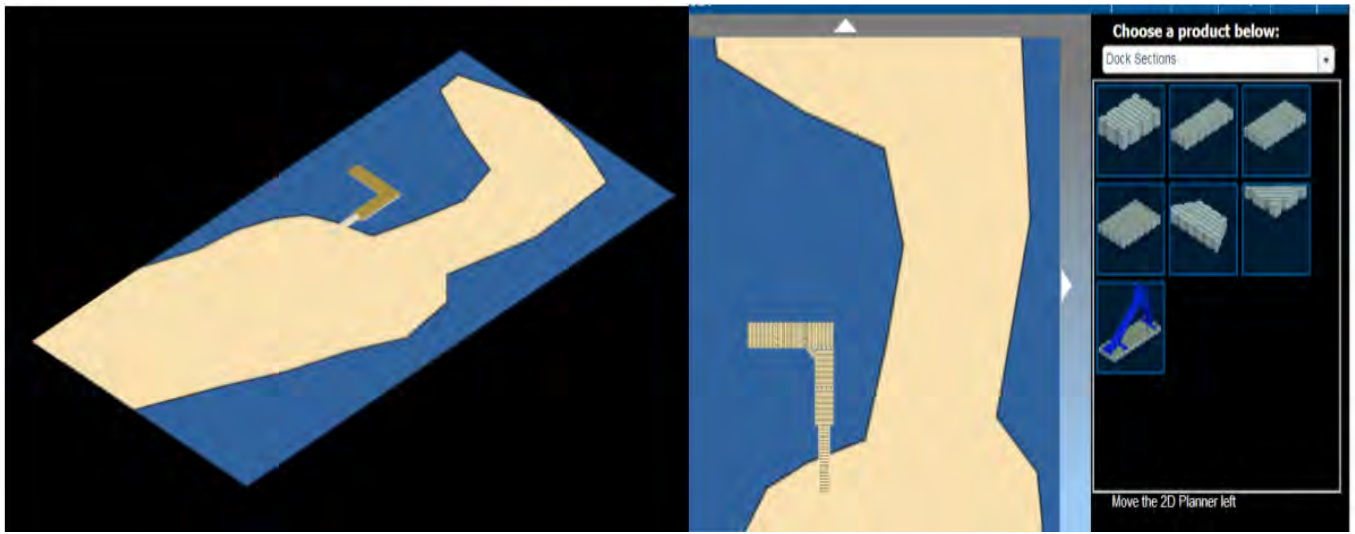
Figure 67: EzDock design

The EzDock design is flawed, it cannot withstand rough seas (greater the two foot waves) without breaking. Therefore this product cannot be considered as a solution.
