Rice Public Library Renovation and Addition

Programming and Existing Conditions Report
June 28, 2019

On Thursday 21 February 2019, we visited the Rice Public Library (RPL). The intent of our visit was to review the existing conditions that are readily visible and comment on their conditions. Ms. Lee Perkins, the Library Director, showed us around and provided information on past building upgrades. The visit and review are being done in anticipation of a renovation and an addition that are currently being planned at RPL. The current library building is on the National Register of Historic Places.

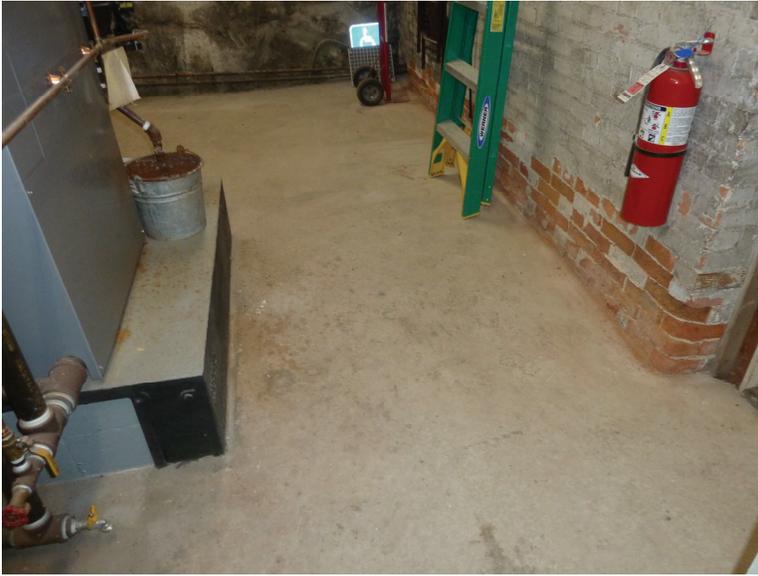
1. Bottom of the brick walls in the basement: We noted damage at the bottom of the brick walls at the basement interior and exterior walls. At the interior walls, the bottom 2ft of the walls appear damaged. In the back of the house areas (boiler, server) the paint is gone, the brick faces are damaged, and some brick appears to be soft (photos 1 and 2). In the more public area (kitchen) the walls have been re-painted, but damage is still visible (photo 3). Similarly, the exterior perimeter walls have damage. Those walls are painted, and the damage appears more sporadic with the paint creating bubbles that eventually burst, exposing damaged brick (photo 4). We note that the bottom of most of the exterior walls are covered with large wood baseboards which hide the brick condition.

Photo 1: Basement boiler room.

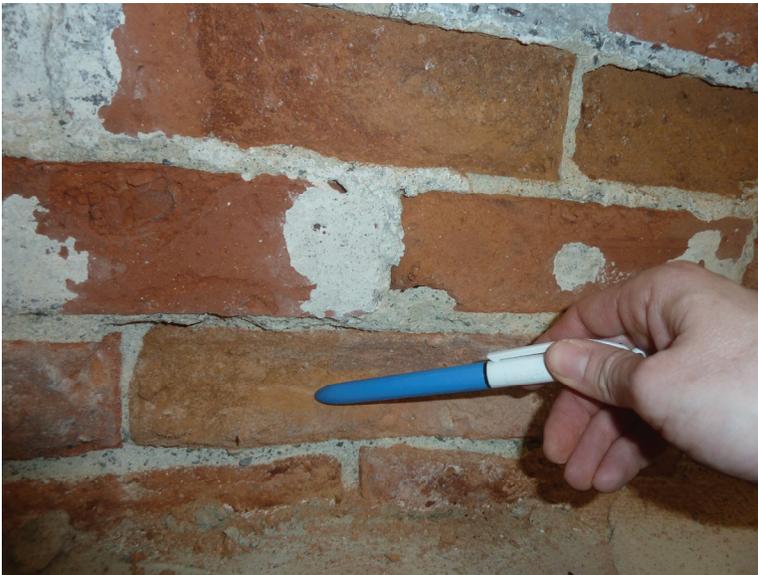
Photo 2: Basement boiler room. Close up of soft brick.

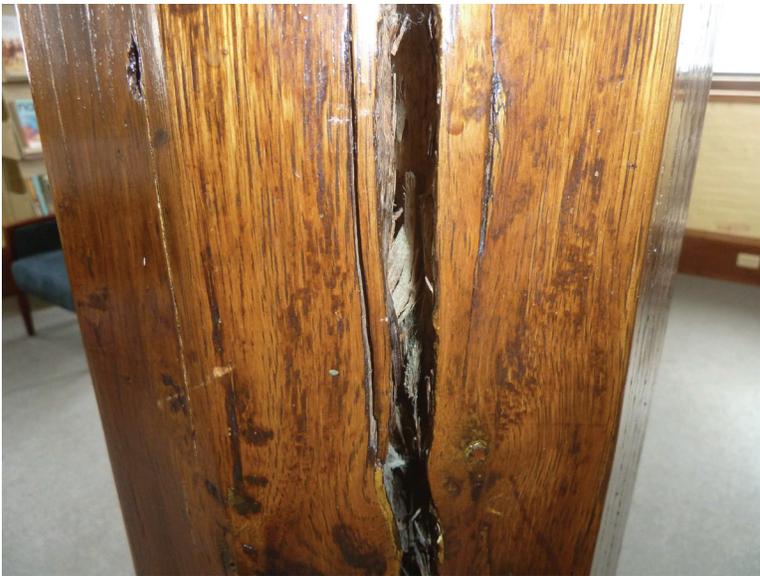
3. Wood octagonal columns at basement: the two octagonal columns in the basement have long checks which open up as wide as $\frac{1}{2}$ " (Photo 6). Checks in compression member are usually not a concern as these do not reduce the capacity or extend to the connections. Ms. Perkins however mentioned that these may be getting larger. As such, we recommend monitoring the checks. If these are in fact getting larger, steel collars should be added intermittently through the height of the columns.

Photo 6: octagon wood column in basement. Note the large checks.

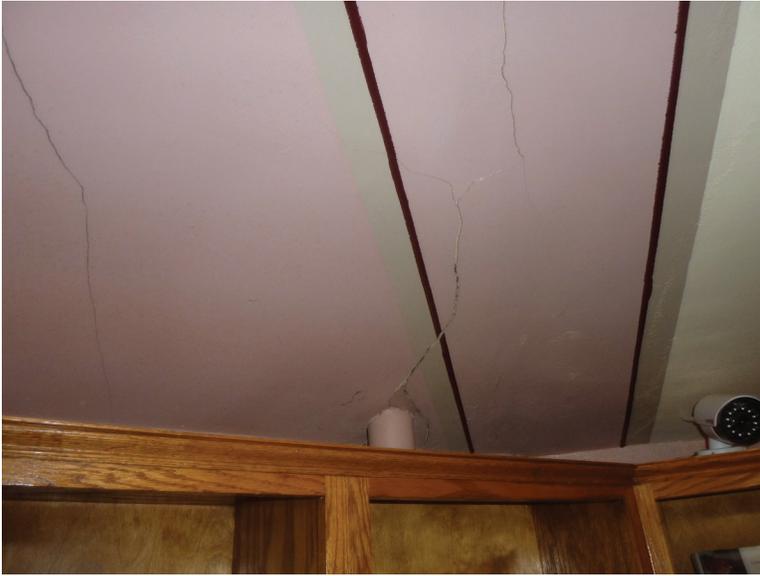
4. Cracks were noted in the corners of the plaster ceiling above the second-floor large reading room (Photo 7). In this area, the ceiling is directly supported from the roof structure. As the roof was recently insulated, it is possible that more snow is accumulating on the roof and increasing deflections. The cracks should be monitor and if found to becoming worse, additional roof investigation/analysis should be performed.

Photo 7: Second floor plaster ceiling. Note the cracks in the plaster.

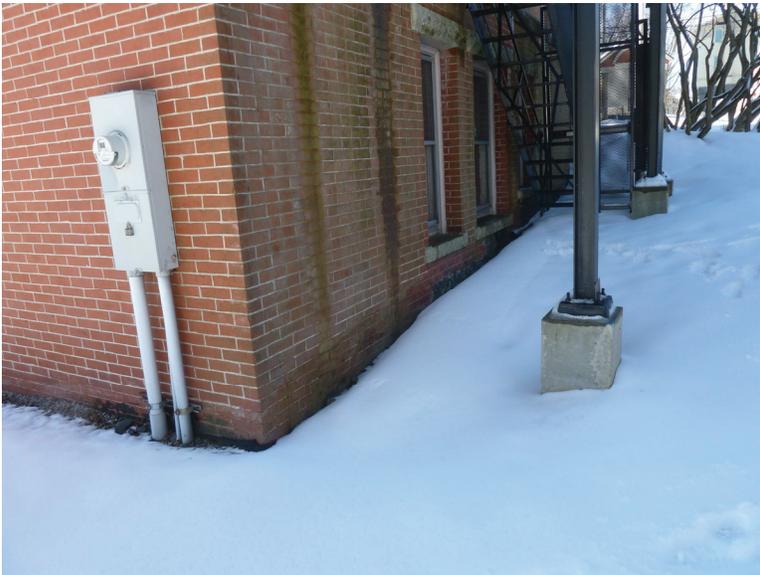
5. Exterior: the exterior walls are in good condition. Very few areas were noted having issues. Some dirt is visible at the north elevation, below the fire staircase. The base of the brick wall at the north-east corner appear to have some efflorescence (Photo 8). The brick in those areas should be cleaned and repointed.

Photo 8: North east corner of building. Note the dirt below the fire escape and some minor effervescence at the base of the wall.

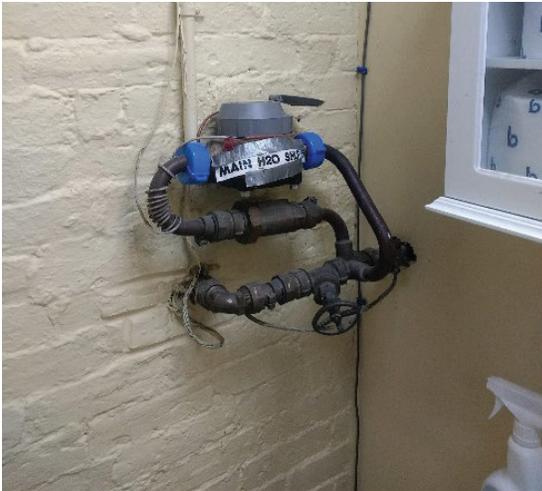
The water entry was in the Staff Bathroom on the Basement Level. Service size was $\frac{3}{4}$ ". The meter was inside the building. The piping was exposed and not insulated. There was a Flood Master FM-080-1 Water Main Shut-off System installed in the Staff Bathroom on the Basement Level, designed to shut-off the water service upon detection of a leak.

Figure 1 - Water Entry

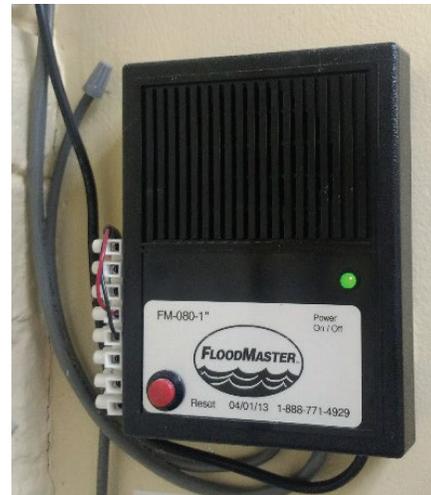
Figure 2 - Leak Detection System

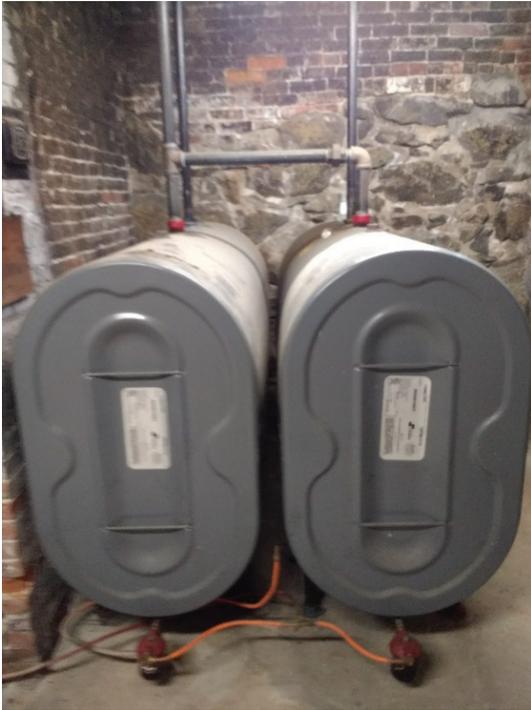
The building has two 330-gallon Aboveground Storage Tanks (ASTs) in the Basement Level Mechanical Room. The fill spouts exit through the first floor on south side of the building.

Figure 3 – Oil Storage Tanks

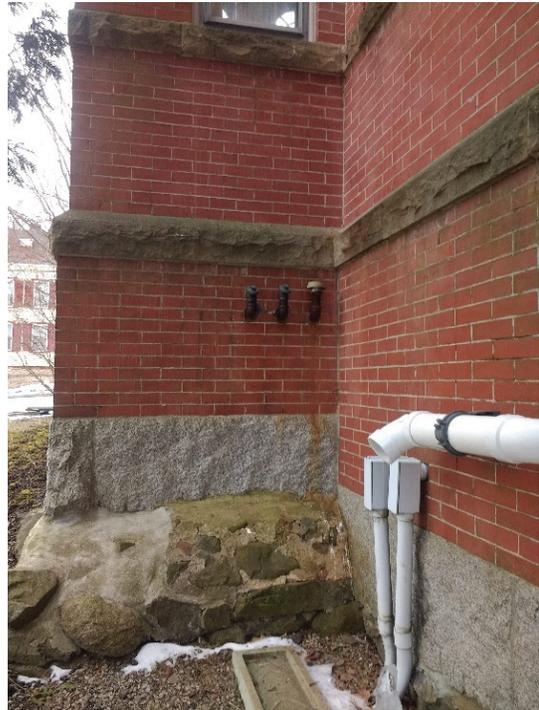
Figure 4 - Oil Fill Spouts

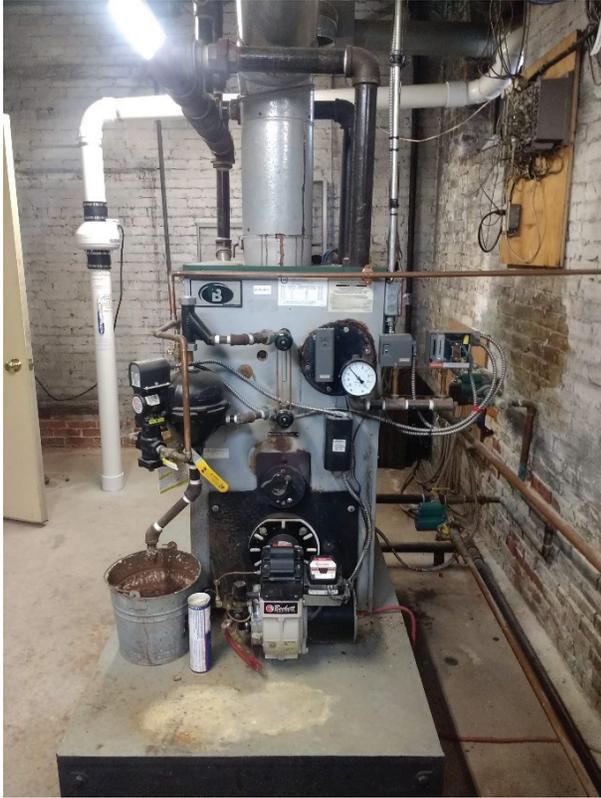
Figure 5 – Oil Fired Boiler

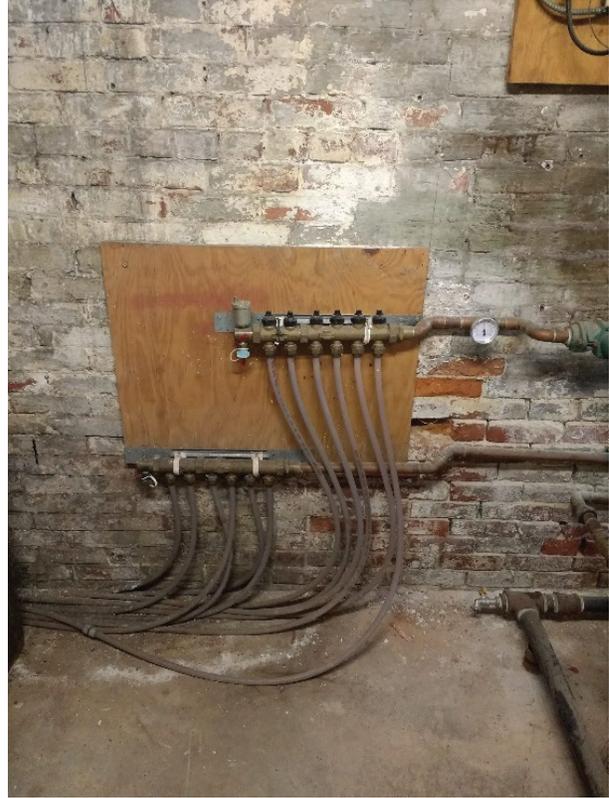
Figure 6 - Radiant Floor Manifolds

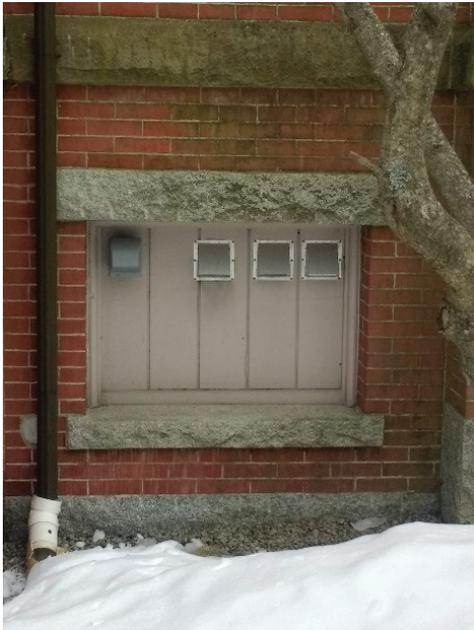
Figure 7 – Bath Fan Exhaust Hoods

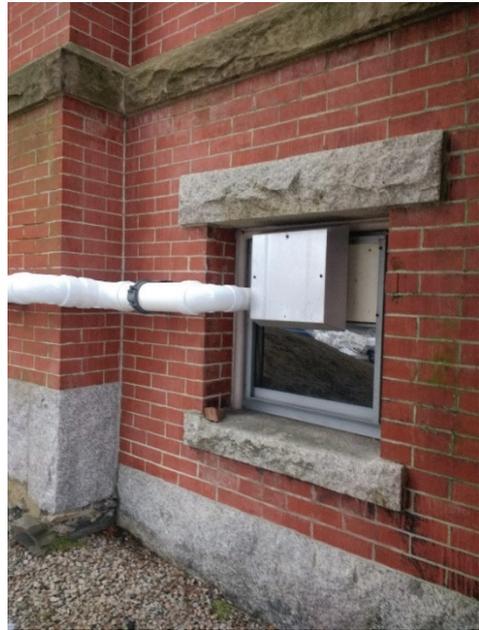
A supply fan provided combustion air to the boiler and was interlocked to come on when the boiler burner came on.

Figure 8 - Boiler Combustion Air Supply Fan Intake

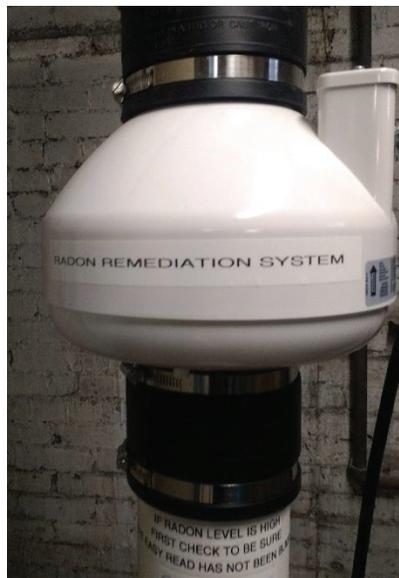
A radon mitigation system was installed in the Basement Level Mechanical Room. According to the Library Director the system was required to be installed and operate continuously as part of the mitigation plan for a hazardous underground chemical plume coming from a former dry-cleaning establishment across the street.

Figure 9 - Radon Mitigation System

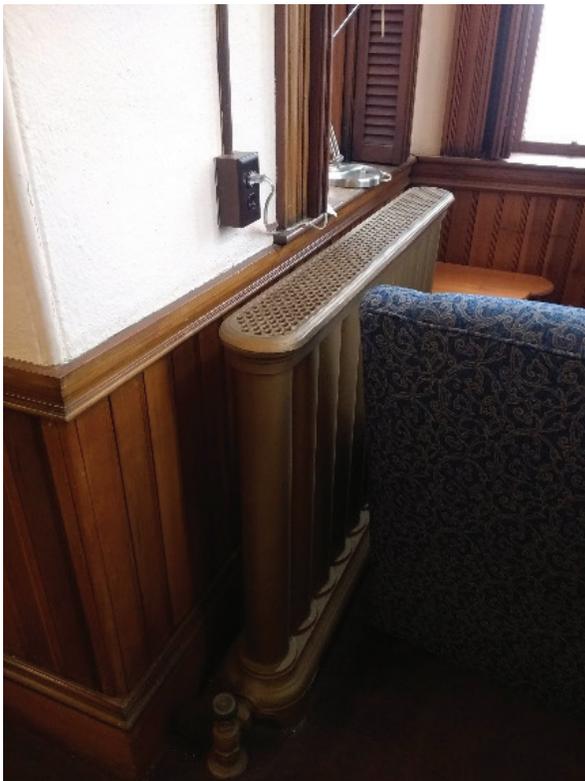
Figure 10 – Typical Radiator on Second Floor

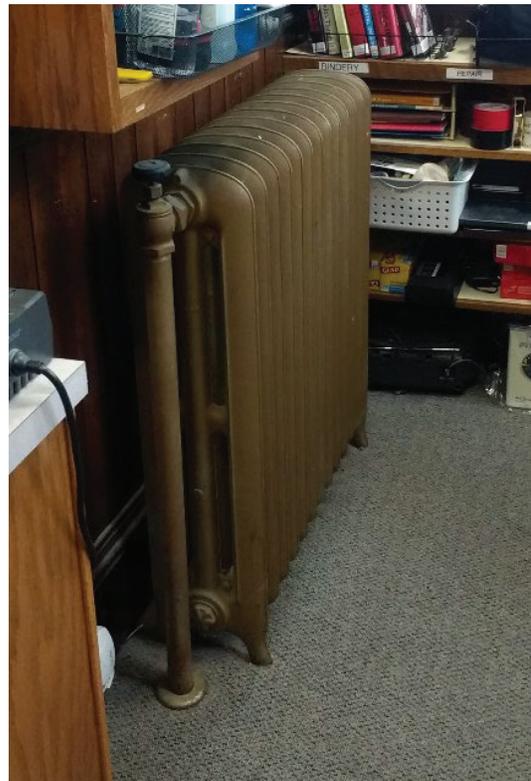
Figure 11 - Typical First Floor Radiator

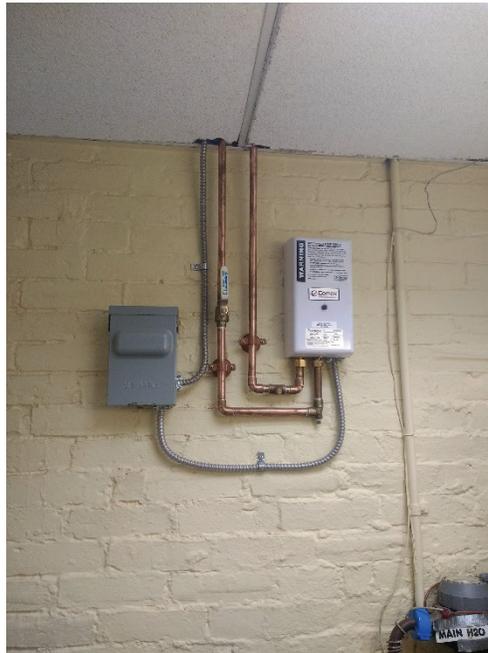
Domestic Hot Water (DHW) was provided by three electric on-demand water heaters. One water heater served the Basement Level Staff Restroom, one served the Public Restroom and Kitchenette Sink (assumed, not confirmed). On the First Level, one water heater served the Public Restroom.

Figure 12 – Typical Electric On-Demand Water Heater

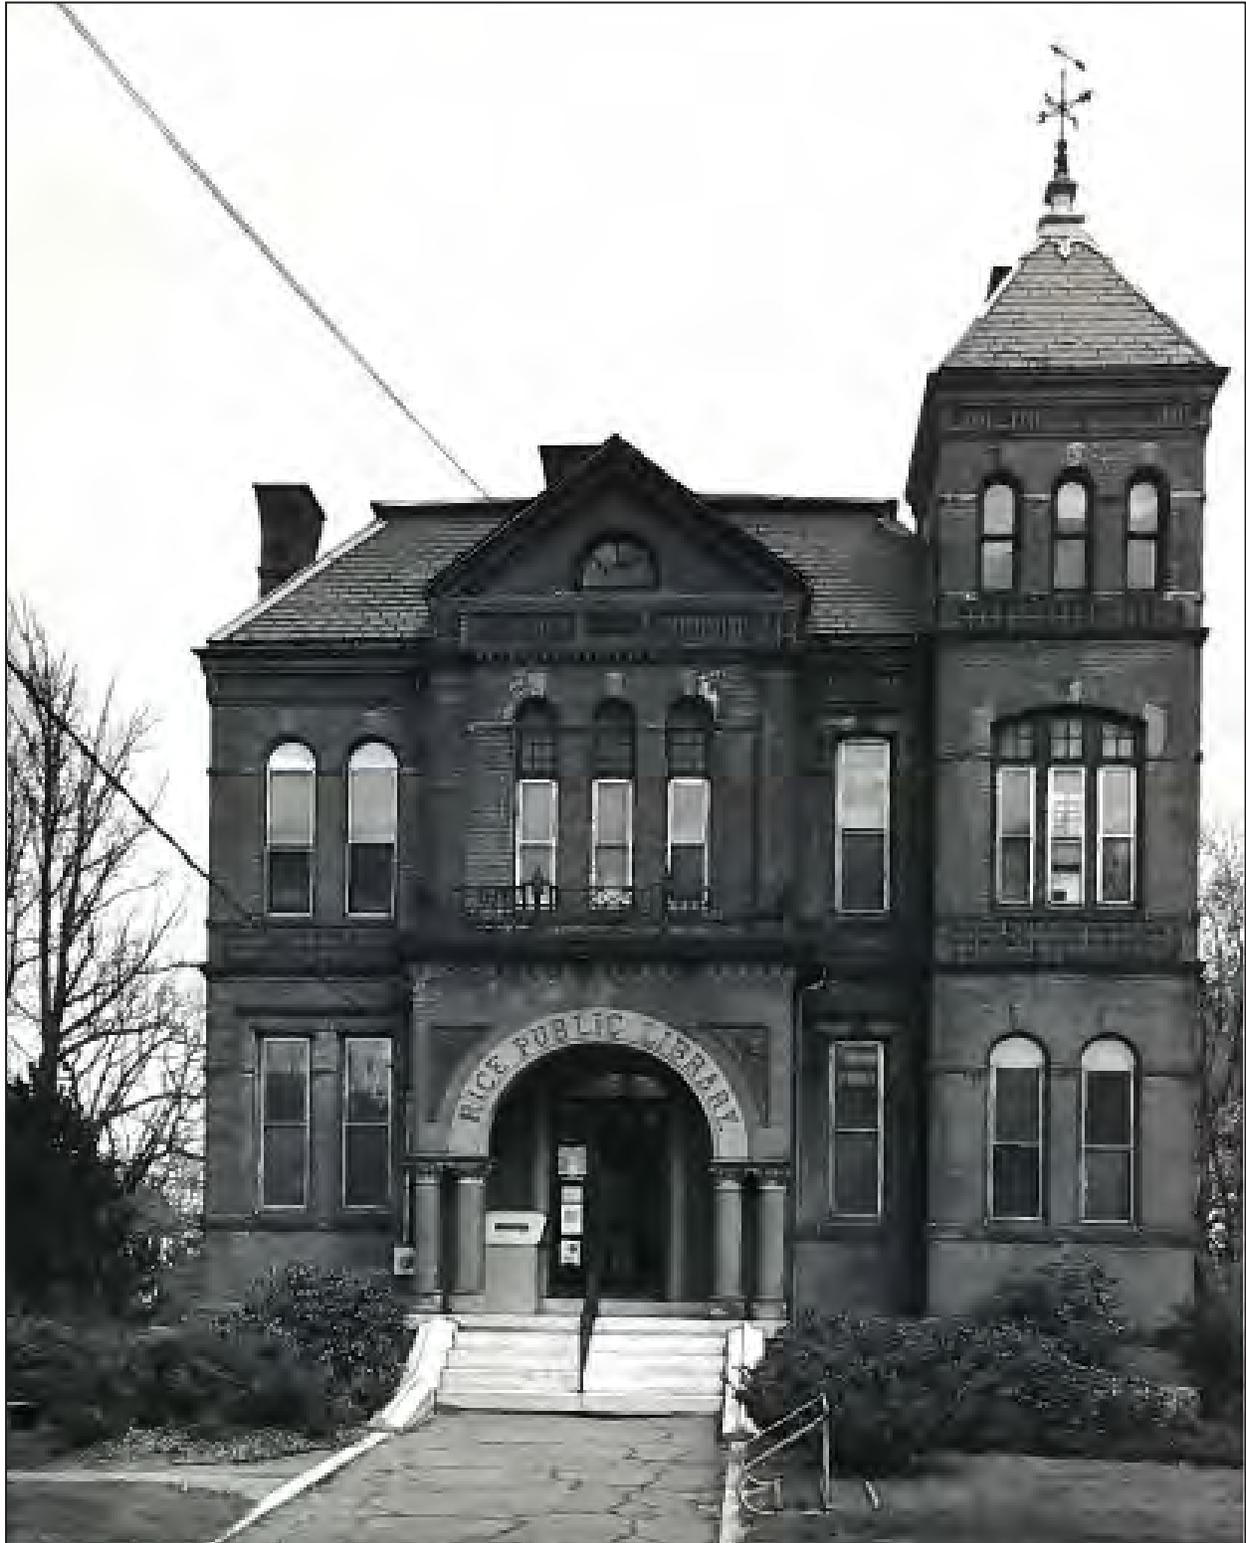
Fig. 1.31 Rice Public Library, west elevation, c. 1985. Note dark window frames and sash, aluminum door at entrance and asphalt walkway. Landscaping has matured since 1979. Masonry is heavily stained and shows efflorescence, mis-matched pointing--or both. (undated photo, RPL)

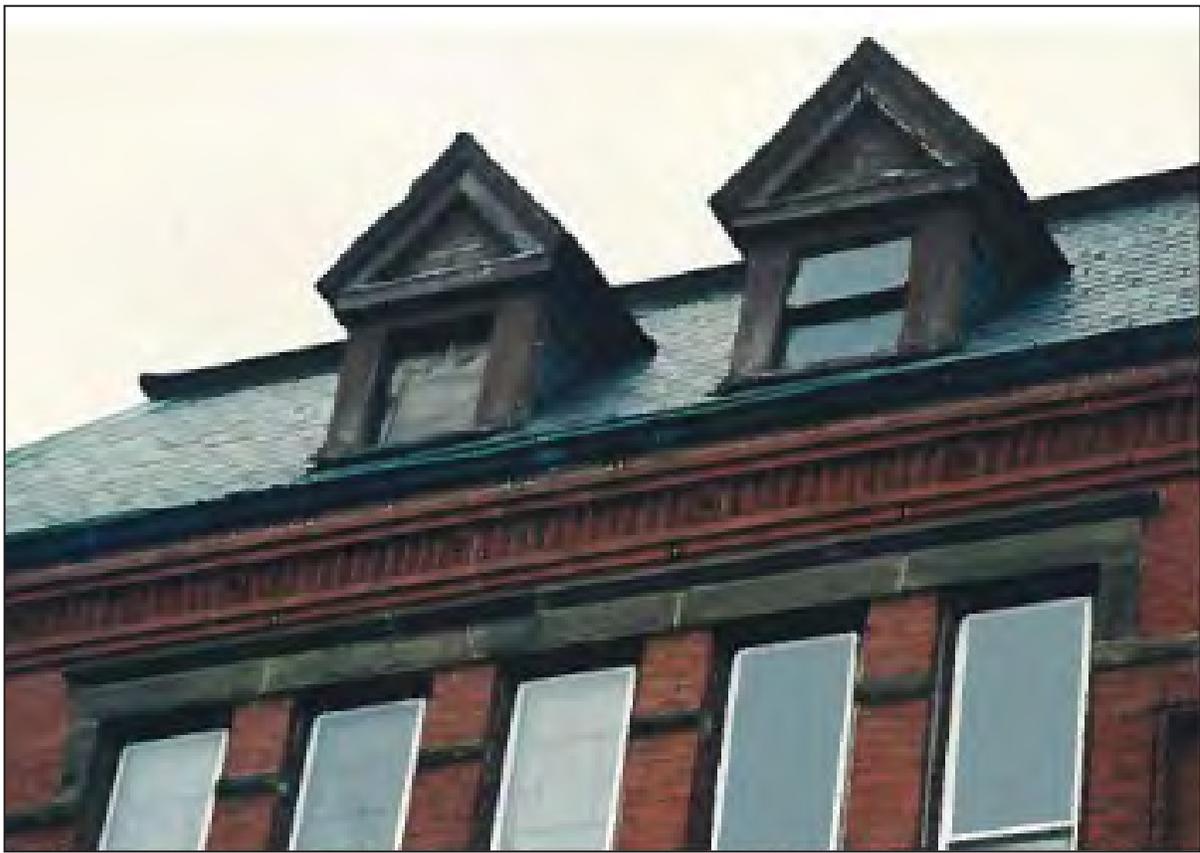
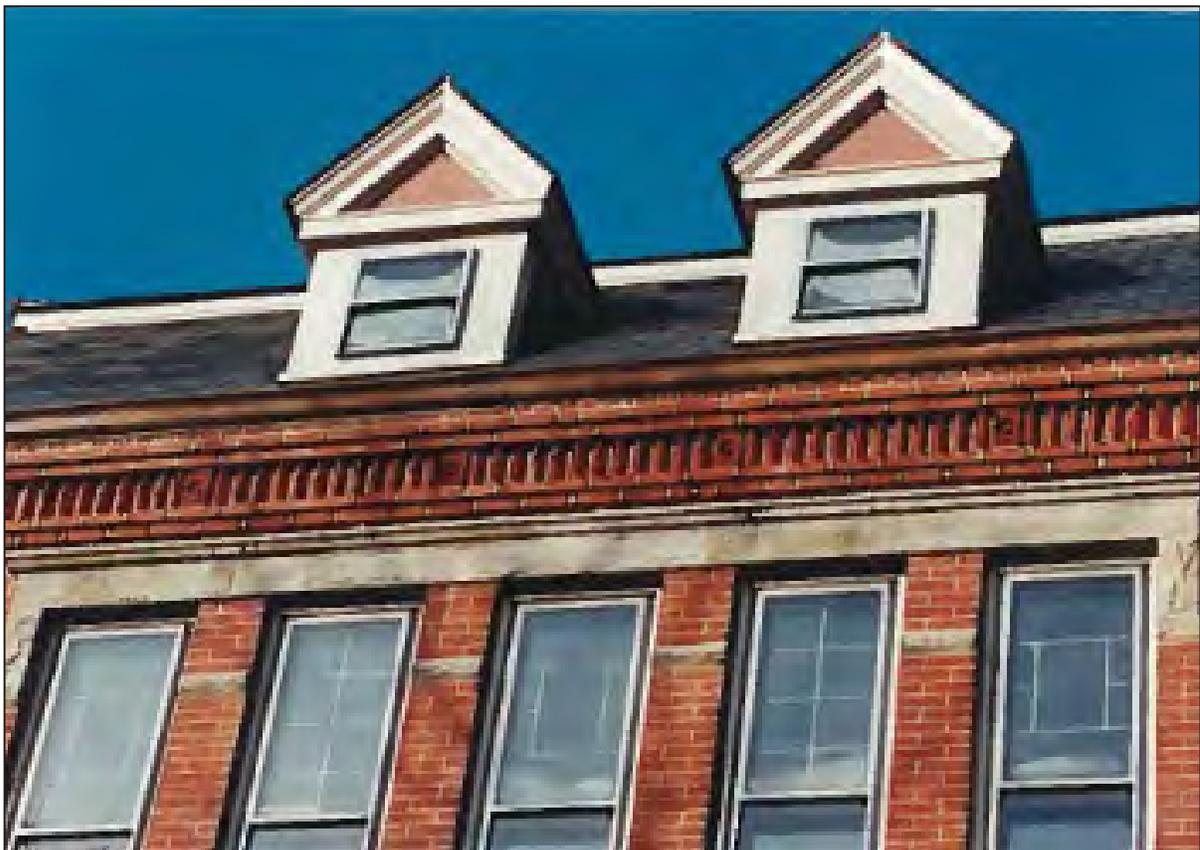
Fig. 1.33 Rice Public Library, south elevation, c. 1991. Before (top) and after (bottom) views of dormer and roof repairs, showing change in trim color from dark to white. Material in pediment may originally have been slate and appears to have been more deeply recessed. (RPL)

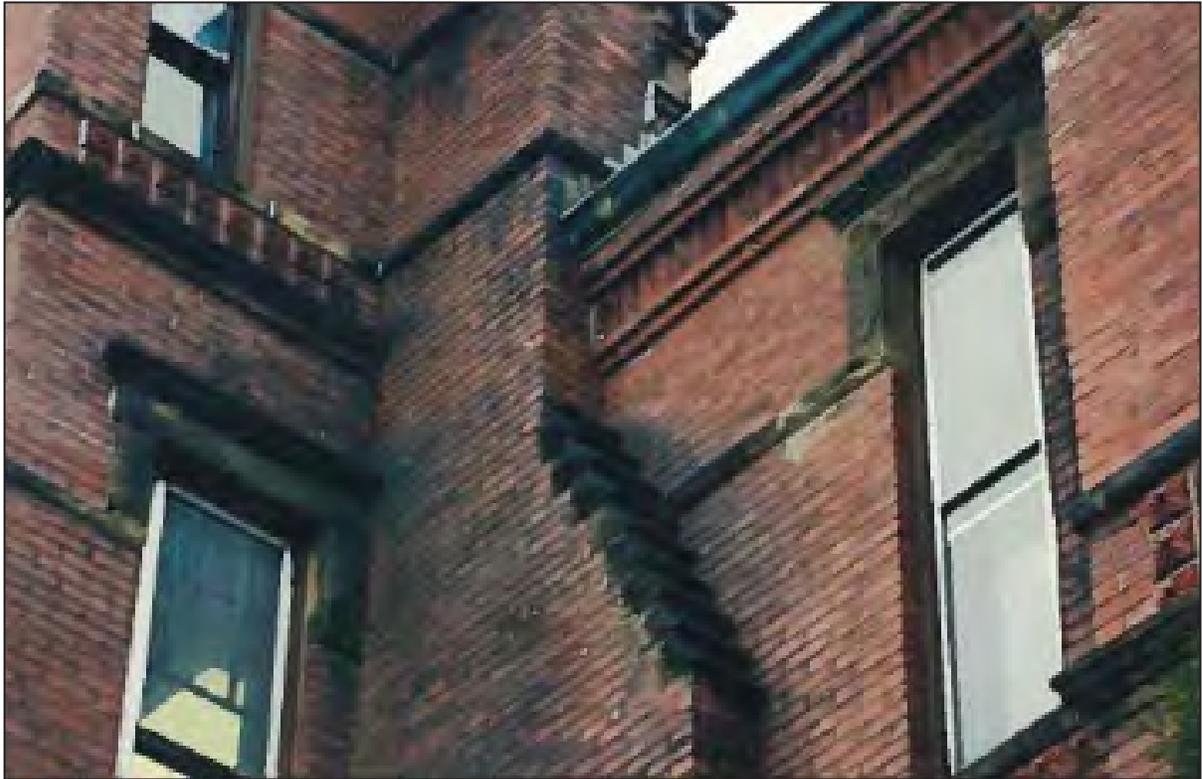
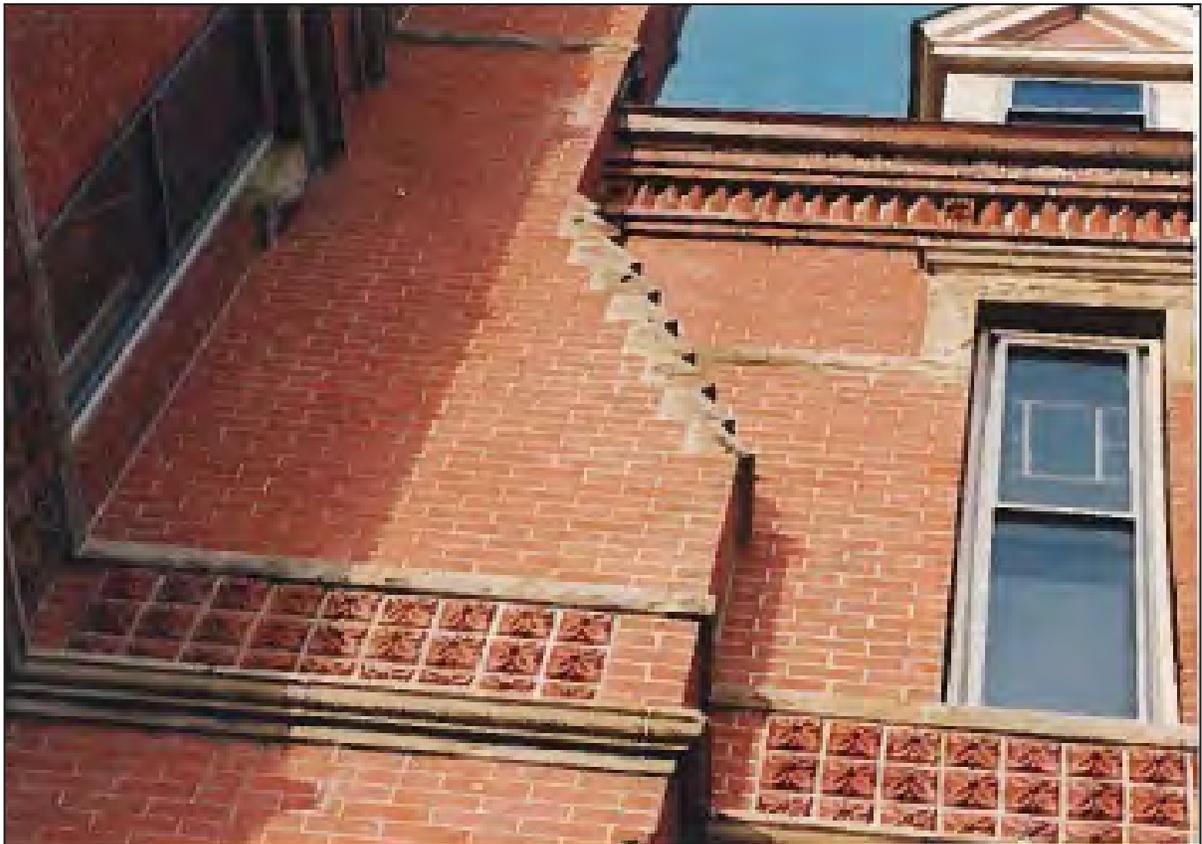
Fig. 1.34 Rice Public Library, south elevation, c. 1991. Before (top) and after (bottom) views of masonry cleaning and repairs. (RPL)

Masonry at the RPL is a distinctive mix of multi-colored and textured brick, granite, sandstone and terra cotta. Masonry appears to have been cleaned and repointed c. 1991 (Fig. 1.34).

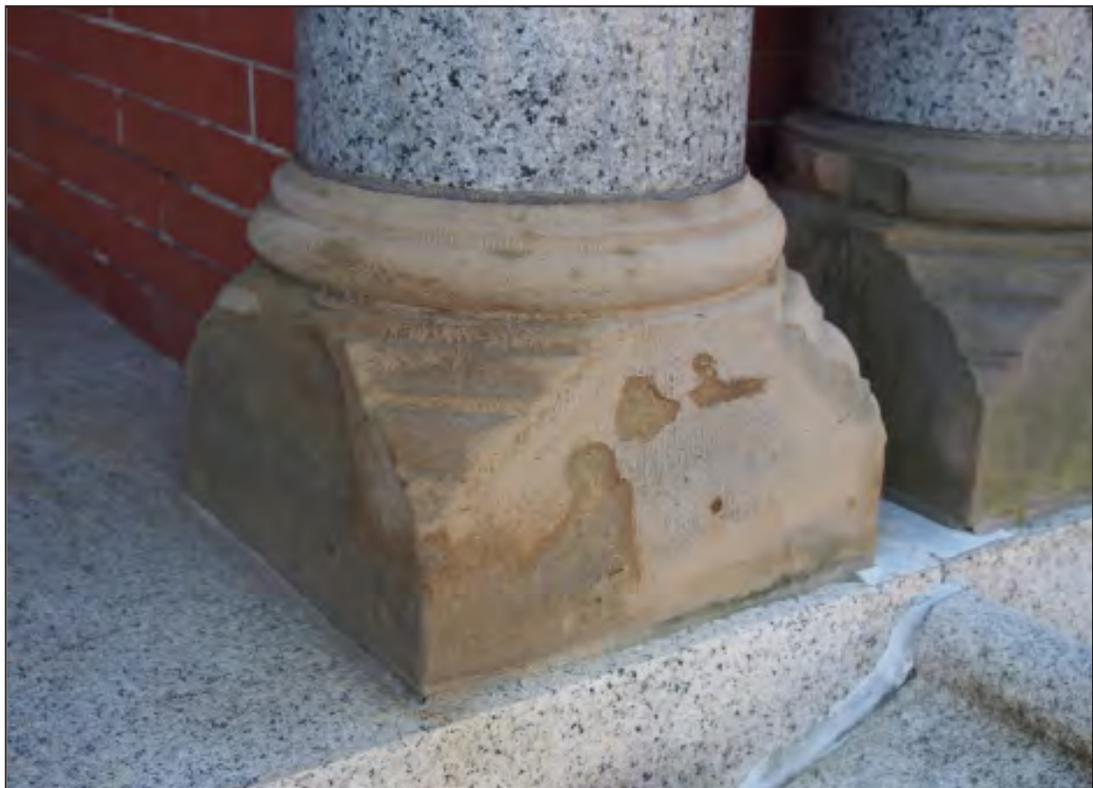
Fig. 2.6 Sandstone column bases show erosion and exfoliation as a result of salt applied to steps. Note also flashing under bases. (Scattergood Design)

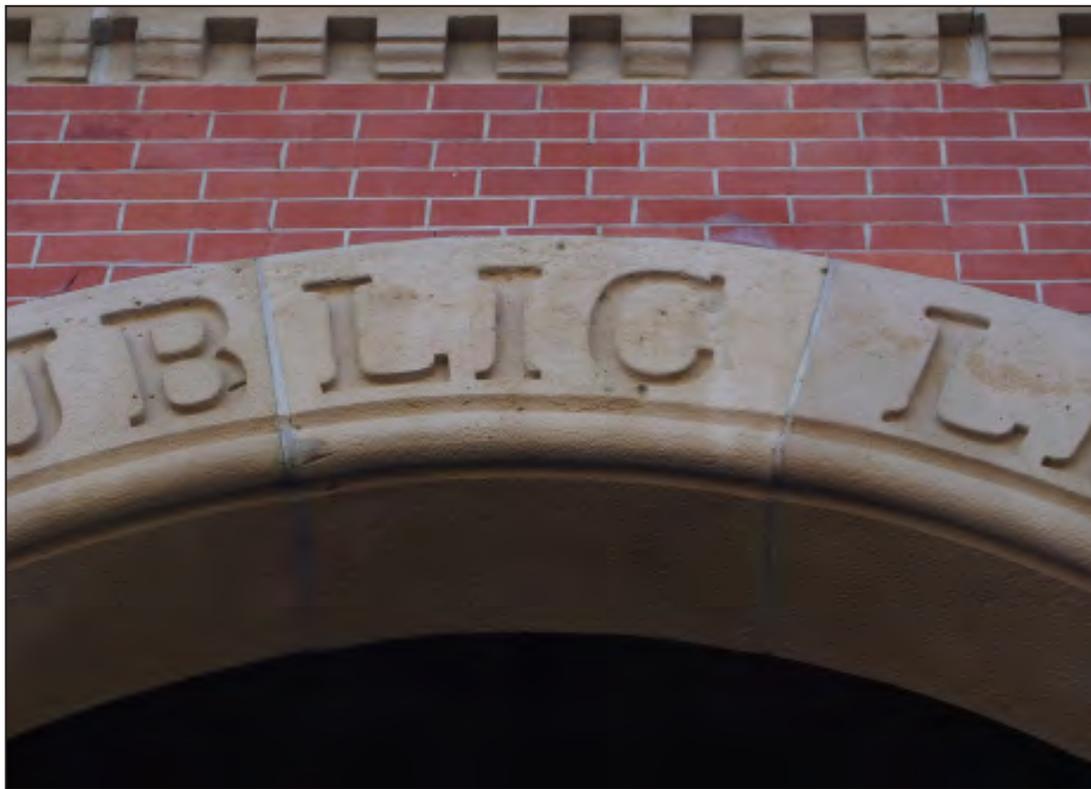
Fig. 2.9 Carved sandstone arch is in good condition, with relatively little erosion. (Scattergood Design)

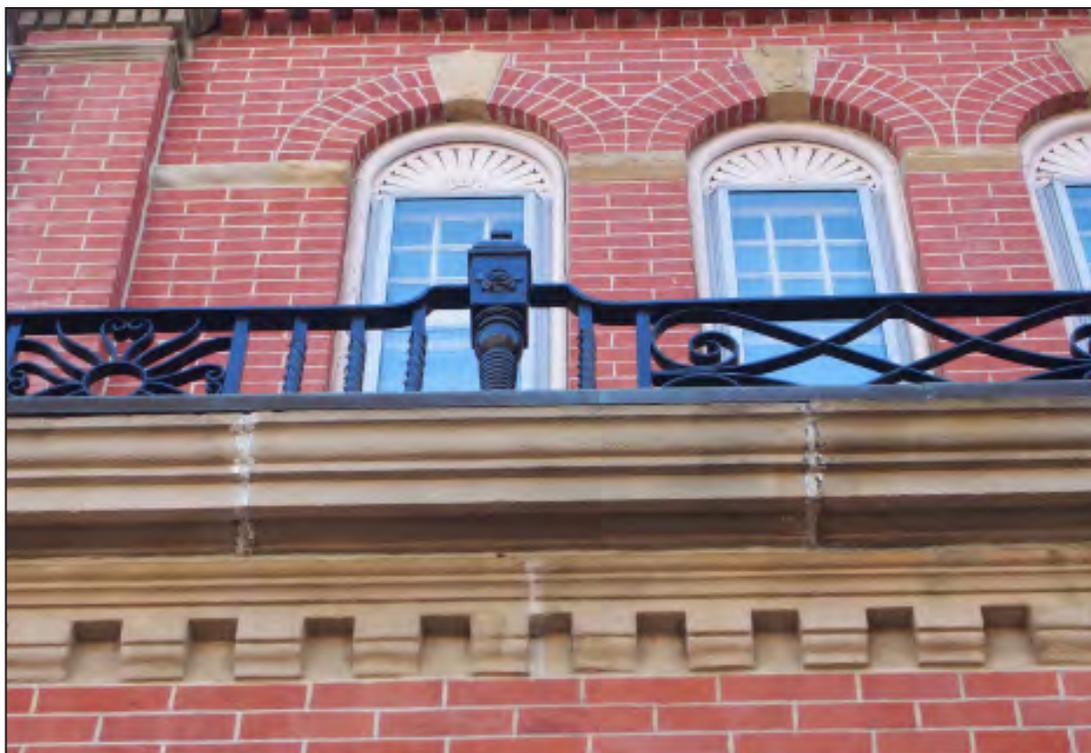
Fig. 2.10 Open joints and mismatched pointing in cornice above entrance. Iron railing has been recently repainted. Photos from the first decades after the Library was completed (Fig. 1.21) suggest that it was originally painted a tone closer to that of the stone. (Scattergood Design)

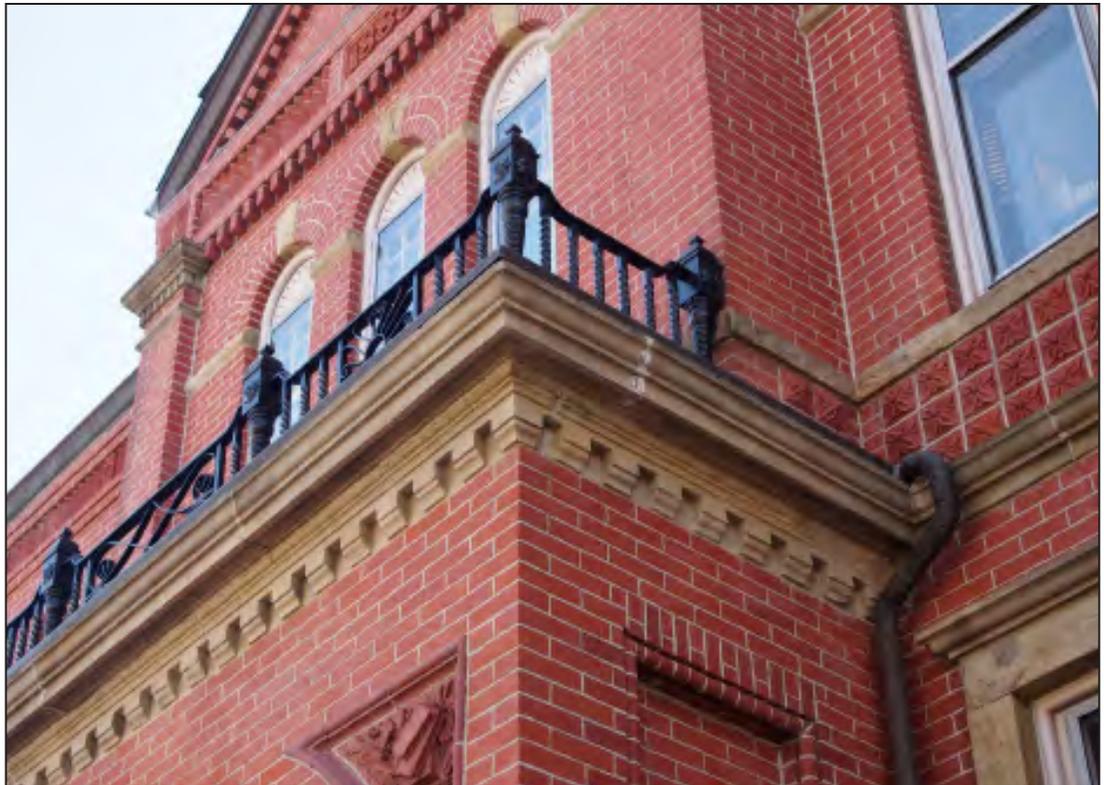
Fig. 2.12 South corner of entrance portico, showing open joints and mismatched mortar (Scattergood Design)

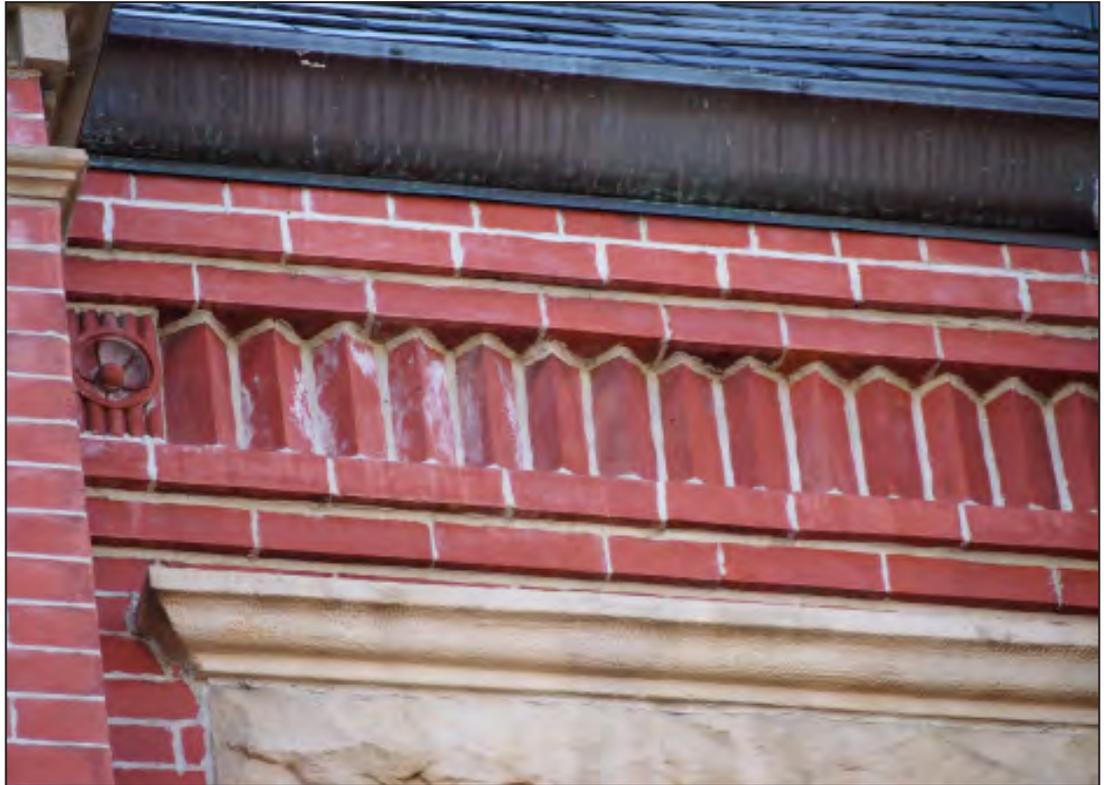
Fig. 2.13 Brick cornice and gutter south of entrance portico. Note smeared mortar in joints of angled brick. (Scattergood Design)

- Most brick and pointing is in good condition, though it appears that masonry saws used for cutting joints in the past chipped the brick edges and repointing mortar has been smeared over the edges (Fig. Fig. 2.13 and 2.24). Areas adjacent to downspouts (Fig. 2.21) have missing mortar. **Repoint approximately 5% of the mortar overall, using appropriate mortar mix and great care in cutting joints.**

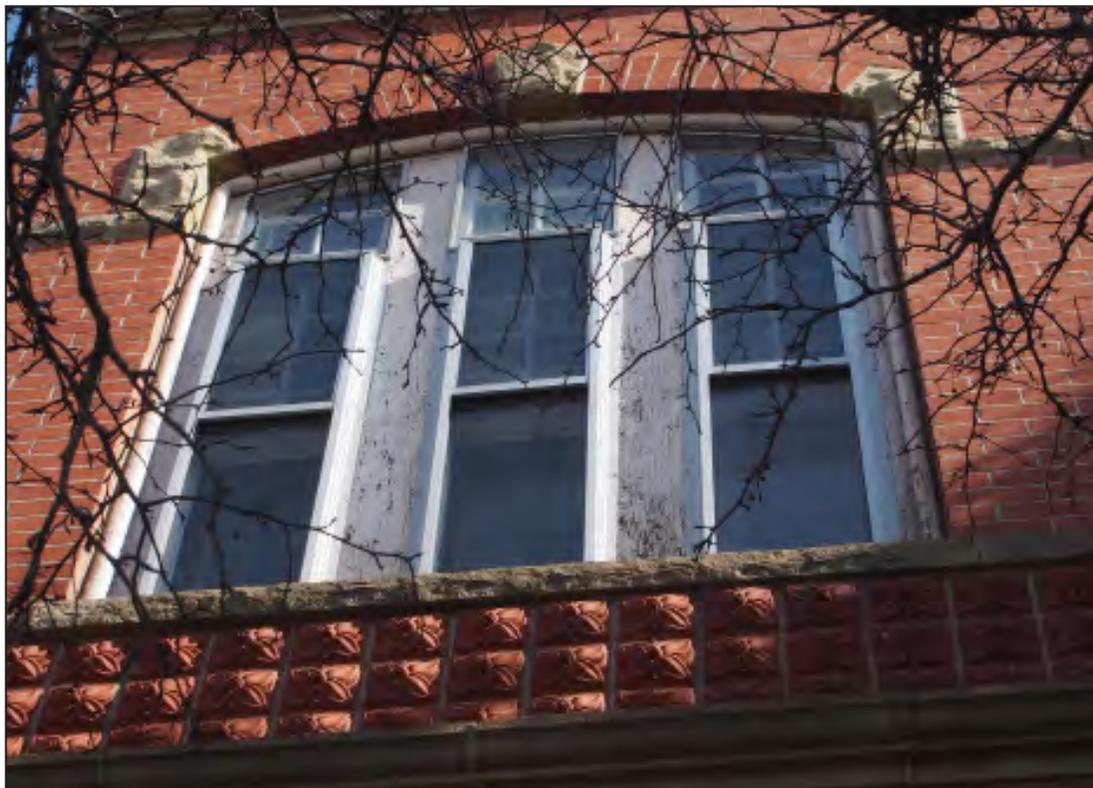
Fig. 2.16 Second floor window on south side of Tower. Note peeling paint at pilasters between sash. Storm windows obscure original sash configuration. (Scattergood Design)

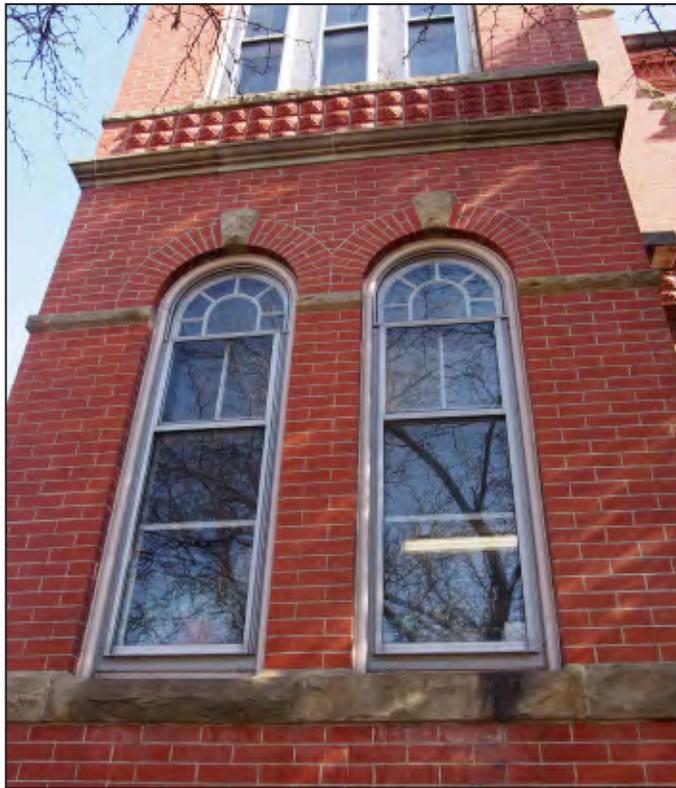
Fig. 2.17 First floor windows, south side of tower. (Scattergood Design)

- Stone under window air conditioners is stained as a result of runoff or biological growth (Figs. 2.17 and 2.18). **Analyze stains and clean with treatments appropriate for the stone.**

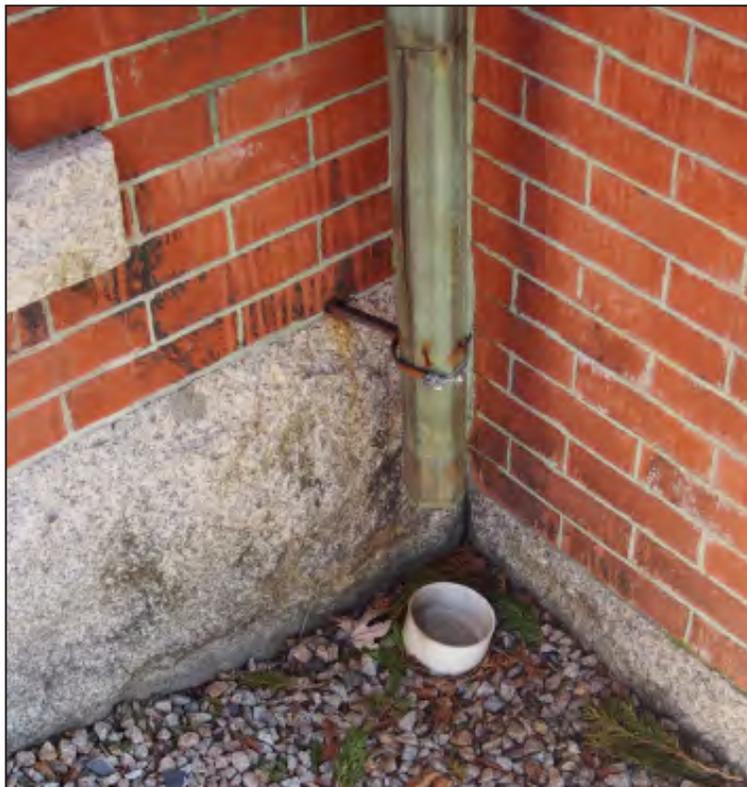
Fig. 2.20 Downspout at north corner of tower is not connected to drain.. (Scattergood Design)

- Downspouts typically feed into an underground drainage system via boots; in two locations, gutters either are disconnected from the boots, or the boots are broken (Figs. 2.20 and 2.40). The erosion of soil along the north, east and south sides (Figs. 2.22, 2.25, 2.38A)—as well as the spalling and efflorescence on perimeter walls of the basement (Figs. 2.105, 2.111, 2.112) indicate that uncontrolled roof runoff has been a problem over many years, as well as potentially leaks and/or blockages in the underground drainage system. **Review condition of underground drainage and repair or replace as required.**

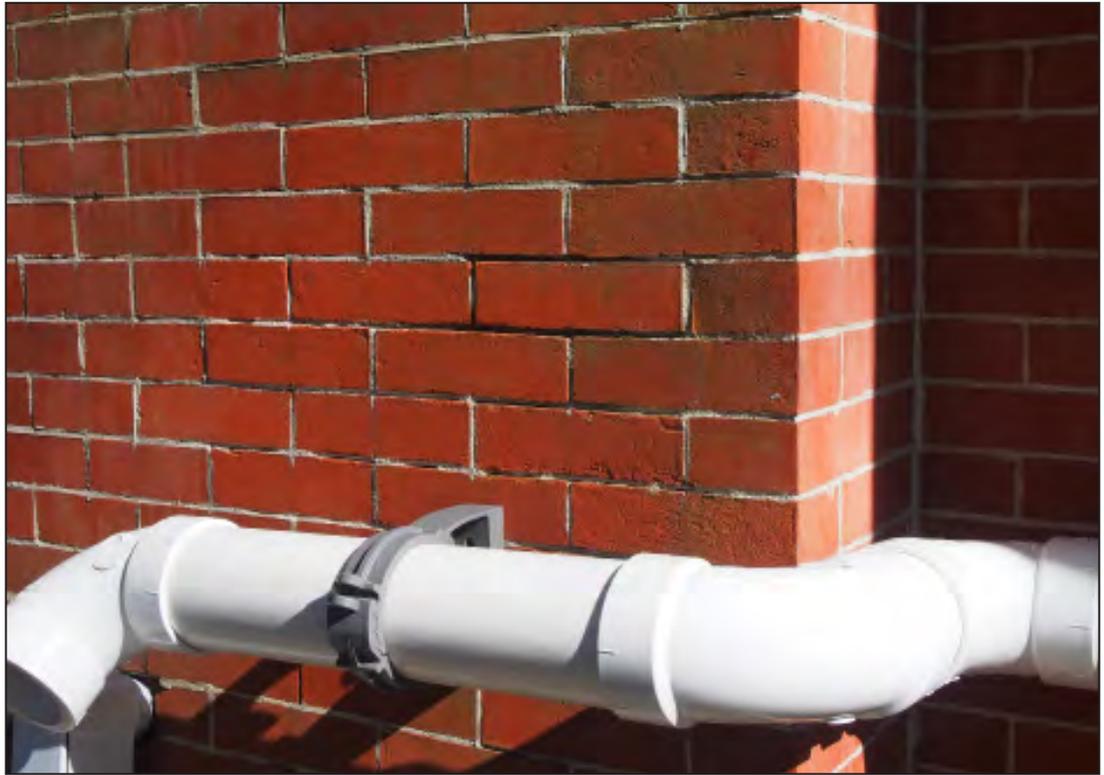
Fig. 2.21 Exposed PVC piping on south elevation with open mortar joints above. (Scattergood Design)

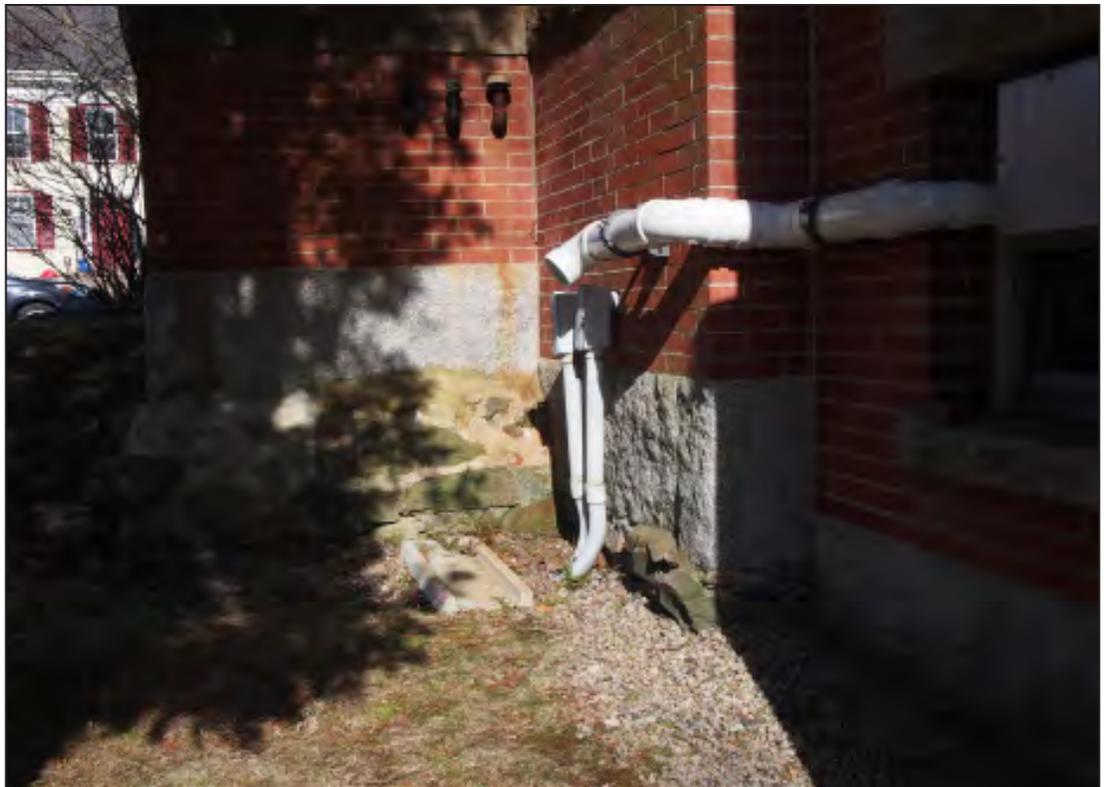
Fig. 2.22 Erosion of site adjacent to South elevation as a result of rainwater runoff. (Scattergood Design)
