Rice Public Library Renovation and Addition

Programming and Existing Conditions Report
June 28, 2019

On Thursday 21 February 2019, we visited the Rice Public Library (RPL). The intent of our visit was to review the existing conditions that are readily visible and comment on their conditions. Ms. Lee Perkins, the Library Director, showed us around and provided information on past building upgrades. The visit and review are being done in anticipation of a renovation and an addition that are currently being planned at RPL. The current library building is on the National Register of Historic Places.

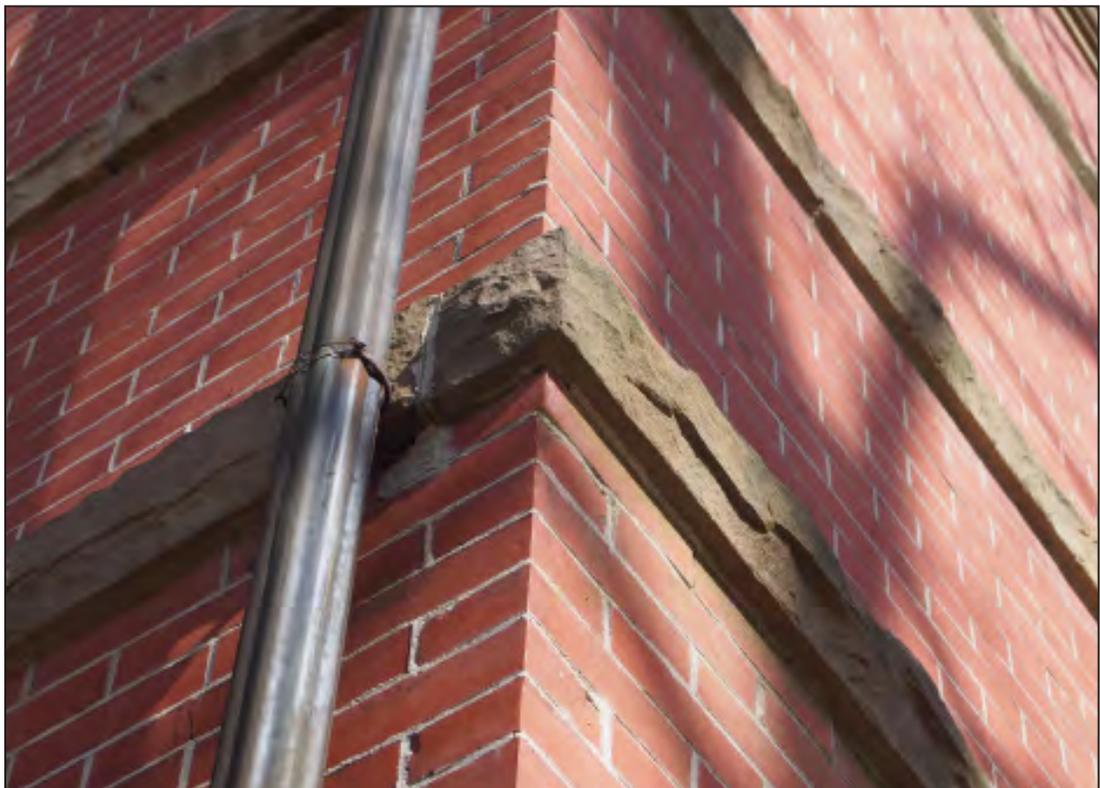
Fig. 2.30 Open joints at sandstone string course adjacent to downspout at southeast corner. (Scattergood Design)

- There are also open joints adjacent to downspouts on the rear (Fig. 2.30). **Repoint, using appropriate mortar mix and great care in cutting joints.**

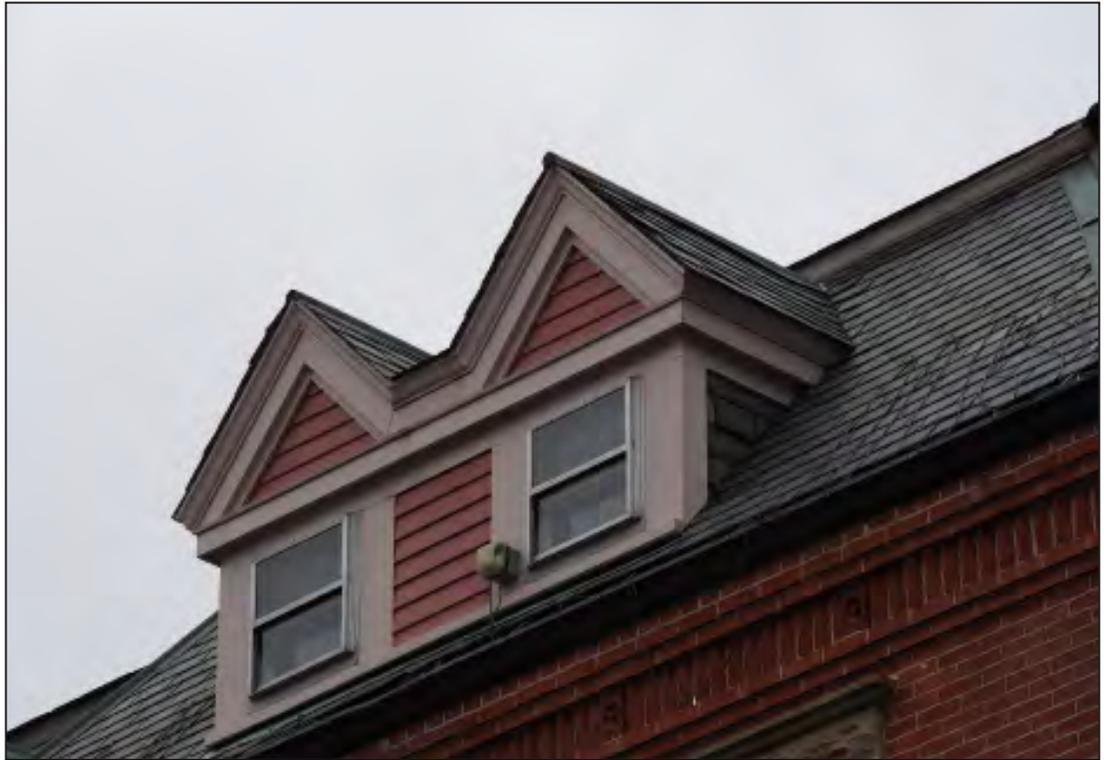
Fig. 2.33 Clapboards on dormer faces may have replaced slate. Note slate on sides. Clapboards, window trim and sash were originally painted a darker color. (Scattergood Design)

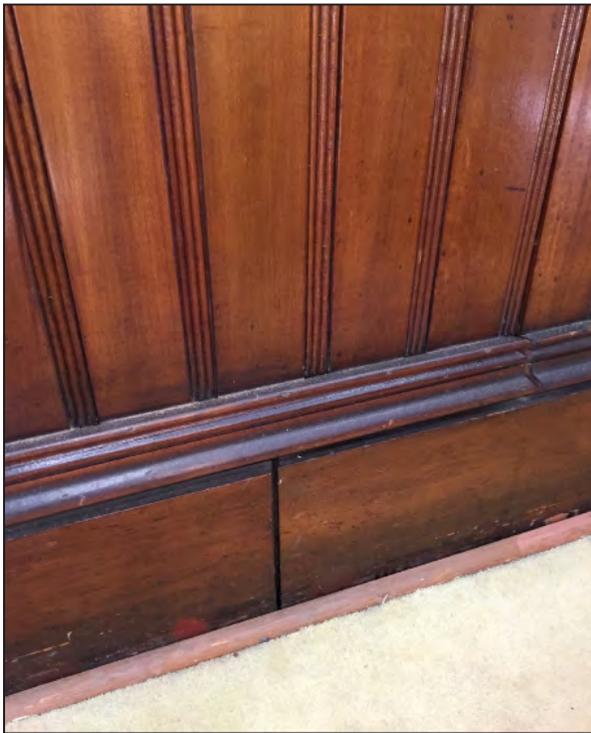
Fig. 2.65 Large crack in baseboard and panelling under window in center of east wall of Reference Room. (Scattergood Design)

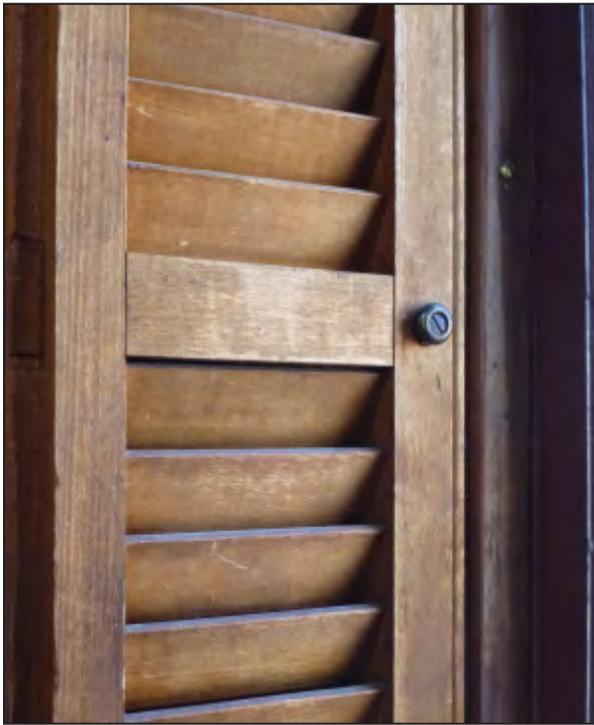
Fig. 2.65 Typical worn finish of wood window shutters. (Scattergood Design)

- Interior shutters are generally in fair to good condition. They could protect the woodwork from UV degradation, but typically are not closed, so the finish is deteriorated (Fig. 2.65). **Refinish.**

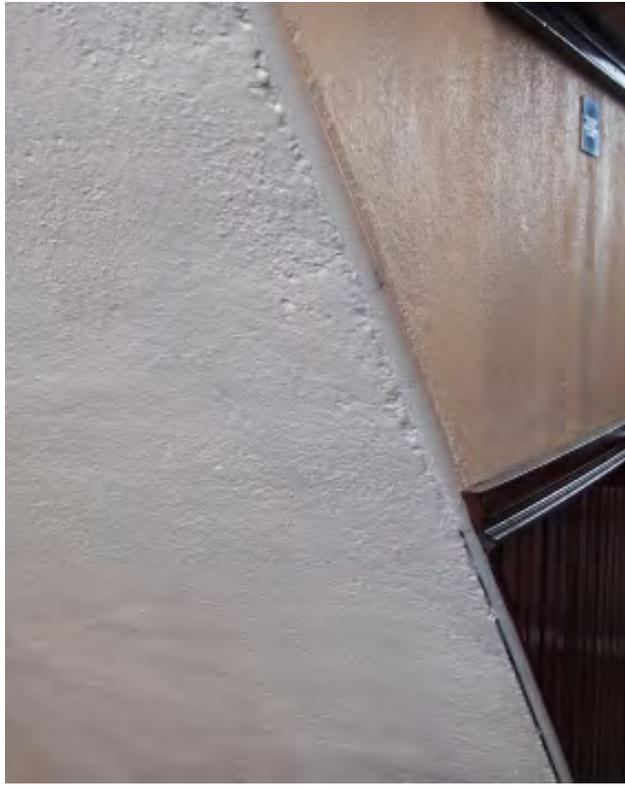
Fig. 2.74B Textured plaster in second floor hall is typical of most rooms. (Scattergood Design)

- Walls above the wainscot are two-coat plaster with a textured finish (Fig. 2.74B), as are ceilings. Most are in good condition.

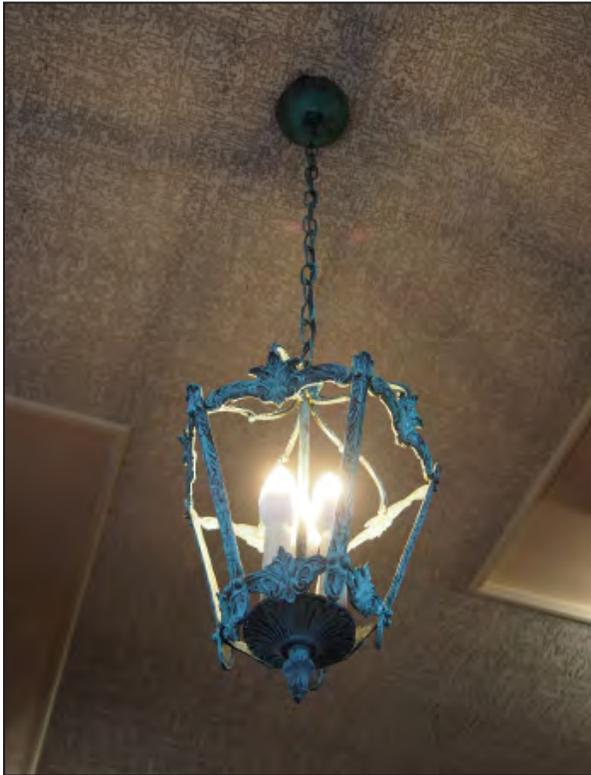
Any remaining original light fixtures appear to have been removed in 1991;²¹ the applied acoustic tile ceilings installed at that time obscure any evidence of earlier fixtures and paint treatments. The wrought iron pendant chandeliers in the vestibule (Fig. 2.50) and the Maine Room (Fig. 2.50) appear to be early 20th century. The date and original location of the two exterior lanterns now stored in the attic (Fig. 2.100) are unknown.

Fig. 2.77 Pendant lantern in Maine Room may originally have been an exterior fixture and appears to be early 20th century. (Scattergood Design)

- There appears to be no original (19th or 20th century) lighting in the building.
- ***Pendants in the first floor vestibule and second floor history room should be researched further to determine their age and origin.***
- The wood valance fixtures in most of the reading rooms (Fig. 2.79) provides efficient lighting to wash walls, but it significantly changes the character of the wall treatment.

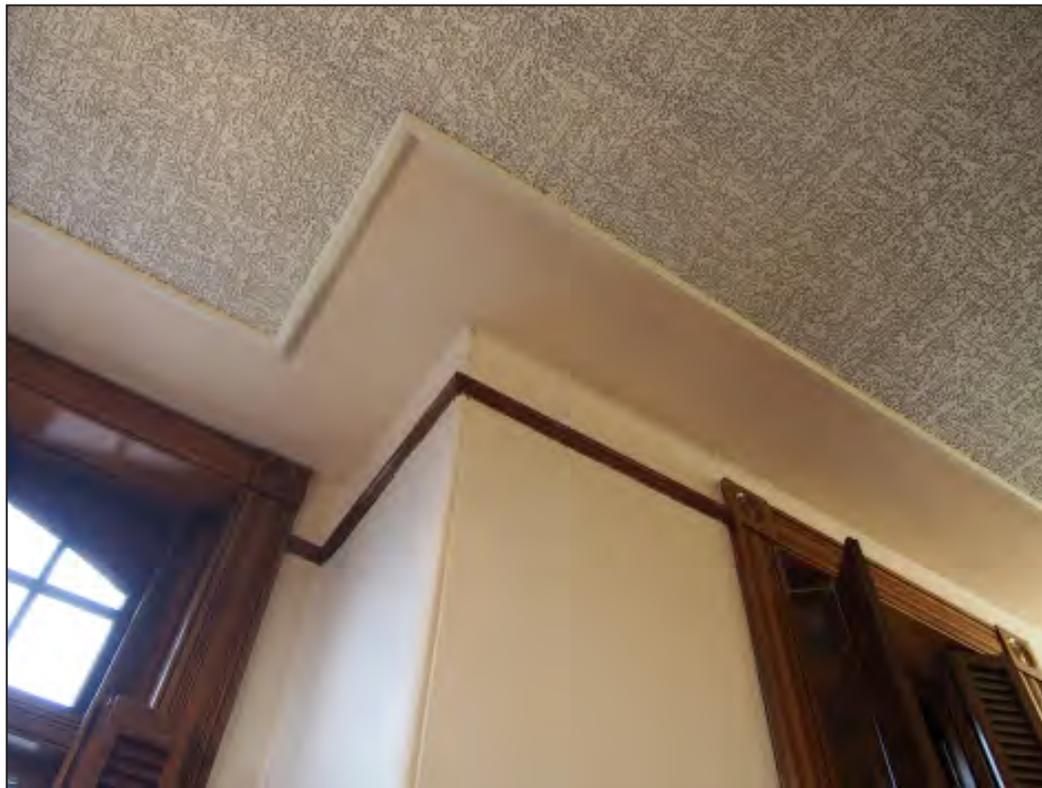
Fig. 2.78 Typical ceiling condition in Maine Room, showing original wood picture rail and inset applied acoustic tile with edge molding, installed c.1991. . (Scattergood Design)

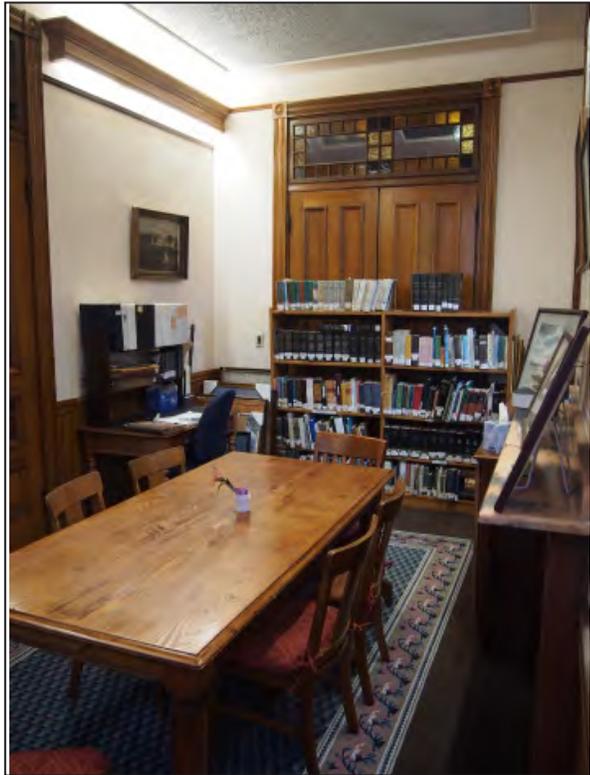
Fig. 2.79 View looking east in Maine Room. (Scattergood Design)

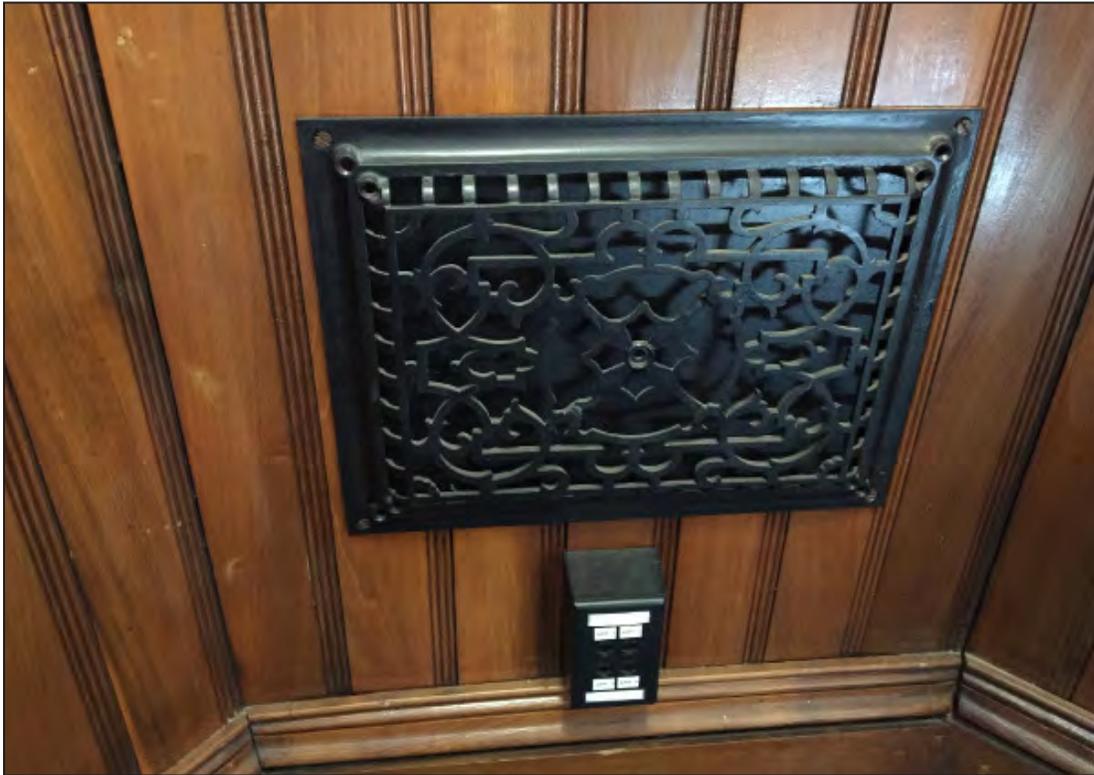
provided through a gravity system, with supply and return grilles located on vertical risers that fill the four corners of the space (Fig. 2.85), Hot air was exhausted through two roof-mounted ventilators at the north and south ends of the hall that are shown on the drawings and are visible in early 20th c. exterior views from all sides (Fig. 1.22 - 1.24).

Fig. 2.85 Heating vent at corner flues in Roberts Room. (Scattergood Design)

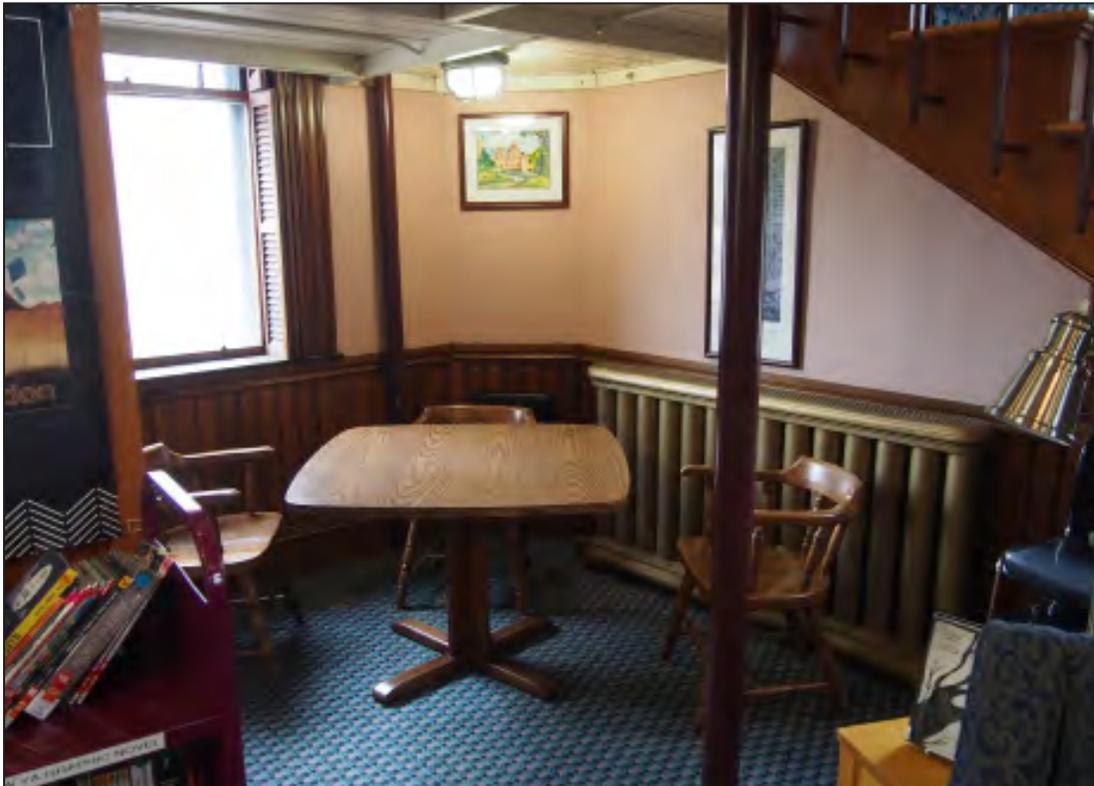
In 1915, the original heating system was replaced.¹⁵ The current furnace was installed in 2011, but cast iron radiators remain in the first and second floors (Fig. 2.86). The fireplaces in the four original reading rooms are very shallow, and it is not clear what fuel was used. Ventilation for the second floor was

Fig. 2.86 Typical steam radiator along walls of Roberts Room. (Scattergood Design)

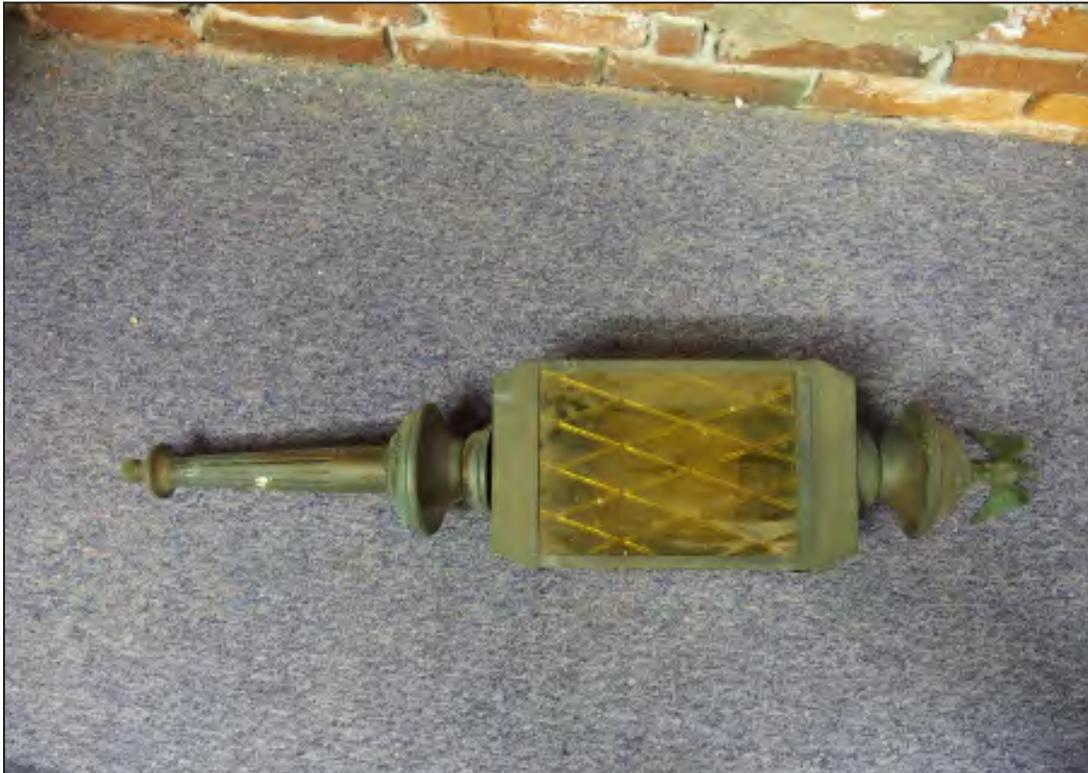
Fig. 2.100 One of two lantern wall sconces which may have flanked the entrance. (Scattergood Design)

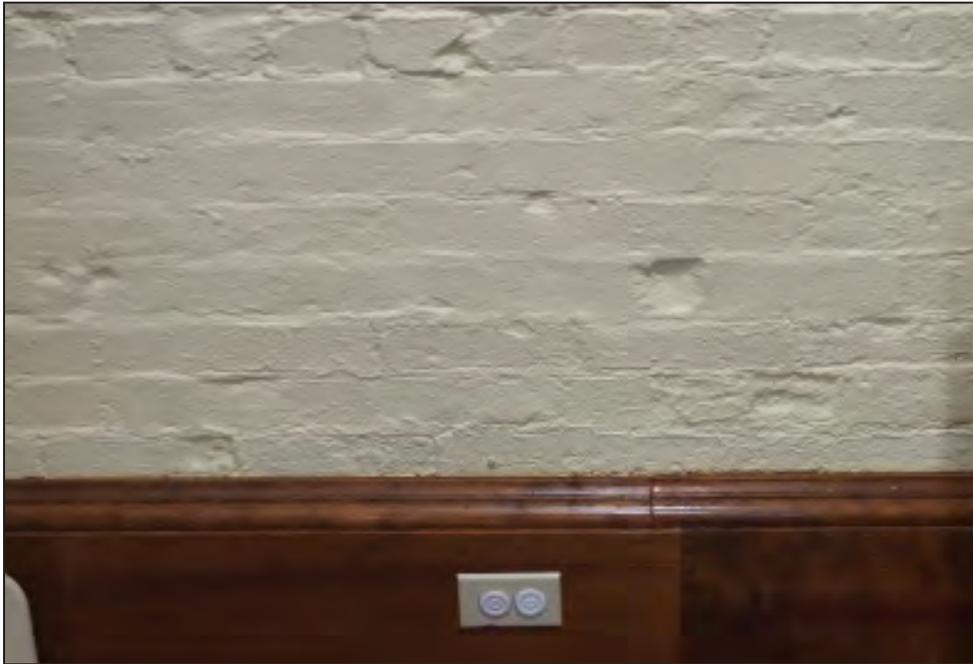
Fig. 2.105 Past brick spalling on south wall of Howells Room. (Scattergood Design)

- Walls in the basement are painted brick. As noted above, brick walls in the eastern portion have been recently painted, but evidence of spalling remains beneath the paint (Fig. 2.105). Unpainted foundation walls in the mechanical room also show efflorescence and loss of mortar. It is not clear how active the water infiltration may be. ***Review condition of underground drainage and repair or replace as required.***

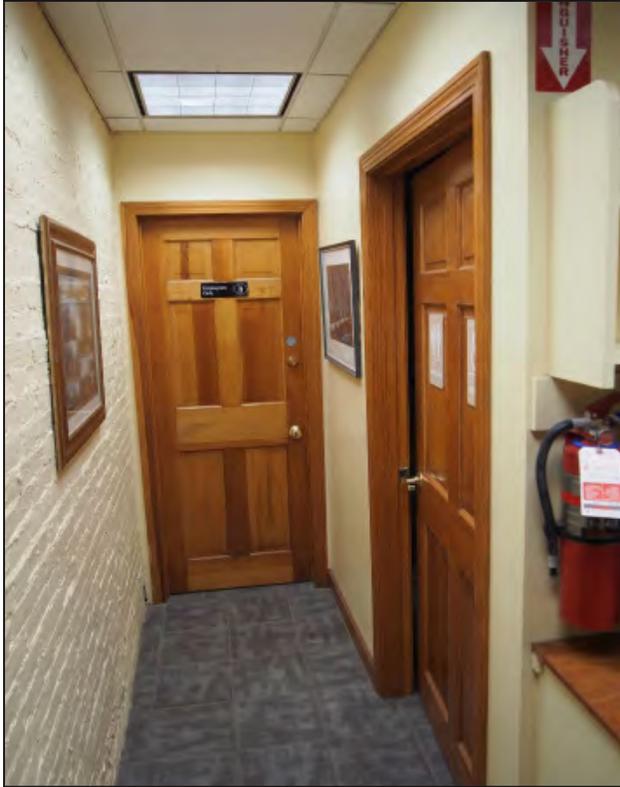
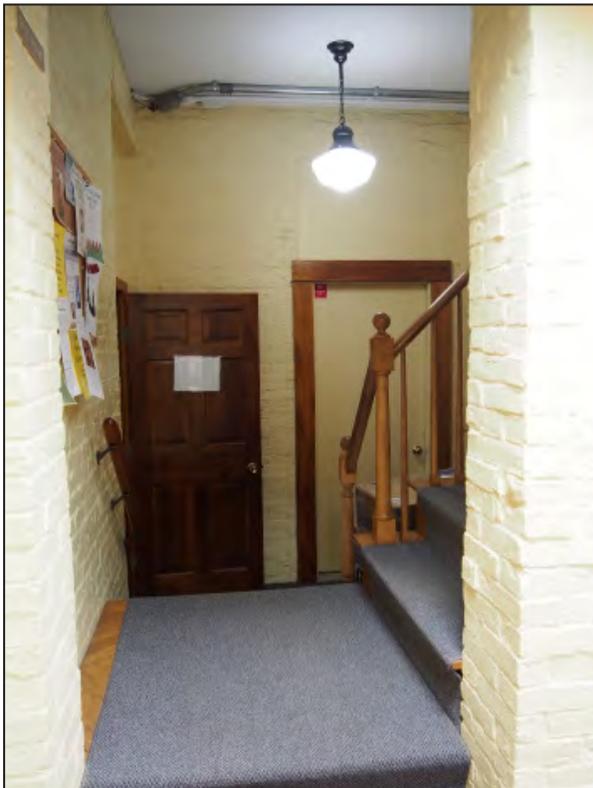
Fig. 2.107 A and B View across stair landing and looking west from Kitchen. (Scattergood Design)

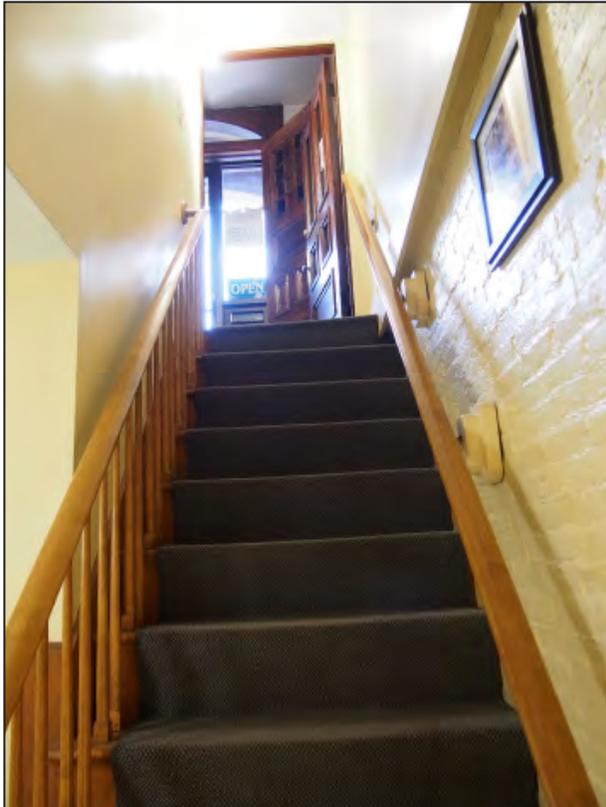
Fig. 2.108 View up stairs from Basement to entrance. (Scattergood Design)

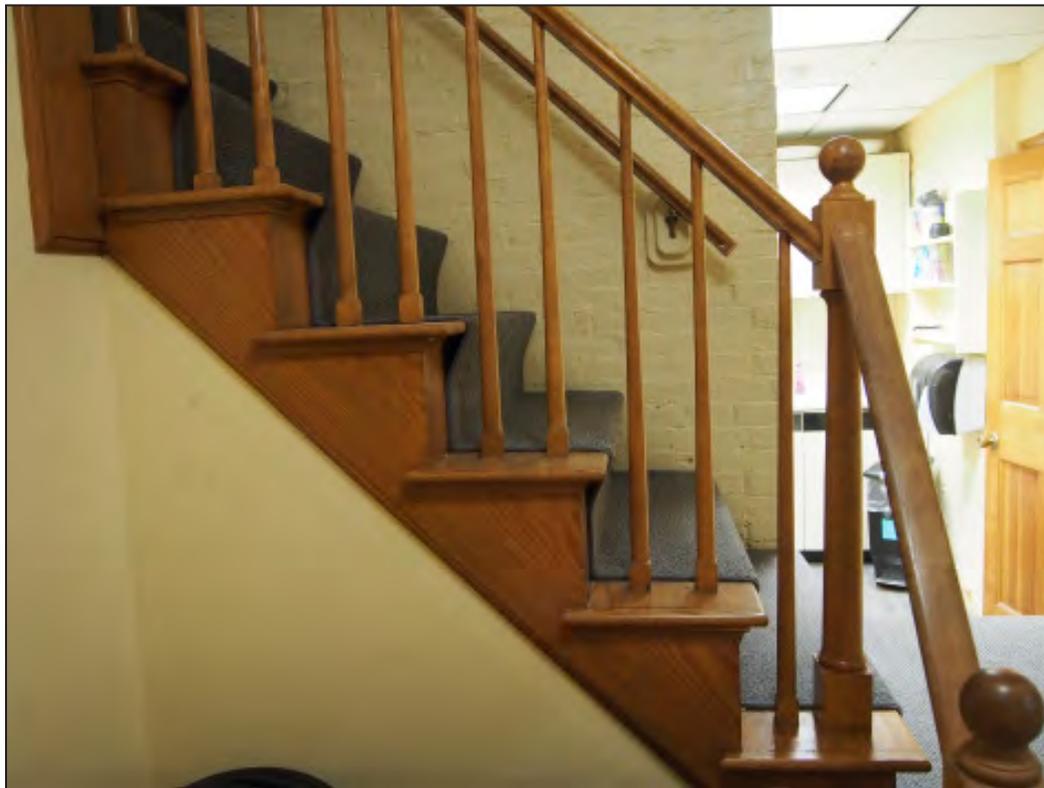
Fig. 2.109 Stair details at Basement level. (Scattergood Design)

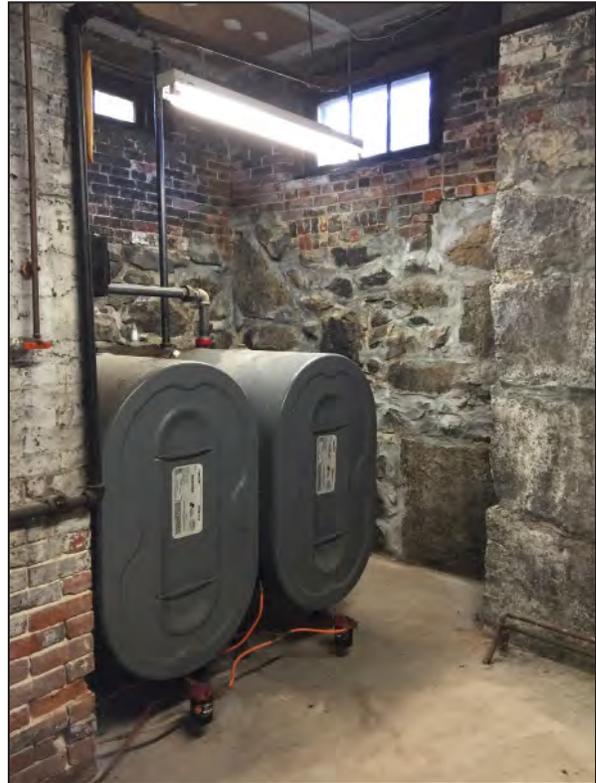
Fig. 2.110 Mechanical Room in southwest corner of Basement. (Scattergood Design)

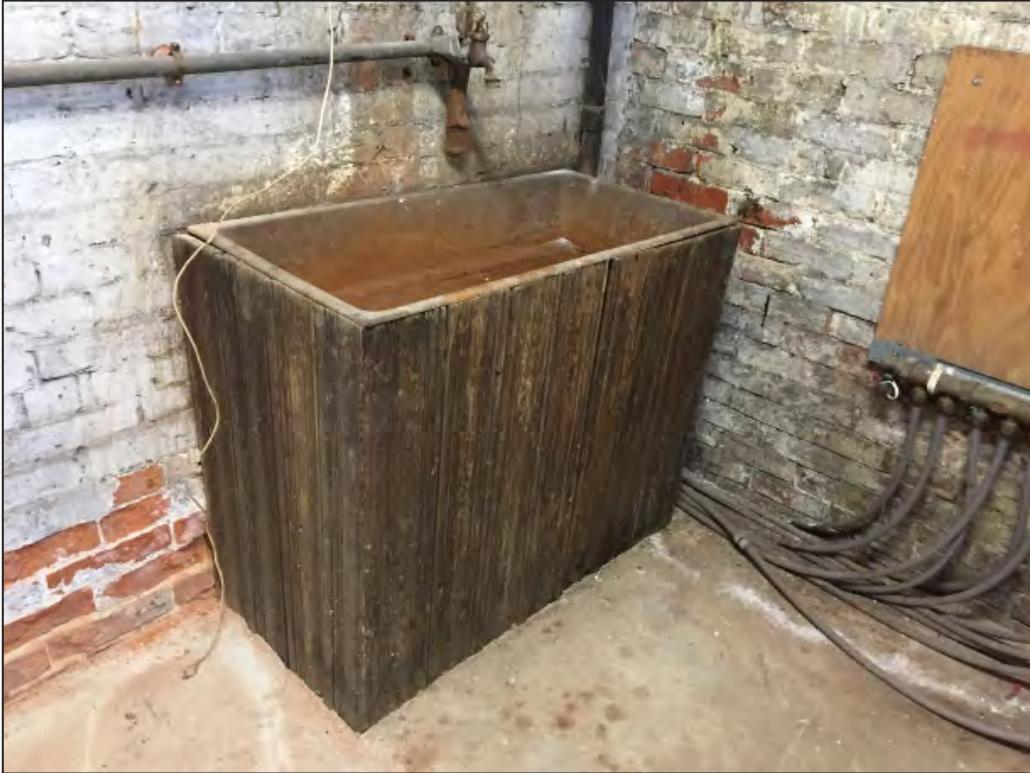
Fig. 2.112 View of old sink with beadboard sides in Mechanical Room. (Scattergood Design)

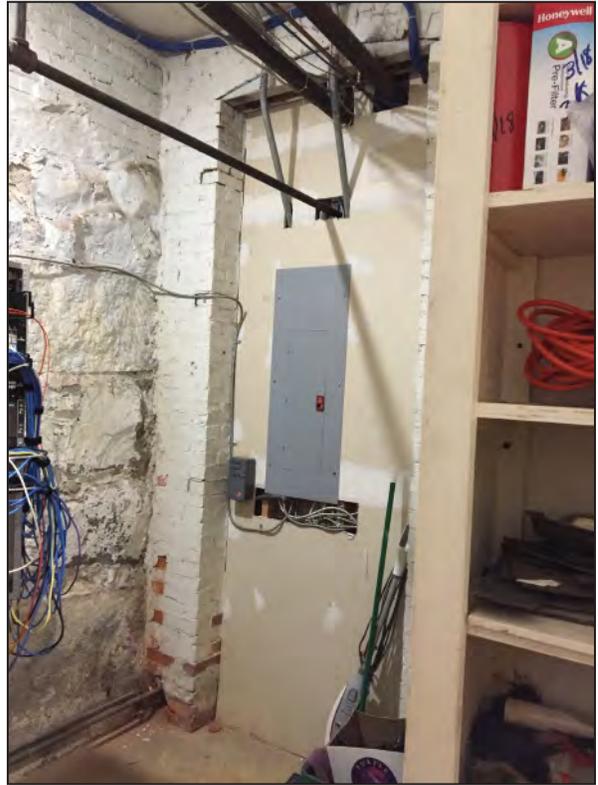
Fig. 2.114 View of Janitor Closet. (Scattergood Design)

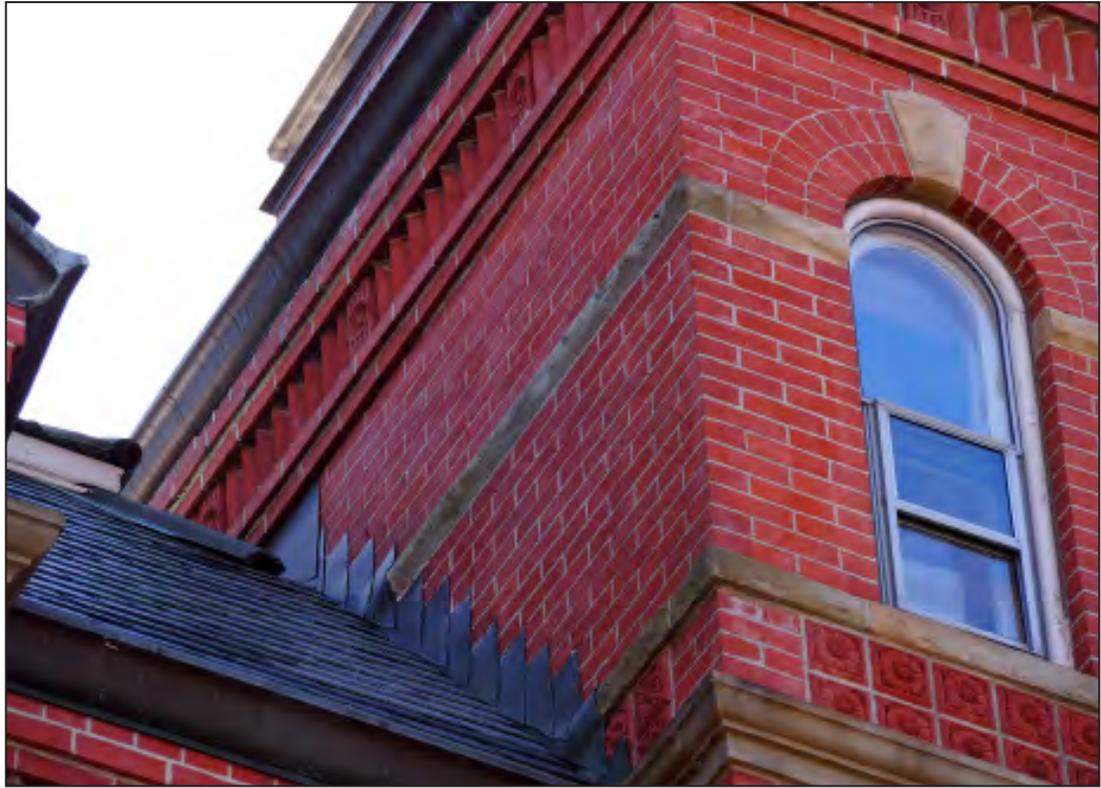
Fig. 2.46 Flashing at north side of tower intersection with main roof. (Scattergood Design)

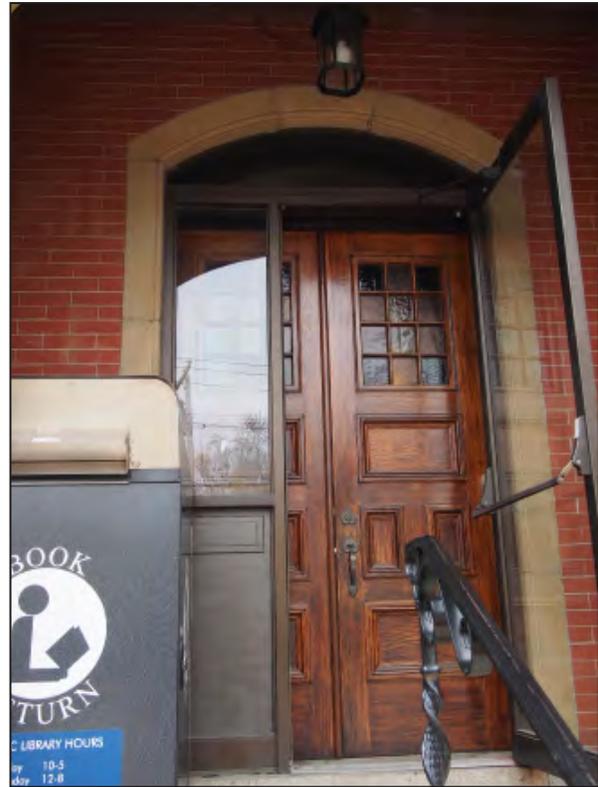
The original front door (Fig. 2.47B) has been preserved between an outer aluminum and glass door and sidelight, and an interior glass vestibule door. (Figs. 2.48 A and B). The original black and white marble floor (Fig. 2.52) remains in place, with a recessed inset for a walk-off mat. Two carved pink marble dedication tablets flank the opening to the Circulation desk (Fig. 2.51A), and a third tablet honoring trustees is located over the fireplace in the stacks.

Fig. 2.47B View of original entrance doors set inside aluminum door and sidelight. (SD)
