Rice Public Library Renovation and Addition

DRAFT Programming and Existing Conditions Report
March 20, 2019

Structural Observation Report
Rice Public Library
8 Wentworth St, Kittery, ME 03904

RICE LIBRARY (MAIN BUILDING) MECHANICAL & PLUMBING EXISTING CONDITIONS REPORT

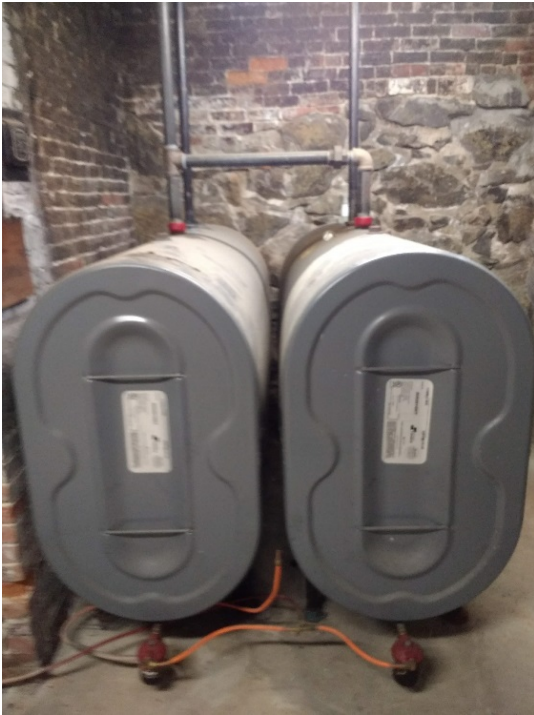
Figure 3 – Oil Storage Tanks

The building has two 330-gallon Aboveground Storage Tanks (ASTs) in the Basement Level Mechanical Room. The fill spouts exit through the first floor on south side of the building.

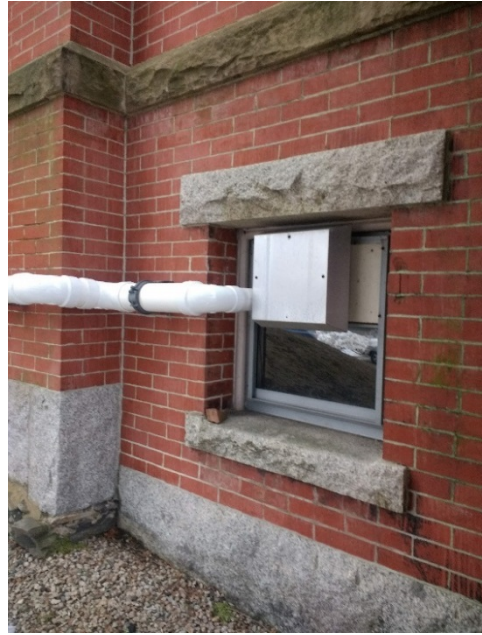
Figure 8 - Boiler Combustion Air Supply Fan Intake

A supply fan provided combustion air to the boiler and was interlocked to come on when the boiler burner came on.

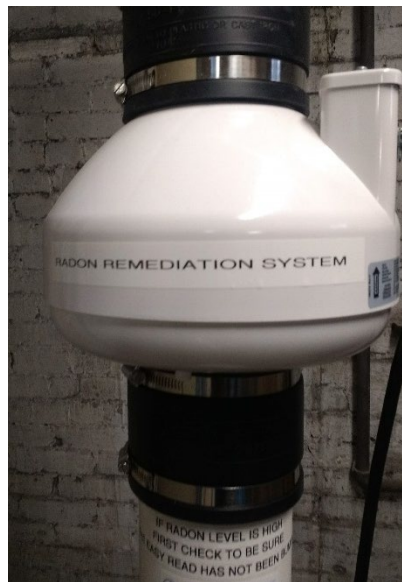
Figure 9 - Radon Mitigation System

A radon mitigation system was installed in the Basement Level Mechanical Room. According to the Library Director the system was required to be installed and operate continuously as part of the mitigation plan for a hazardous underground chemical plume coming from a former dry-cleaning establishment across the street.

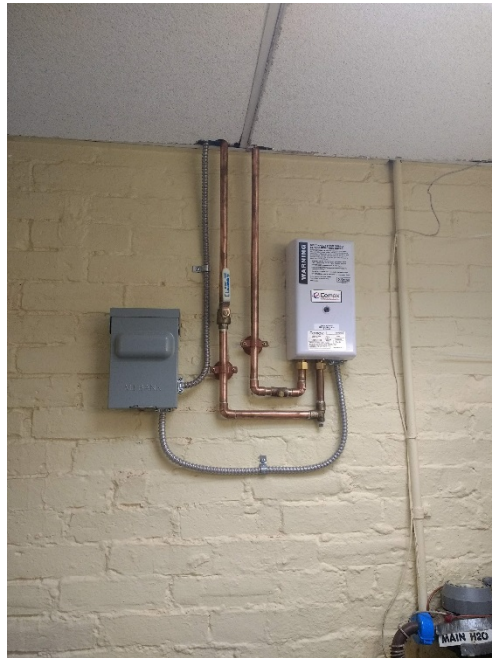
Figure 12 – Typical Electric On-Demand Water Heater

Domestic Hot Water (DHW) was provided by three electric on-demand water heaters. One water heater served the Basement Level Staff Restroom, one served the Public Restroom and Kitchenette Sink (assumed, not confirmed). On the First Level, one water heater served the Public Restroom.
